Technical Service Bulletin

96 Garage door opener intermittently loses programming

96 13 64 2029384/2 June 20, 2013. Supersedes Technical Service Bulletin Group 96 number 12-32 dated April 27, 2012 for reasons listed below.

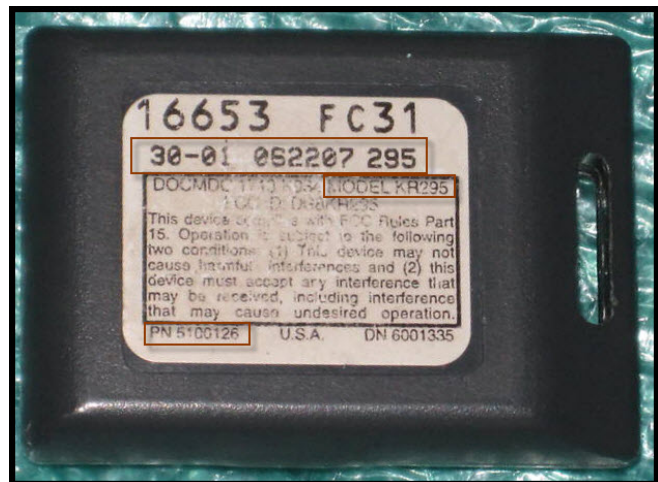
Figure 1. Sentex Transmitter (back view) with model number KR295, where “295” denotes the operational frequency.

2. If the transmitting frequency is found to be 295Mhz, the garage door opener control module needs to be replaced. Proceed to “Replace the garage door opener control module”, below.

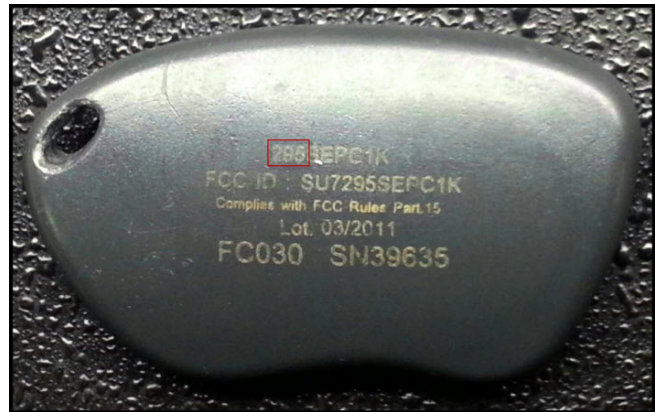
Figure 2. Stingray Transmitter (back view) with model number 295SEPC1K, where “295” denotes the operational frequency.

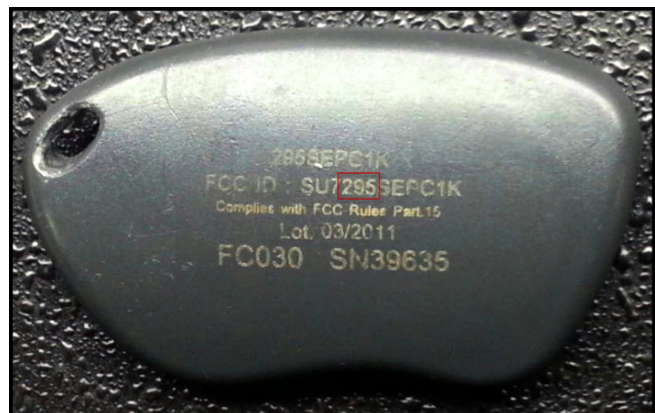
Figure 3. FCC ID is listed as “SU7295SEPC1K”, where “295” indicates the transmitting frequency.

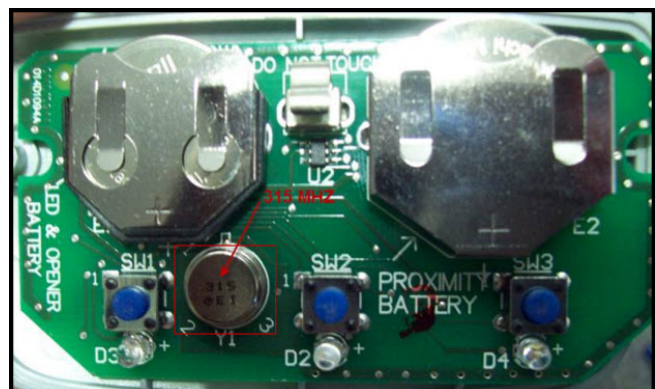
Figure 4. Circuit board component with stamped frequency of “315”, indicating the transmitting frequency. This unit is not affected by this condition because it operates at 315Mhz.

If the transmitting frequency is not found to be 295Mhz, this TSB does not apply. Continue analysis on the issue.

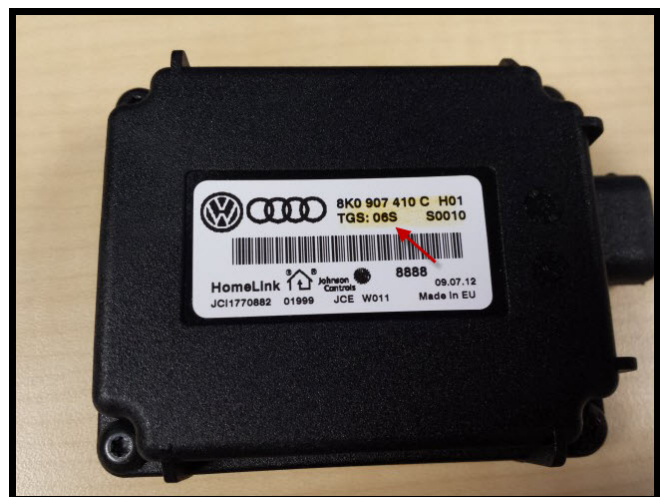
Figure 5. Locating the TGS level on the part label. This example shows part number 8K0907410C, with TGS level 06S.

1. Ensure that the Parts Manager uses the ETKA FI Search to find the correct part number, as there are multiple service parts numbers available. The required service part number may vary based on vehicle build date, and it may be different than the original part number taken from the vehicle.
2. Confirm that the new service part has the appropriate TGS level (Figure 5):
 - If the vehicle requires part number **8K0907410C**, the improved part will have a TGS level of **06S** or higher.
 - If the vehicle requires part number **4G0907410A**, the improved part will have a TGS level of **03S** or higher.
 - If the TGS level is lower than expected, reorder the part. If an older part is sent again, contact the Technical Assistance Center.
