# Technical Service Bulletin

## 61 Blistering in paint on carbon composite panels

61 13 19 2033516/2 June 13, 2013. Supersedes Technical Service Bulletin Group 61 number 13-18 dated June 12, 2013 for reasons listed below.

Model(s)	Year	VIN Range	Vehicle-Specific Equipment
R8 Spyder	2012	All	Not Applicable

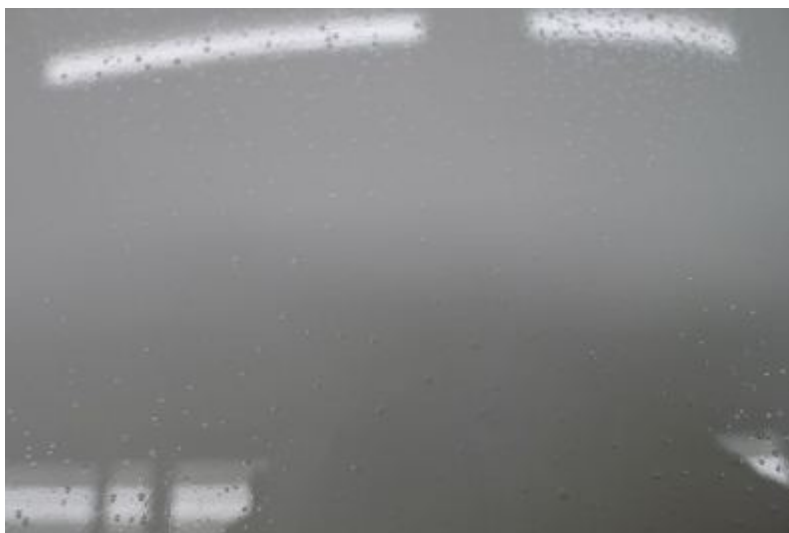
The painted surface of certain carbon composite constructed exterior body panels exhibit a 'blistering' condition (Figure 1).

**Figure 1.** Paint blistering condition.

Due to a malfunction during the resin injection process in the manufacture of these panels, the painted surface of the panel may blister under certain environmental circumstances.

Should the blistering condition described in this TSB be discovered, the vehicle will need to be transported to your Authorized Audi R8 Body Shop as the affected panel must be **replaced**. The panel cannot be refinished as recurrence of this paint condition is likely if an affected panel is refinished.

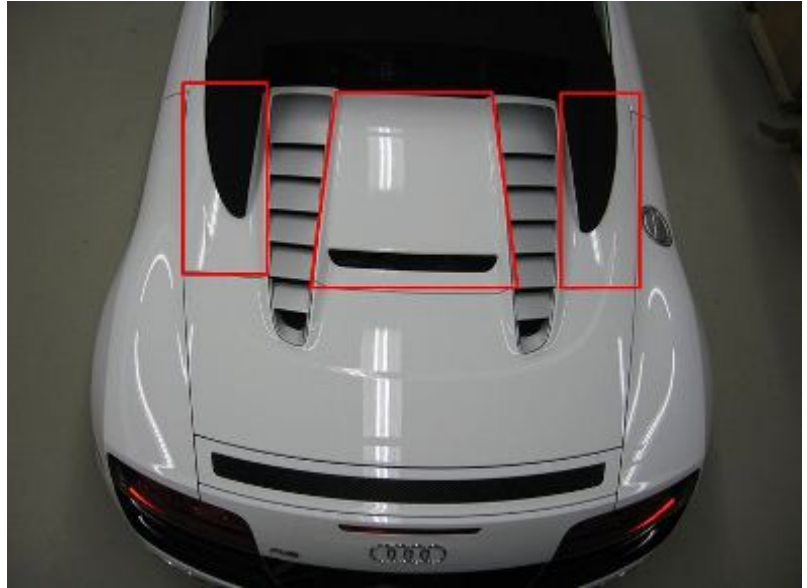
- Convertible top compartment cover (Figure 2)

**Figure 2.** Areas of the cover that are affected.

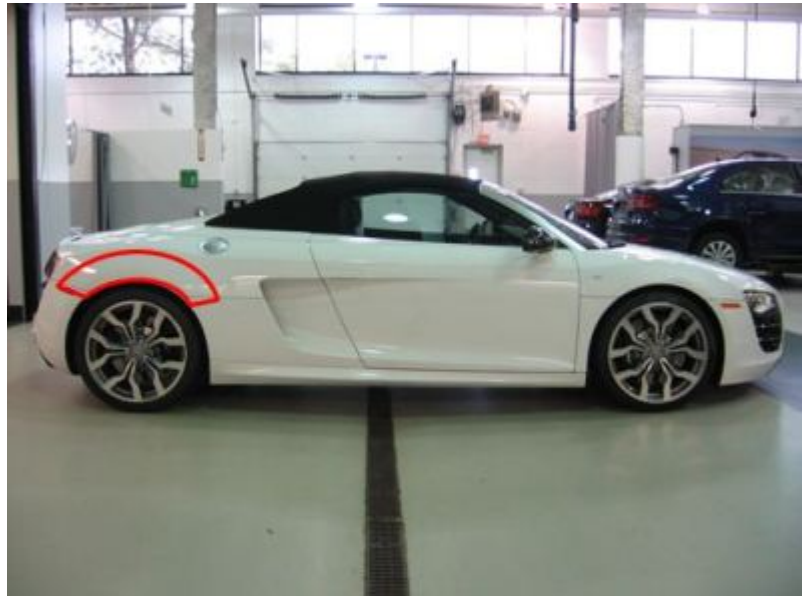
- Upper rear quarter panel - right (Figure 3)

**Figure 3.** Area of right rear quarter panel affected.

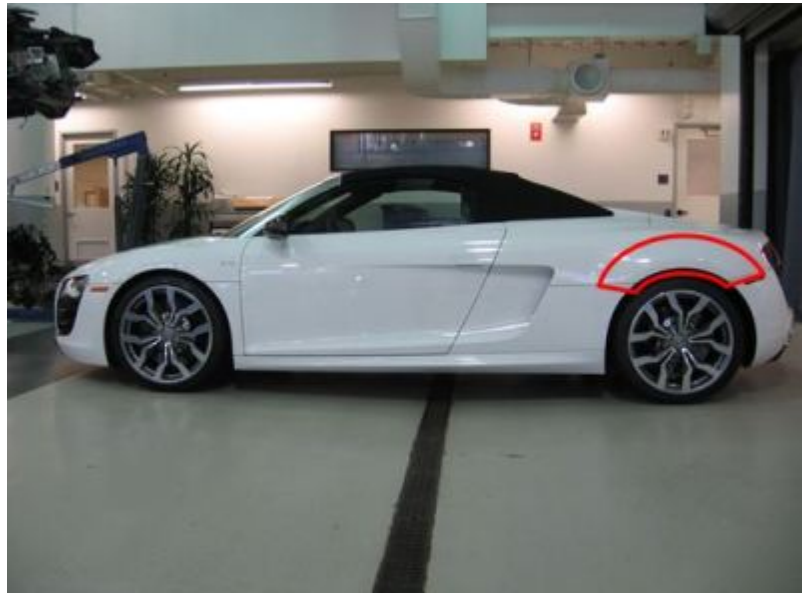
- Upper rear quarter panel - left (Figure 4)

**Figure 4.** Area of left rear quarter panel affected.
