Technical Service Bulletin

46 S4 and S5 squealing from front brakes (PR-1LJ)

46 13 41 2027636/6 June 11, 2013. Supersedes Technical Service Bulletin Group 46 number 13-30 dated March 13, 2013 for reasons listed below.

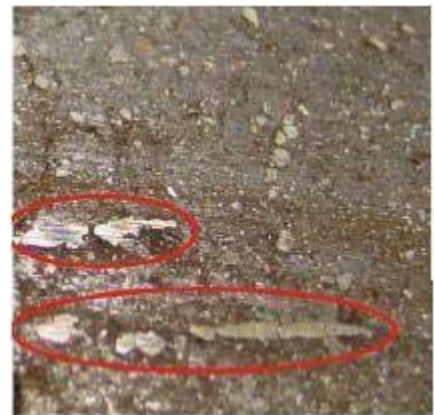
- Foreign bodies between brake disc and brake pad, such as small stones, grit, or sand.
- Un-ground or corroded friction materials.
- Brake discs or brake pads are close to their wear limit. (Front brake disc wear limit: 28mm. Front brake pads wear limit with backing plate and dampening sheet: 7mm.)
- Metallic deposits from disc material in brake pad (Figure 1).

Figure 1. Metallic deposits.

- Deposits in brake pad.

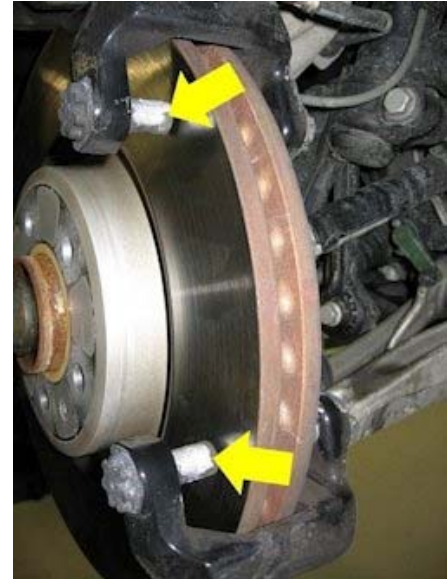
Figure 5. Caliper carrier guide pins with anti-seize (**G 052560A2**) lubricant applied where the pads make contact.

- Apply a thin coat of anti-seize (**G 052560A2**) lubricant to the guide pins of the caliper carrier prior to installing the brake pads (Figure 5). Only apply this lubricant to the section of the guide pins that will be contacted by the brake pads.
