# Technical Service Bulletin

## 97 ABS warning light on - wire harness damage

97 13 35 2033412/1 March 27, 2013.

Model(s)	Year	VIN Range	Vehicle-Specific Equipment
A5/S5/RS5 Cabriolet	2010 - 2014	All	Not applicable
A4/S4	2009 - 2014	All	Not applicable
Audi Q5	2009 - 2014	All	Not applicable
A5/S5/RS5	2008 - 2014	All	Not applicable

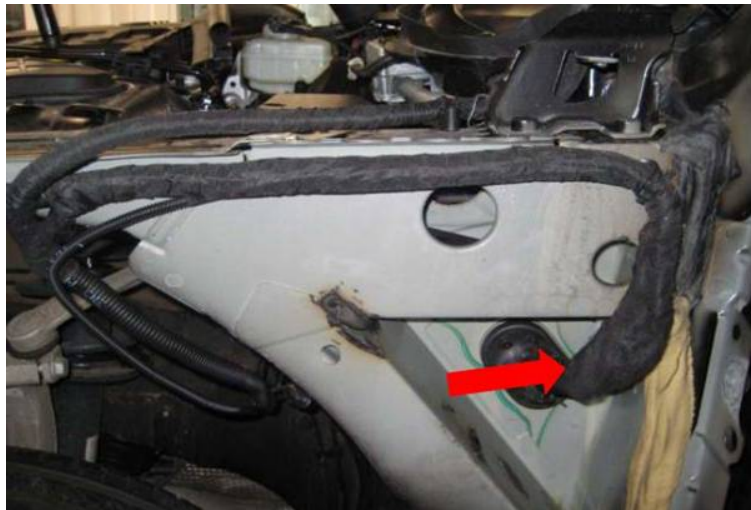
The insulation for the ABS wheel speed sensor is damaged in production. Over time, this can lead to corrosion on the wires and restricted functions with the ABS control module. Only the wires in the left bulkhead grommet (Figure 1) are affected.

**Figure 1.** Left front fender is removed to show the left bulkhead grommet

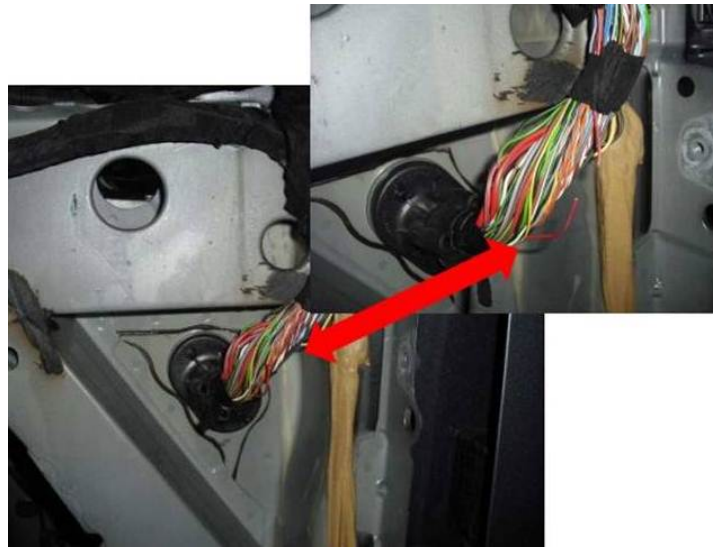
- Apply a load (1.7 A = 21 W) on pin 7 (T38a) to ground
- Set the digital multi-meter to DC Volts (Direct current voltage)
- Connect the black multi-meter measuring tip to pin 7 (T38a) and connect the red measuring tip to fuse SC6 while keeping the fuse in the socket.
- If the voltage drops (over 0.3 V), the wiring loom around the grommet must be checked (Figure 2)

**Figure 2.** Affected area of the left front wiring loom behind the fender

**Tip:** For better access to all sections of the wiring loom, the wheel arch liner and the windscreen washing reservoir must be removed.

3. Repair the damaged cable in the wiring loom using the VAS1978B wiring harness repair kit.
4. Remove the sections of the individual cable where the copper wires are black or corroded.
5. Pull back the insulation for the complete wiring loom, for a distance of about 40 cm from the grommet towards the front of the vehicle, and inspect for additional damage or corrosion.

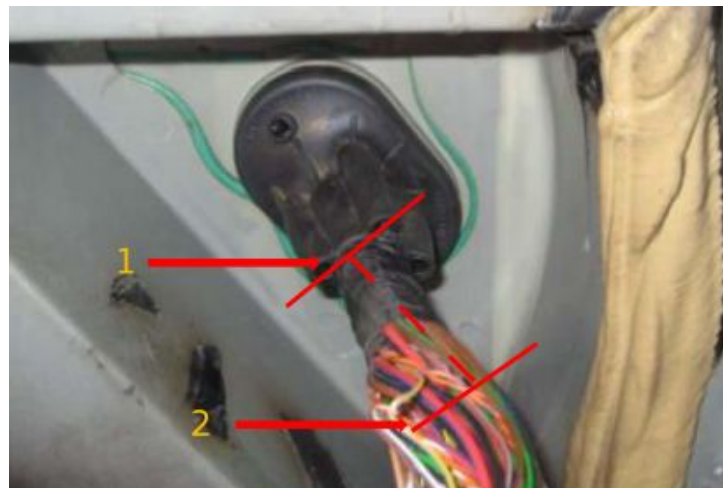
- Measure the distance from the **grommet front side** (Figure 3, point 1) to the **point of damage point** (Figure 3, point 2). Include this measured distance in the TACS contact.

**Figure 3.** Measuring point of damage in relation to the end of the grommet

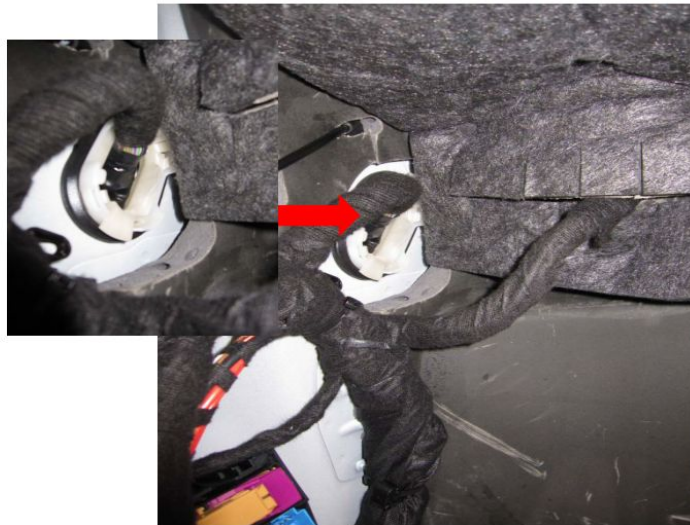
- Take a photo, using camera flash, of the grommet and original harness position from the passenger compartment (Figure 4). Please attach the photo to the TACS contact.

*Figure 4. Grommet position photo, taken from inside the passenger compartment.*
