Technical Service Bulletin

94 Headlight switch pressed in

94 13 12 2017566/4 March 29, 2013. Supersedes Technical Service Bulletin Group 94 number 09-23 dated August 12, 2009 for reasons listed below.

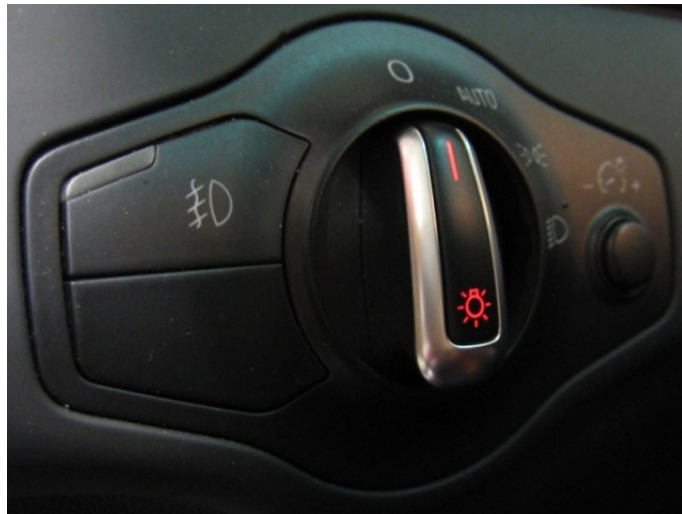
Headlight switch knob is pressed in. The switch functions correctly.

The headlight switch knob was designed with a normal position and a pushed-in position (Figures 1 and 2). This is a deliberate design feature designed to avoid injuries in the event of a collision.

Figure 1. The headlight switch knob, pushed in.

1. Pull out the knob and return it to the original position.
2. Explain the safety feature to the customer.

Do not replace the switch as it will be debited.

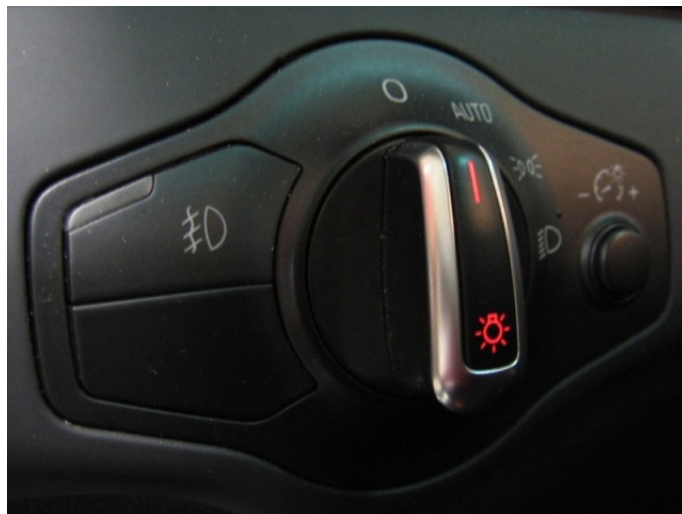
Figure 2. The headlight switch knob, in normal position.
