Technical Service Bulletin

21 Mil on - P0299 Negative pressure deviation, turbocharger excessive wastegate play

21 13 12 2031245/3 April 1, 2013. Supersedes Technical Service Bulletin Group 21 number 13-11 dated March 6, 2013 for reasons listed below.

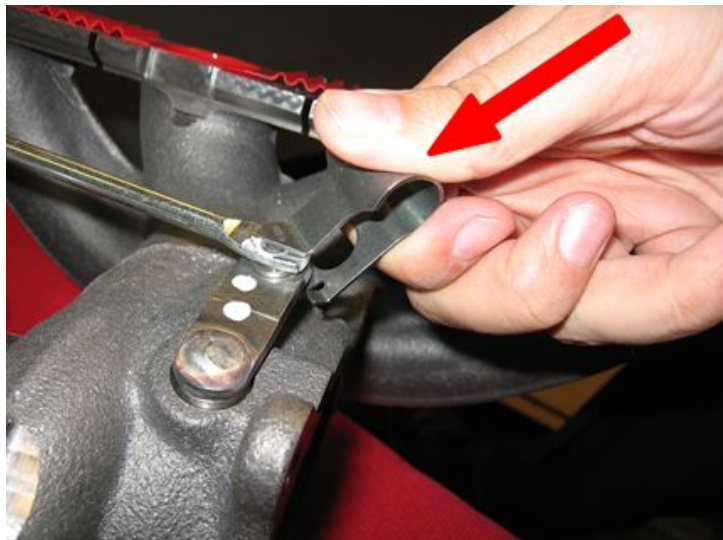
Figure 1. Fit the clip from the side.

1. Remove turbocharger as per ELSA instructions: *Repair Manual >> Engine / Engine Mechanical >> 21 Turbocharger, G-Charger >> Removal and Installation >> Turbocharger.*
2. Install clip **06J145220B** on a replacement turbocharger's link plate and actuating rod joint as illustrated (Figures 1 and 2).

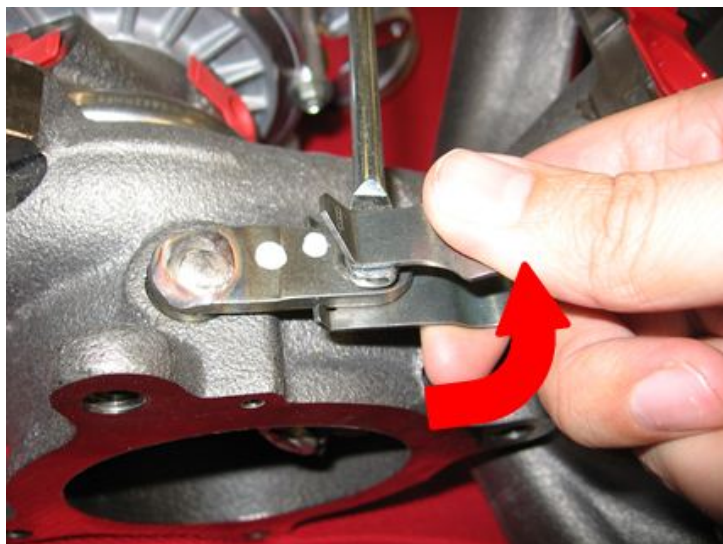
Figure 2. Turn the clip counter clockwise till the lugs slot in.

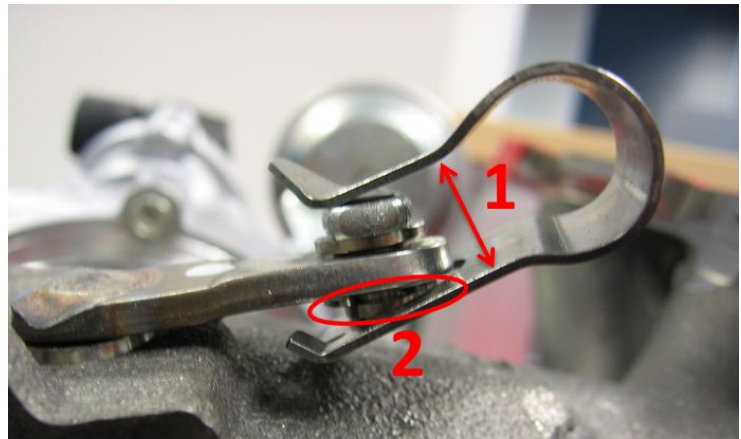
Figure 3. (1) Maximum opening of clip, (2) Position of original circlip

- The spring clip must not be overstretched. The maximum opening of the spring clip is 14 mm (Figure 3, 1).
- The spring clip must be replaced after every removal.

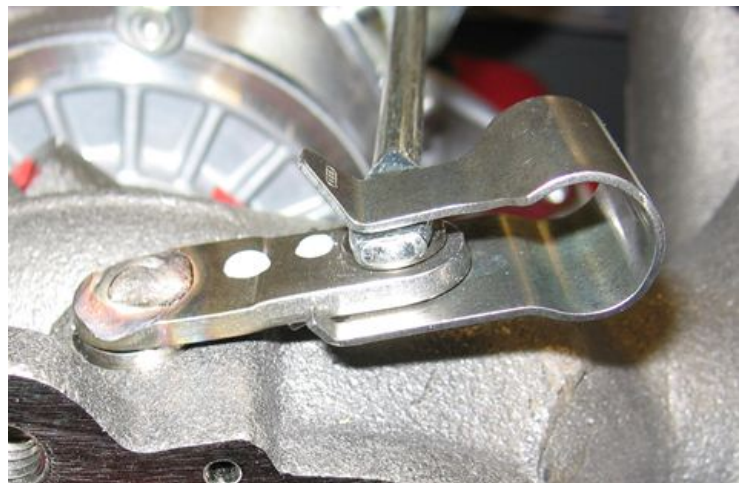
Figure 4. Correctly-fitted clip.

3. After fitting the spring clip, check for correct fit (Figure 4).

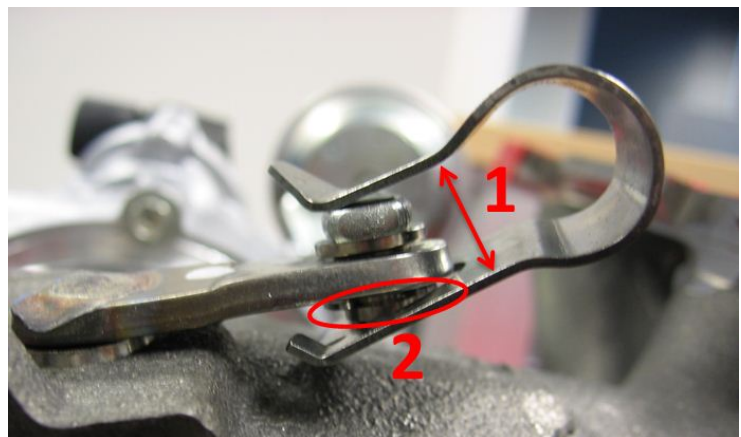
Figure 5. (1) Maximum opening of clip, (2) Position of original circlip

4. After fitting the spring clip, check the position of the original circlip (Figure 5, 2) and correct it if necessary.
