Technical Service Bulletin

21 Mil on - P0299 Negative pressure deviation, turbocharger excessive wastegate play

21 13 13 2031245/4 April 4, 2013. Supersedes Technical Service Bulletin Group 21 number 13-12 dated April 1, 2013 for reasons listed below.

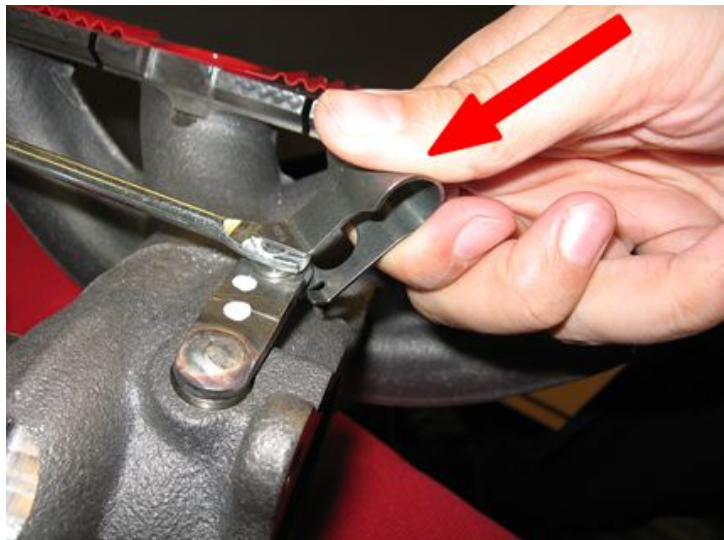
Figure 1. Fit the clip from the side.

1. Remove turbocharger as per ELSA instructions: *Repair Manual >> Engine / Engine Mechanical >> 21 Turbocharger, G-Charger >> Removal and Installation >> Turbocharger.*
2. Install clip **06J145220B** on a replacement turbocharger's link plate and actuating rod joint as illustrated (Figures 1 and 2).

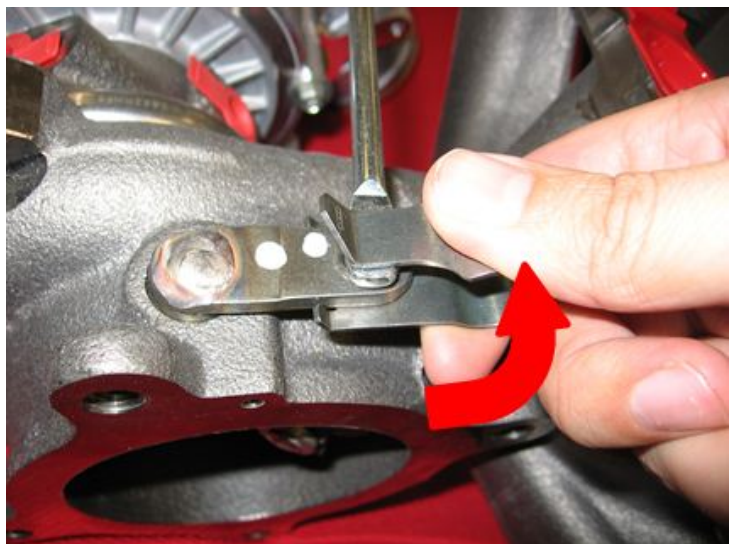
Figure 2. Turn the clip counter clockwise till the lugs slot in.

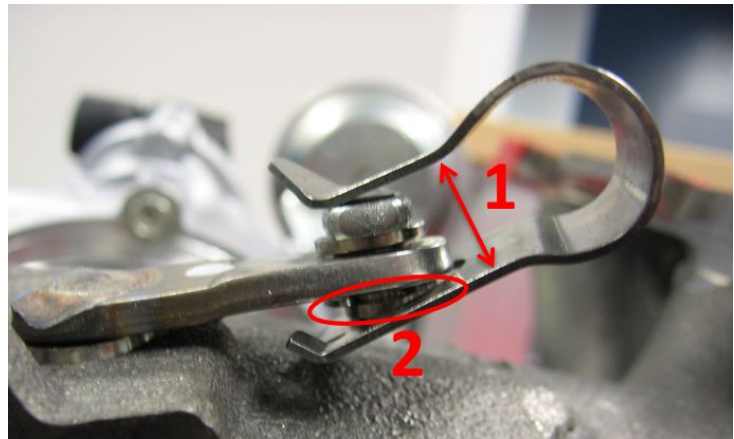
Figure 3. (1) Maximum opening of clip, (2) Position of original circlip

- The spring clip must not be overstretched. The maximum opening of the spring clip is 14 mm (Figure 3, 1).
- The spring clip must be replaced after every removal.

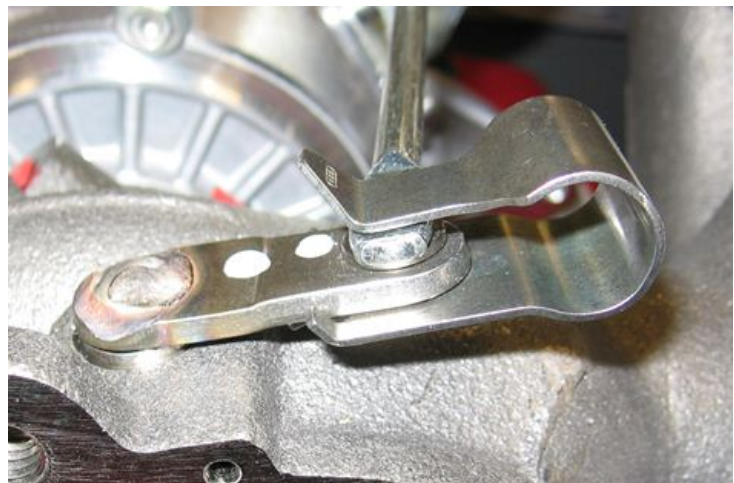
Figure 4. Correctly-fitted clip.

3. After fitting the spring clip, check for correct fit (Figure 4).

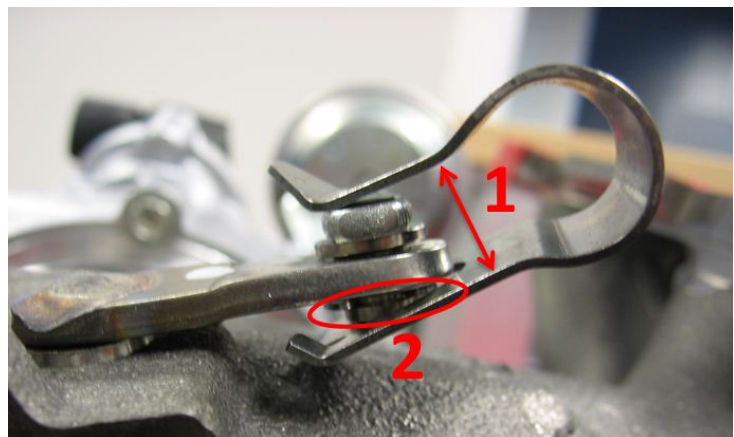
Figure 5. (1) Maximum opening of clip, (2) Position of original circlip

4. After fitting the spring clip, check the position of the original circlip (Figure 5, 2) and correct it if necessary.
