Technical Service Bulletin

35 0B5 7 Speed S-tronic, leaks from transmission

35 13 09 2028085/3 April 1, 2013. Supersedes Technical Service Bulletin Group 35 number 12-07 dated December 21, 2012 for reasons listed below.

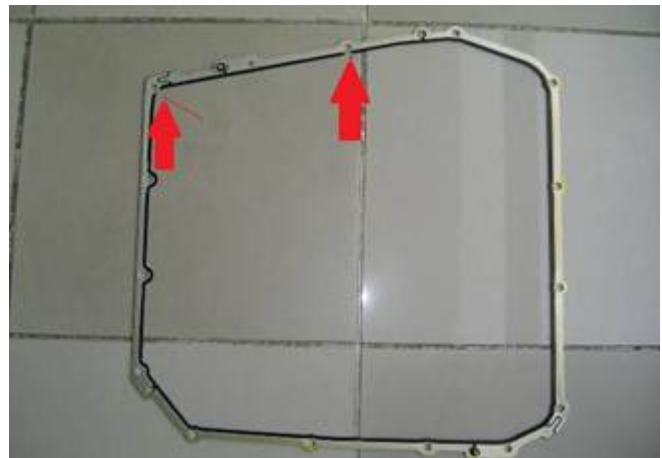
- Leaking from the oil pan seal (Figure 1).

Figure 1. Leak on the oil pan seal (red arrows).

2. Warm up the vehicle (test drive) and re-check for leaks.
3. If the leak is around the oil pan, remove the oil pan and check the gasket for imperfections or damage. If the oil pan is undamaged, only replace the oil pan seal.

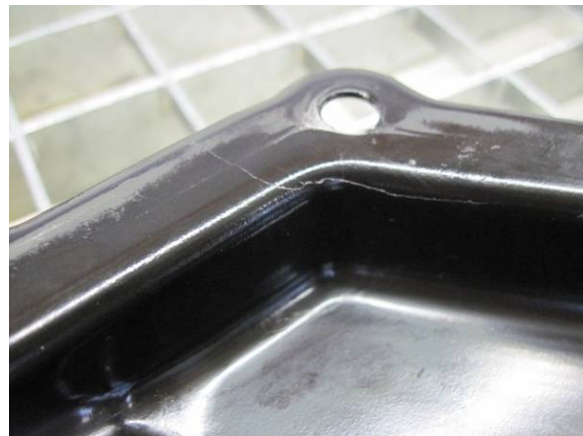
- Crack in the oil pan (Figure 2).

Figure 2. Crack in the oil pan.

5. If pan is cracked as in Figure 2, and no loose bolts on the mechatronics unit are found, replace oil pan and seal.
6. If there is a leak between gearbox housing and intermediate housing as in Figure 3, reseal the case by following instructions in ELSA >> *Repair manual* >> *Transmission* >> *S Tronic Transmission Internal Components* >> *35 Gears, Shafts* >> *Removal and Installation* >> *Sensor Module with Transmission Input Speed Sensor -G612-, -G632-, -G676- and Circuit Board 3.*

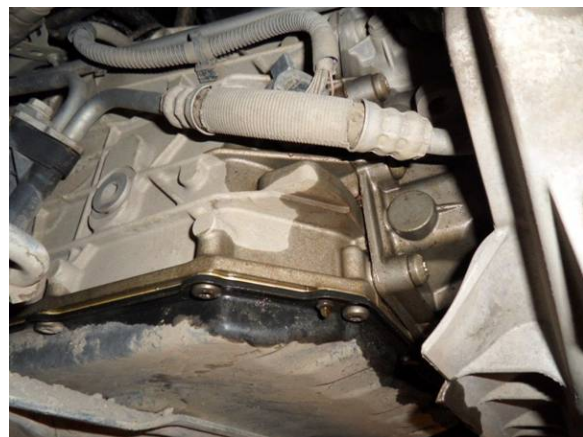
- Leak between gearbox housing and intermediate housing (Figure 3).

Tip: The source of the leak may be confused with o-ring of drain plug.

Figure 3. Leak between gearbox housing and intermediate housing.

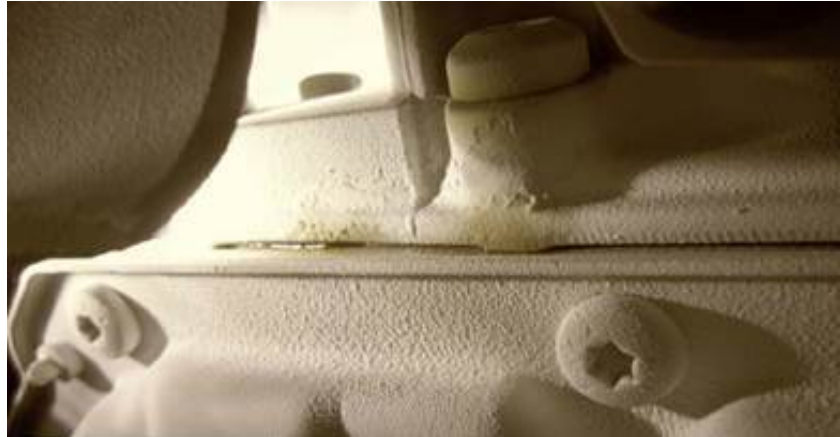
Figure 4. Leak located with Talcum spray.

1. Locate the leak by first thoroughly cleaning and drying the stained area. Then, apply talcum spray (or similar) to the area that was stained with oil (Figure 4).

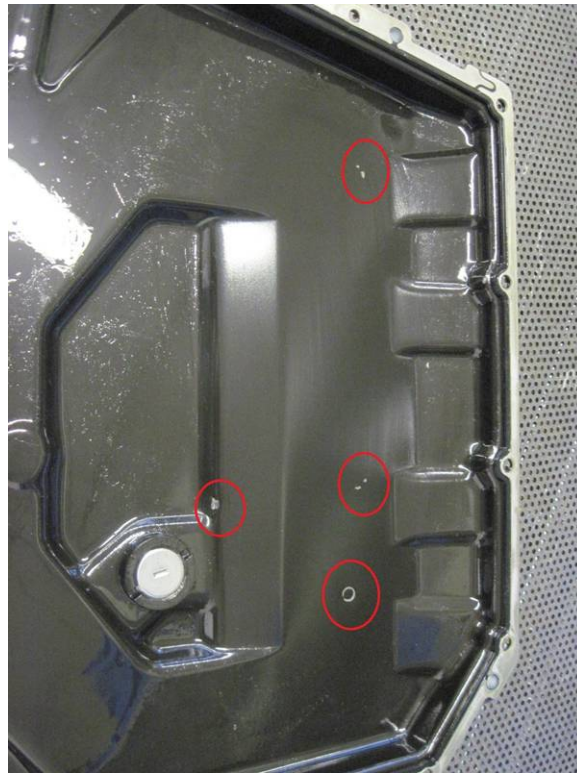
Figure 5. Damaged oil sump because of loose bolts.

4. If the oil pan is damaged (Figure 5), check the mechatronics for loose bolts (Figure 6). Replace any loose bolts and torque according to the repair manual instructions. Also, replace the pan and seal.

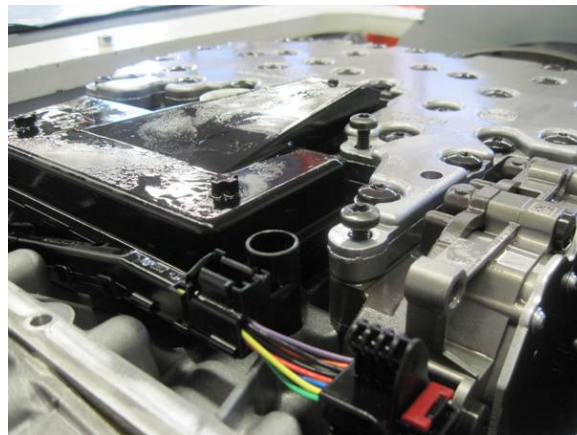
Figure 6. Loose bolts in the mechatronics.

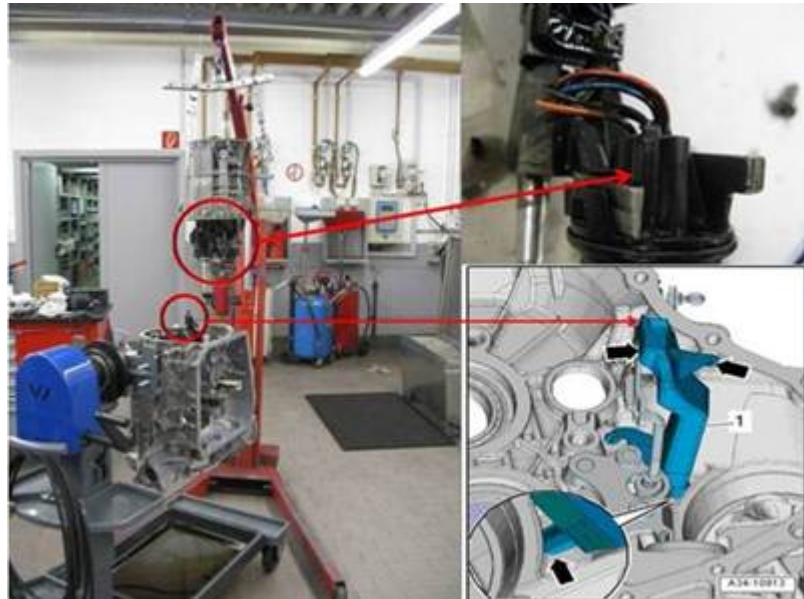
Figure 7. Caution points: drip tray Sensor module connector.

Tip: Use caution when lifting or lowering intermediate housing to avoid damage to components (Figure 7).
