66 Wind noise from exterior rear view mirror housing at turn signal seam

66 13 27 2033517/1 April 8, 2013.

Model(s)	Year	VIN Range	Vehicle-Specific Equipment
Q5	2009 - 2014	All	Not applicable

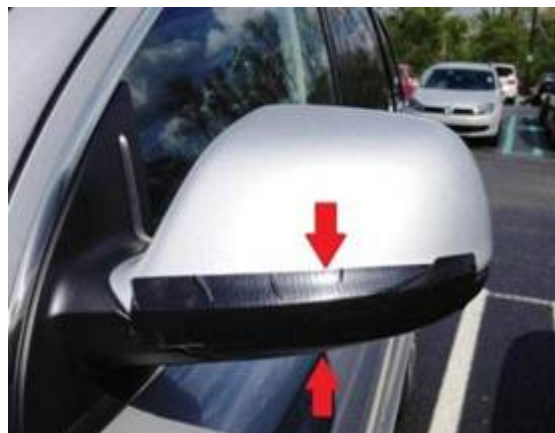
1. Confirm through diagnosis and road tests that the source of the wind noise is coming from the exterior rear view mirror housing, specifically at the area of the housing where the turn signal lamp is mounted (Figure 1).

Figure 1. Application of tape over turn signal lamp.

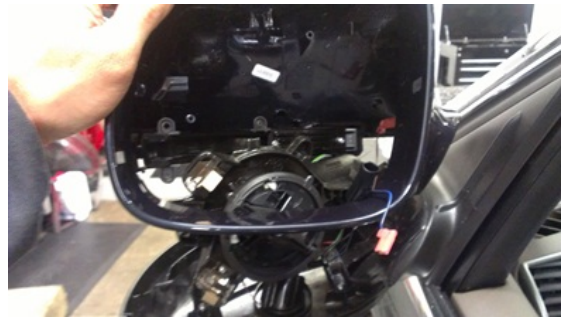
Figure 2. Removal of the mirror housing from the mirror base.

- Should the root cause of the wind noise be from the seams at the turn signal lamp, remove the turn signal lamp from the mirror housing, starting with the removal of the mirror housing from the mirror base (Figure 2).

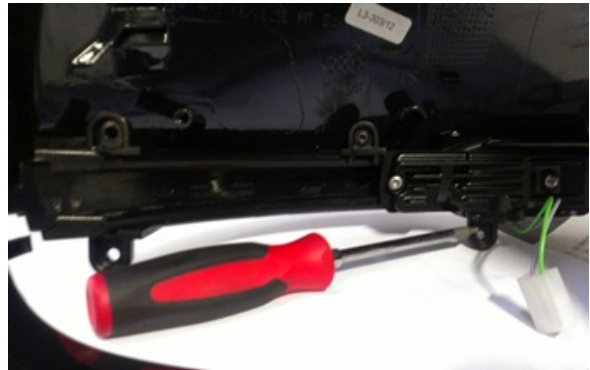
Figure 3. Removal of the turn signal lamp from the mirror housing.

- Remove the turn signal lamp from the mirror housing (Figure 3).

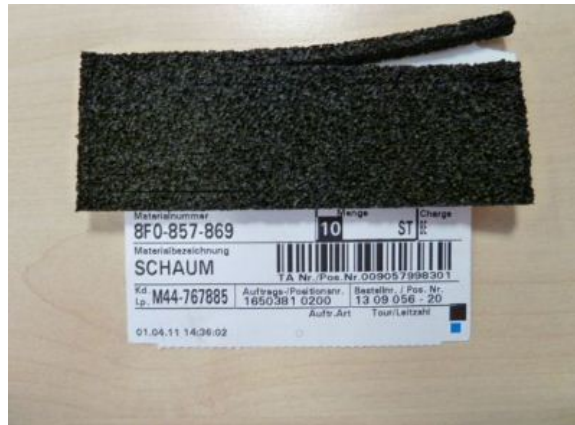
Figure 4. Sealing foam tape.

- Insert strips of sealing foam tape **8F0857869** into the channel that surrounds the turn signal lamp (Figure 4).

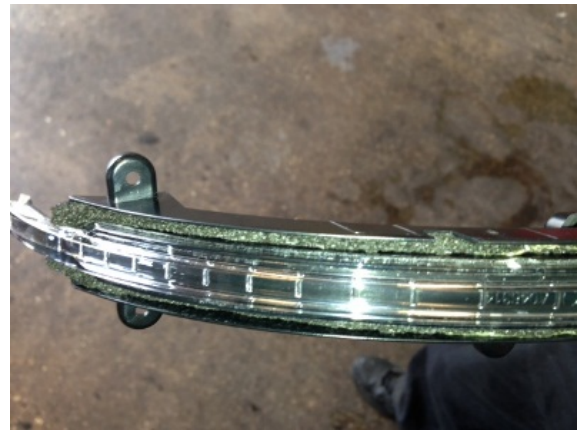
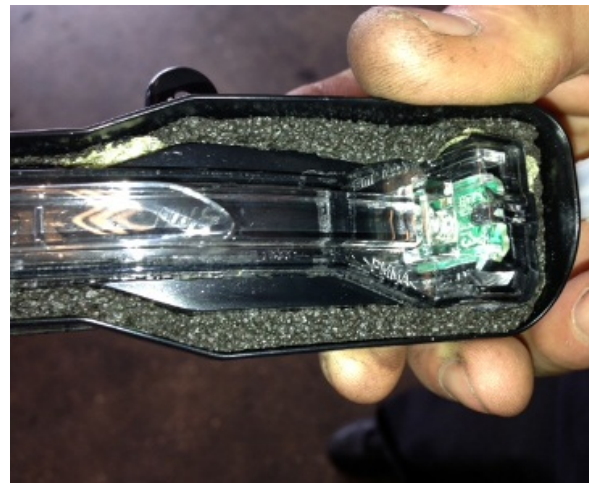
Figure 5. Turn signal lamp with sealing foam tape installed.

Figure 6. Turn signal lamp with sealing foam tape installed.

5. Leave no gaps around the perimeter of the turn signal lamp channel (Figures 5 and 6).
