Technical Service Bulletin

70 Noises from the instrument panel area

70 13 30 2033711/1 April 25, 2013.

Model(s)	Year	VIN Range	Vehicle-Specific Equipment
A4 / Allroad	2013	A000001 – A209596	Not applicable
A4 / Allroad	2013	N000001 – N040070	Not applicable

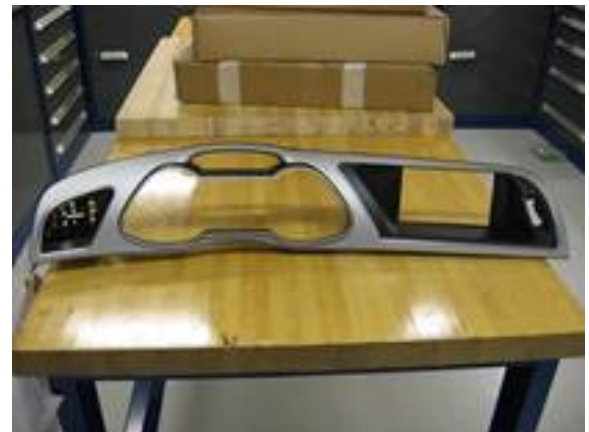
Figure 1. Instrument panel trim.

Squeak or rattle noises from the instrument panel area.

Due to the multiple components that comprise the trim assembly, the panel surrounding the instrument cluster, MMI display screen, etc. can create these noises over bumps or when flexing.

An improved instrument panel trim (Figure 1) is implemented in production.

Replace the instrument panel trim.
