# Technical Service Bulletin

## 43 Air suspension height is uneven, pressure holding valve closed

43 13 12 2020095/4 February 4, 2013. Supersedes Technical Service Bulletin Group 43 number 10-04 dated September 29, 2010 for reasons listed below.

Model(s)	Year	VIN Range	Vehicle-Specific Equipment
4L (Q7)	2007 - 2010	000001 - 999999	Not Applicable

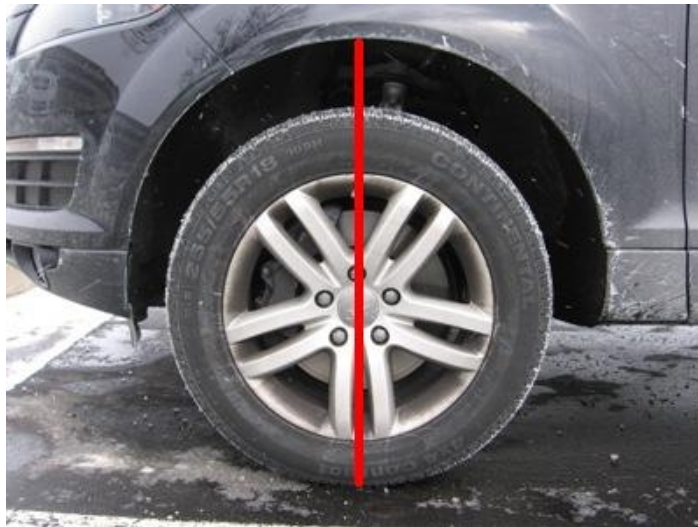
**Figure 1.** The distance to be measured.
