Technical Service Bulletin

92 Rattle from instrument panel area

92 13 06 2021833/4 February 1, 2013. Supersedes Technical Service Bulletin Group 92 number 10-05 dated July 21, 2010 for reasons listed below.

Model(s)	Year	VIN Range	Vehicle-Specific Equipment
TT (8J)	2007 - 2009	All	Not Applicable
TT (8J)	2010	000001-018286

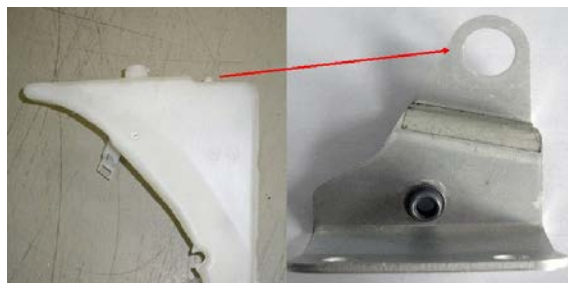
Rattling noises that appear to be coming from the front of the vehicle or from the instrument panel area.

Excessive free play between the mounting bracket for the windshield washer reservoir and the washer reservoir.

Figure 1. Area of contact between the mounting bracket for the windshield washer reservoir and the washer reservoir.

Self-adhesive foam pad **8E5868739** attached to the mounting bracket.
