94 Xenon headlights are adjusted too low

94 13 08 2032852/1 February 26, 2013.

Model(s)	Year	VIN Range	Vehicle-Specific Equipment
A4	2013-2015	000001-999999	Xenon headlights

Technical Service Bulletin

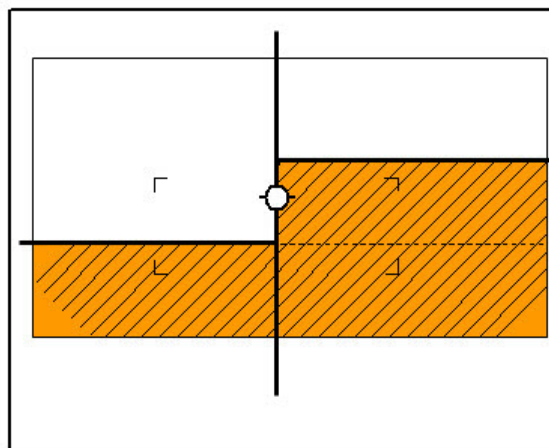
Distinct cut-off beam pattern: The light distribution of the MY09-MY12 headlight has a very sharp cut-off beam pattern (Figure 1). This was intentionally designed this way to reduce the amount of light seen by oncoming vehicles. As a result, the area above the cut-off beam pattern is perceived as being very dark. This is usually due to the fact that the human eye is focused on the illuminated area directly in front of the driver's vehicle. This is most noticeable when driving through long dips in the road (i.e., when coming to the bottom of a large hill).

Figure 1. MY09-MY12 xenon headlight beam pattern

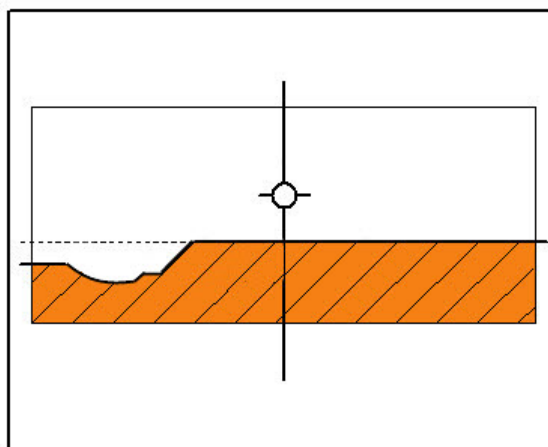
The illumination of the headlight has been changed for the MY13+ A4 to help further reduce the amount of light seen by oncoming traffic (Figure 2). These changes only apply to MY13 vehicles and beyond.

Figure 2. New MY13 xenon headlight beam pattern

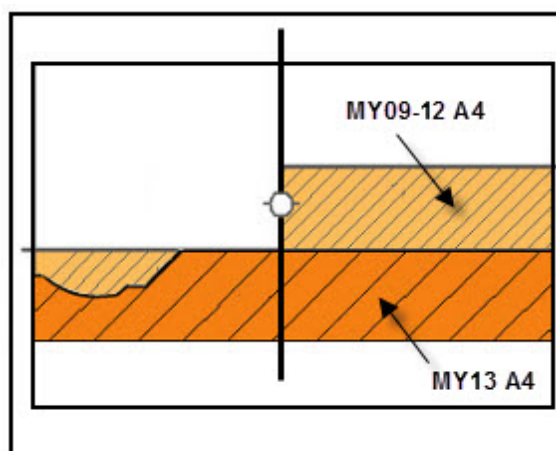
Figure 3. Comparison of new and previous generation headlight beam pattern

Explain to the customer the changes in the beam pattern from the pre-MY13 beam pattern to the current MY13 beam pattern (Figure 3). Also explain the risks of adjusting the beam too high, which can cause an unsafe condition for oncoming traffic.
