Technical Service Bulletin

46 Q5 squealing from front brakes, 2.0T & 3.2L (PR-1LA)

46 13 50 2033102/1 July 22, 2013.

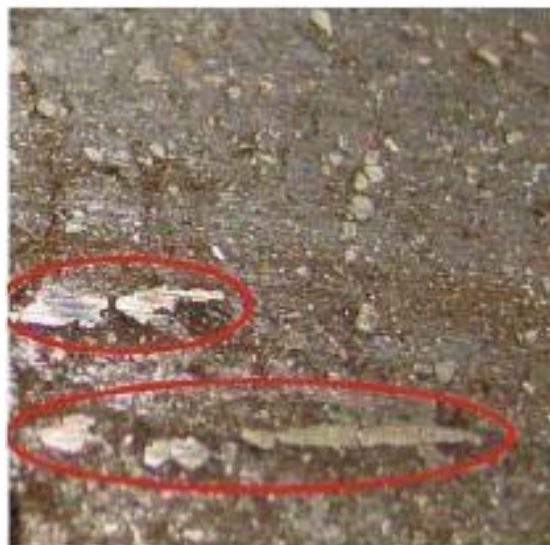
- Foreign bodies between brake disc and brake pad, such as small stones, grit, or sand.
- Un-ground or corroded friction materials.
- Brake discs or brake pads are close to their wear limit (Front brake disc wear limit: 28mm. Front brake pads wear limit with backing plate and dampening sheet: 7mm).
- Metallic deposits from disc material in brake pad (Figure 1).

Figure 1. Metallic deposits.

- Deposits in brake pad.

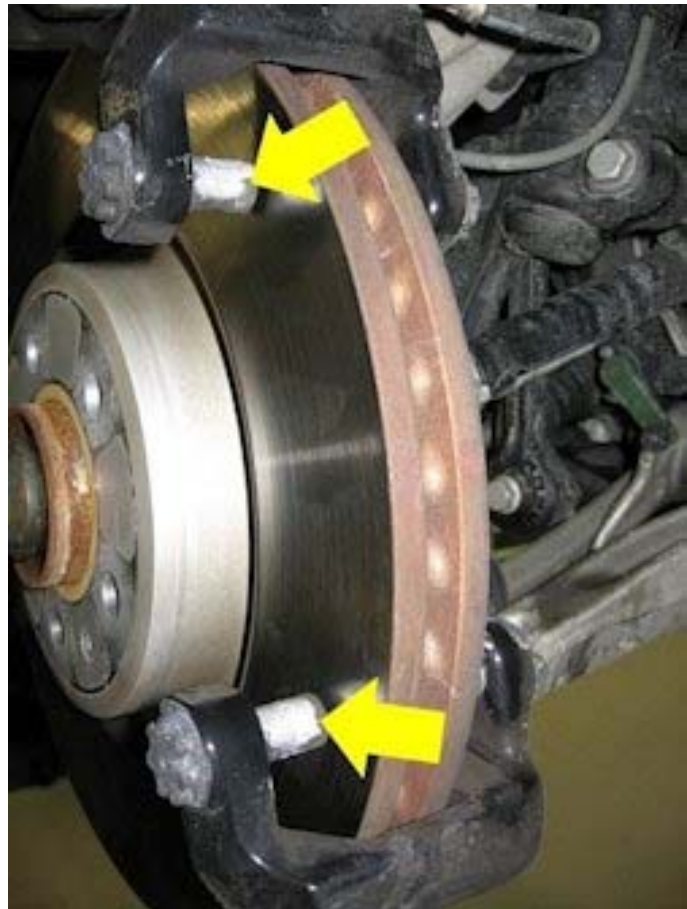
Figure 5. Caliper carrier guide pins with anti-seize lubricant applied where the pads make contact.

2. Apply a thin coat of anti-seize lubricant (**G 052560A2**) to the guide pins of the caliper carrier prior to installing the brake pads (Figure 5). Only apply the lubricant to the section of the guide pins that will be contacted by the brake pads.
