# Technical Service Bulletin

## 55 Rear Lid Switch (DTC 03073 - Closed Rear Lid Sensor - Incorrect Signal)

55 13 31 2033675/4 July 18, 2013. Supersedes Technical Service Bulletin Group 94 number 13-23 dated July 12, 2013 for reasons listed below.

Model(s)	Year	VIN Range	Vehicle-Specific Equipment
Q7	2007-2014	All	Not Applicable

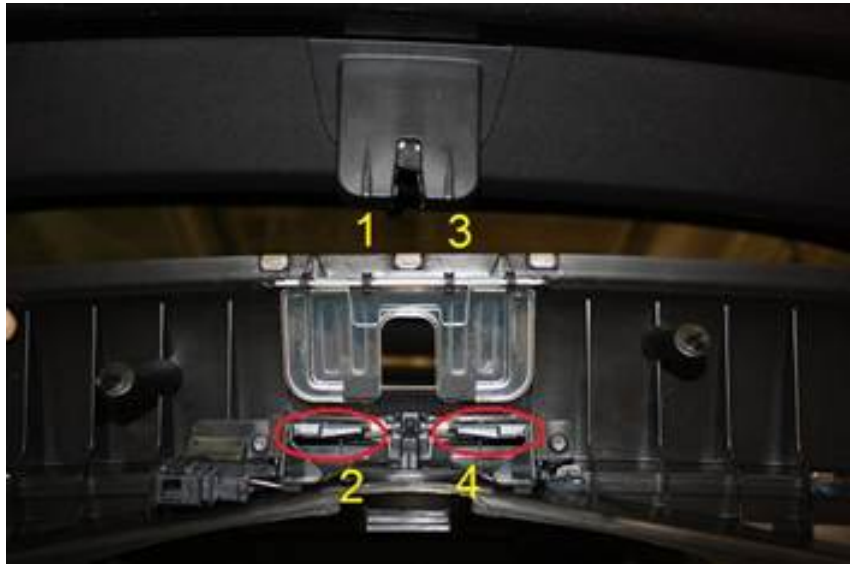
In order for the vehicle to receive a proper rear lid status signal when the lid is operated, the paddle switches on the rear sill trim must contact the opposing lid latch points uniformly.

- Paddle switch G526 (Figure 1, 2) must contact lid latch point 1 (Figure 1, 1), as shown in the image at right.
- Paddle switch G525 (Figure 1, 4) must contact lid latch point 3 (Figure 1, 3), as shown in the image at right.

**Figure 1.** Inside vehicle view of rear lid latch showing location of G526 (2) and G525 (4) on rear sill trim, and contact points (1 and 3).

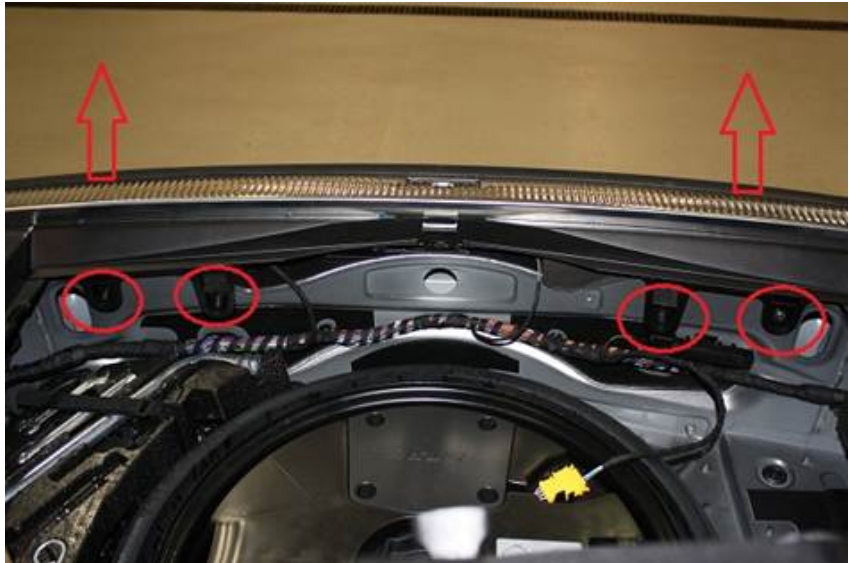
**Figure 2.** Rear cargo area trim plate removal. The T25 Torx® screws to be removed are circled in red.

1. Remove the rear trim plate by first removing the four T25 Torx® screws (Figure 2), then carefully pulling up on the plate.

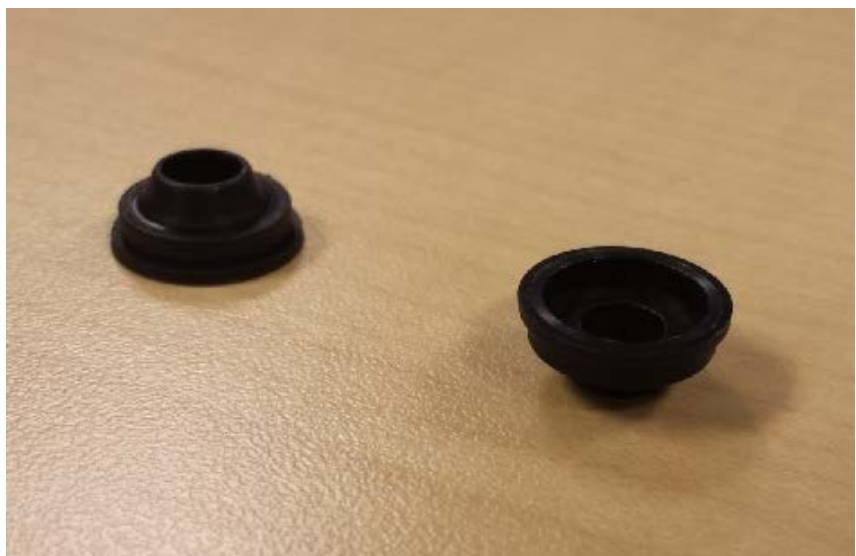
**Figure 3.** Spacers for underneath paddle switch assembly.

2. Remove the two T20 Torx® screws that hold down the paddle switch assembly. Install spacers (4L0863191A 4PK) (Figure 3) between the paddle switch and the trim. The large diameter faces the switch and small diameter faces the mounting.

**Tip:** If factory service parts are not available, improvise by using spacers with dimensions of no less than 5.5mm I.D., no greater than 13mm O.D., and no thicker than 5.6mm.

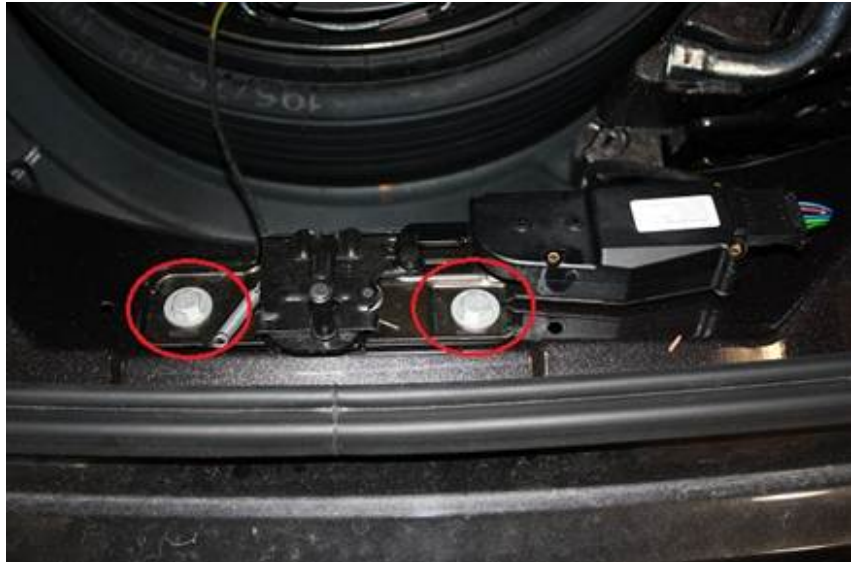
**Figure 4.** Power lid's motorized striker plate bolted mounting.

3. Reinstall rear trim plate and clear DTC(s). Confirm that the concern is corrected and return vehicle to customer.
4. If concern is still present, remove the rear trim to adjust the striker plate.  
Note the current position of the striker plate by using the serrated lines surrounding the bolt or surrounding the nut's integrated washer (Figure 4 and Figure 5).

**Tip:** Use a permanent marker to mark original position in case striker adjustment is needed.

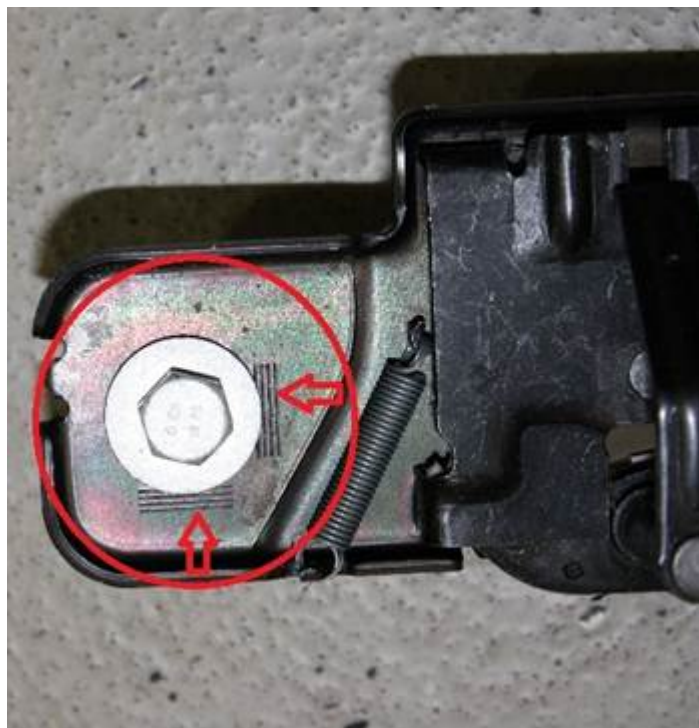
**Figure 5.** Power lid's motorized striker plate adjustability and serrated indicators.

- Center the striker plate latch to the lid latch. Adjust until the lid is able to close smoothly with proper switch actuation.

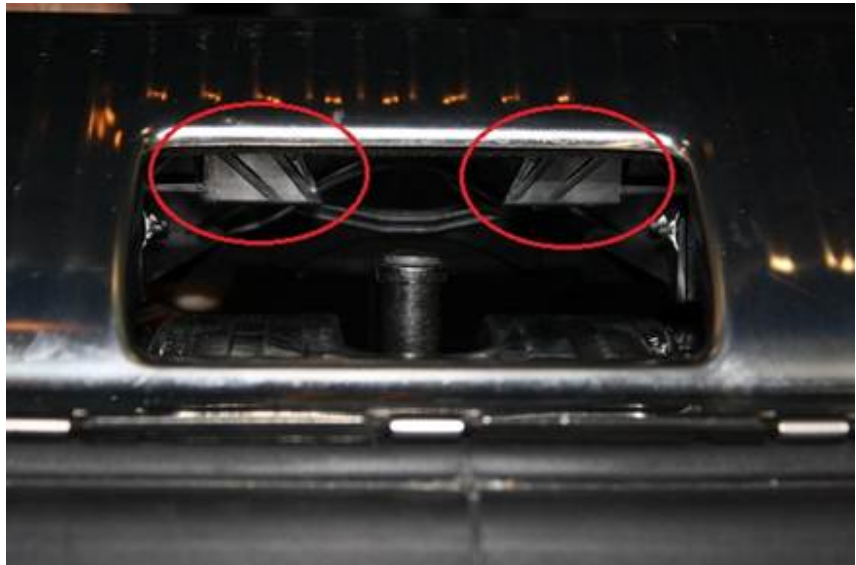
*Figure 6. Overhead view of paddles contacted by rear lid latch.*

**Tip:** Moving the striker plate latch towards the front of the vehicle will bring the lid latch closer to actuating the paddle switches (Figure 6). Do not move the latch forward too far to ensure that the lid is not pulled in with greater force than necessary.
