# Technical Service Bulletin

## 61 Convertible top inoperative

61 13 20 2029956/2 July 2, 2013. Supersedes Technical Service Bulletin Group 61 number 12-16 dated July 6, 2012 for reasons listed below.

Model(s)	Year	VIN Range	Vehicle-Specific Equipment
A4 Cabriolet	2003 - 2009	All	Not Applicable

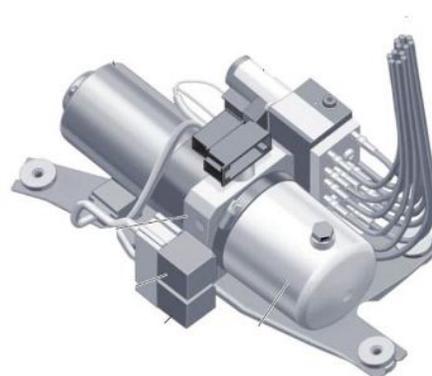
Loss of convertible top operation may be due to a faulty hydraulic pump drive motor (Figure 1).

*Figure 1. Hydraulic pump assembly.*

- a. Check for suitable voltage and ground at the drive motor during relay activation.
    - b. If voltage and ground are checked and OK and the drive motor does not activate, the pump drive motor is faulty. The entire hydraulic pump assembly does not need to be replaced. Replace only the pump drive motor and the pump lever.

**Tip:** Only replace the hydraulic pump assembly if the root cause of the failure is not merely the drive motor.
