Technical Service Bulletin

87 Air conditioning inoperative

87 13 43 2020124/10 July 12, 2013. Supersedes Technical Service Bulletin Group 87 number 13-42 dated June 11, 2013 for reasons listed below.

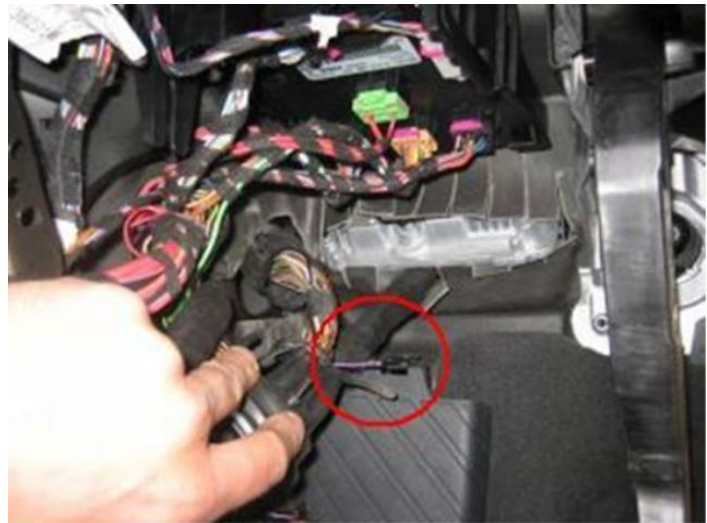
There are two known sections in the wiring harness that can be affected, but the potentially affected areas are not limited to these two known sections. One of the known sections is in the driver's footwell area where the wire harness enters the interior of the car from the engine bay (Figure 1).

Figure 1. Wire harness in driver footwell area.

6. If a cut wire is found, install an overlay wire for the LIN bus signal. Do *not* attempt to repair the existing wire harness.

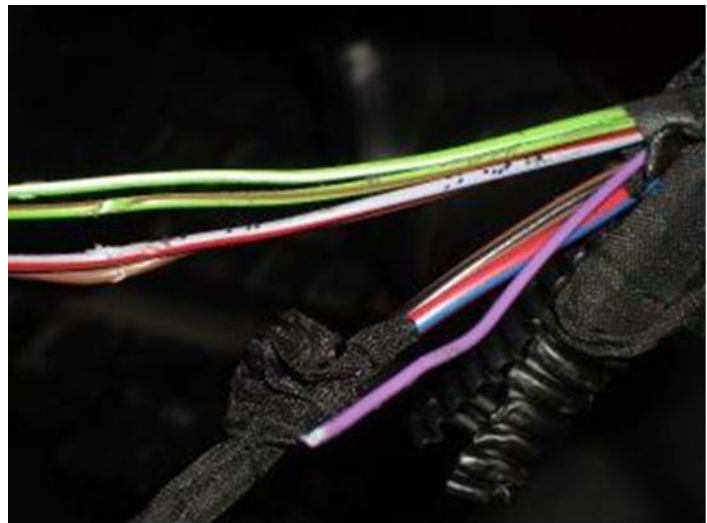
The second known section is in the wire harness located under the driver's side headlight (Figure 2).

Figure 2. Wire harness under driver's side headlight.

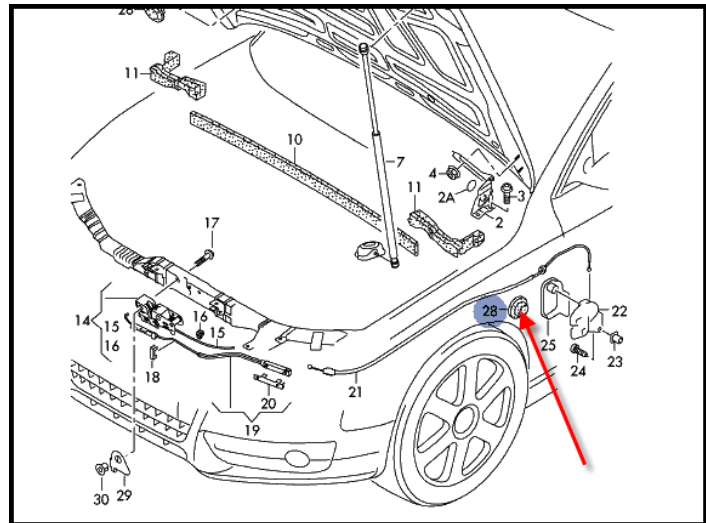
Figure 3. Grommet in driver's side fender/lower A-pillar area used for pass-through for new overlay wire.

- a. Route the new LIN bus wire from the vehicle electrical system control module, J519, to the sender for sensor G395 so that it enters the interior of the vehicle through the driver's side fender/lower A-pillar area through the grommet indicated in the images at right (Figures 3 and 4).

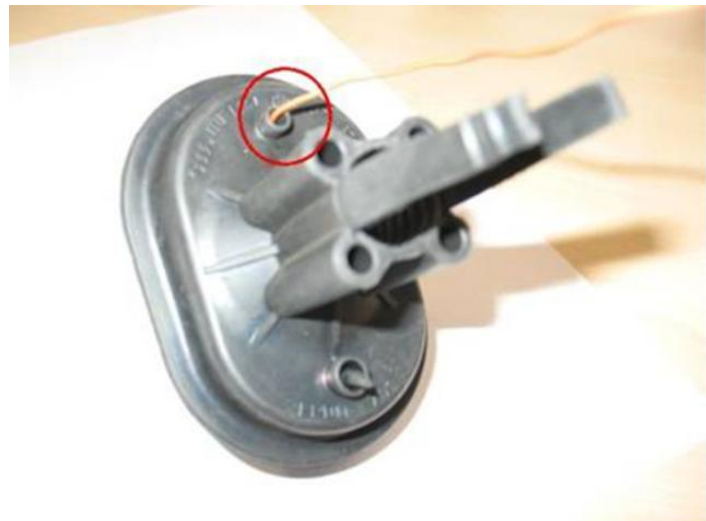
Figure 4. Access hole in grommet.

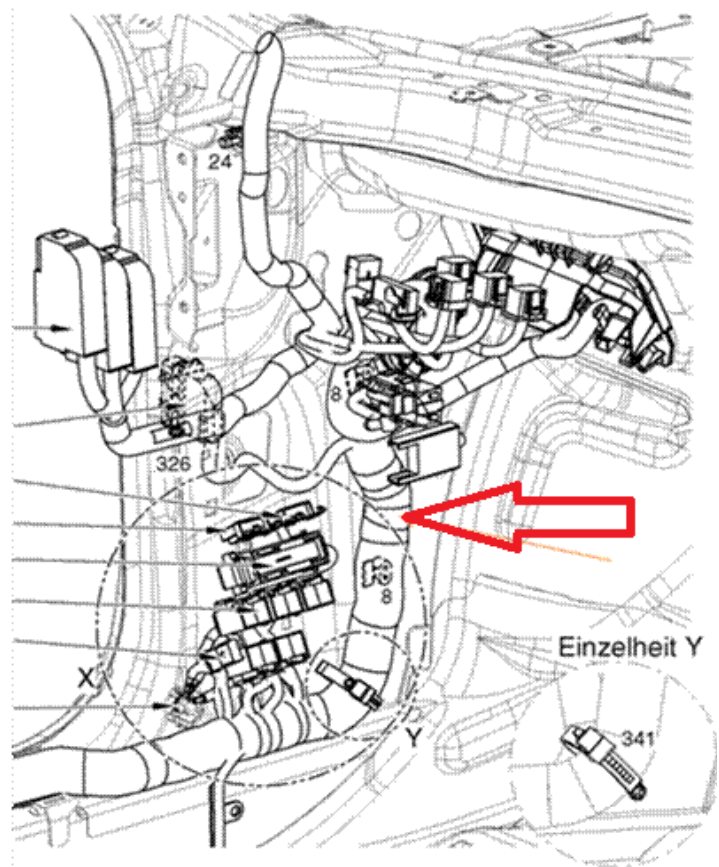
Figure 5. Cable routing with charisma switch option.

On vehicles with a charisma switch (ride selection switch located on the instrument panel) route the new cable of the sender for sensor G395 to junction B549 (Figure 5, red arrow).

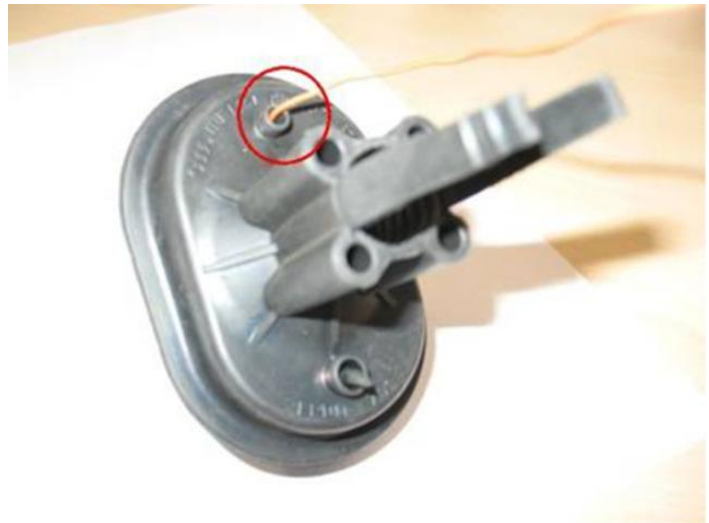
Figure 6. Access hole in grommet to be sealed with Butyl sealant.

- b. Seal off the opening around the wire with Butyl sealant to prevent water intrusion (Figure 6).
