91 Generation 3 CAN radio: CD drive malfunction

91 13 88 2021780/4 July 2, 2013. Supersedes Technical Service Bulletin Group 91 number 10-70 dated October 26, 2010 for reasons listed below.

Model(s)	Year	VIN Range	Vehicle-Specific Equipment
A4 / S4	2009 – 2015	All	Gen III CAN radio (non-Navigation)
A5 / S5	2008 – 2015		
A5 / S5 Cabriolet	2010 – 2015		
Audi Q5	2009 – 2015

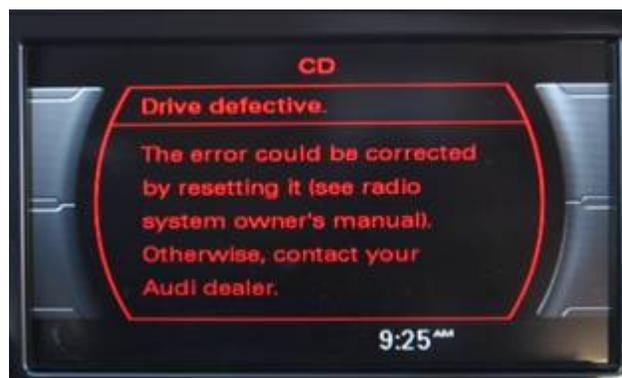
- The following sequence of error messages is seen on the radio display screen after a CD was loaded into or removed from the internal CD drive:
 - “Drive defective.
The error could be corrected by resetting it (see radio system owner’s manual). Otherwise, contact your Audi dealer.” (Figure 1)

Figure 1. The “Drive defective” error message.

1. Do not replace the radio. The CD drive is fully functional after an ignition cycle or radio reset is performed.
2. Erase and ignore the CD drive faulty DTC.
3. Explain the behavior to the customer to prevent a reoccurrence of the complaint.

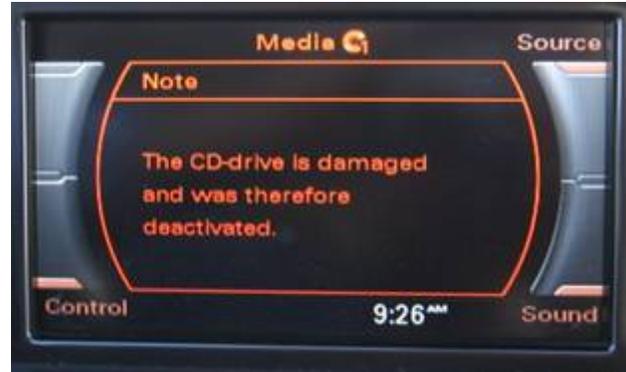
- “The CD-drive is damaged and was therefore deactivated.” (Figure 2)

Figure 2. The “damaged CD drive” error message.

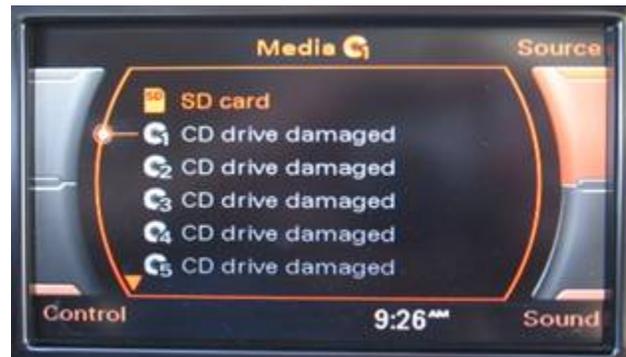
- The CD drive cannot be selected in the Source list and is described as “damaged.” (Figure 3)

Figure 3. CD drive is not available in the Source selection screen.
