# Technical Service Bulletin

## 91 Bluetooth® - Cannot initiate call - Android phone

91 13 92 2030947/2 July 16, 2013. Supersedes Technical Service Bulletin Group 91 number 12-61 dated September 25, 2012 for reasons listed below.

Model(s)	Year	VIN Range	Vehicle-Specific Equipment
All Audi	2005-2014	Not Applicable	Bluetooth

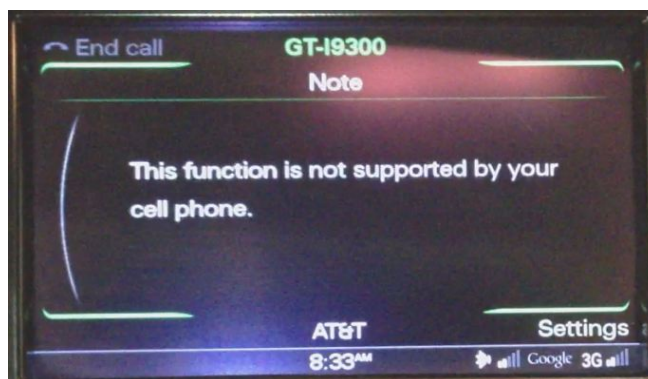
The customer complains that when he or she is trying to place a phone call from the vehicle while using a Bluetooth®-connected phone, the phone call disconnects before it begins and an error shows on the MMI display. The message may be "Function not supported" (Figure 1) or "Network error".

Figure 1. Error message on MMI display.

- The customer is using a phone with the Android operating system. In addition, Skype®, or another network-based communication software, is installed on the phone.
- Call can be placed directly from the phone without a problem.

When a call is placed using this phone, the prompt must be answered every time or the customer must adjust the phone settings to disable the prompt.

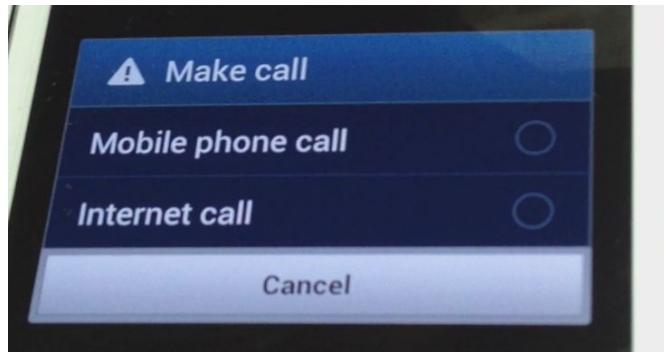
When the phone gets the request to place a call from the vehicle, a prompt appears on the phone asking the user to choose how the call should be placed (Figure 2.). If the prompt is ignored, the MMI system disconnects the call assuming the phone is not responding.

*Figure 2. Prompt that appears on the phone.*
