Technical Service Bulletin

96 Garage door opener intermittently loses programming

96 13 68 2029384/3 July 12, 2013. Supersedes Technical Service Bulletin Group 96 number 13-64 dated June 20, 2013 for reasons listed below.

Model(s)	Year	VIN Range	Vehicle-Specific Equipment
A4	2009-2013	All	Not Applicable
A5 / A5 Cab	2008-2013		
A6 (C6)	2009-2011		
A6/A7 (C6)	2011-2013		
A8 (D4)	2011-2013		
TT	2007-2013		
R8	2007-2013		
Audi Q5	2009-2013		
Audi Q7	2009-2013

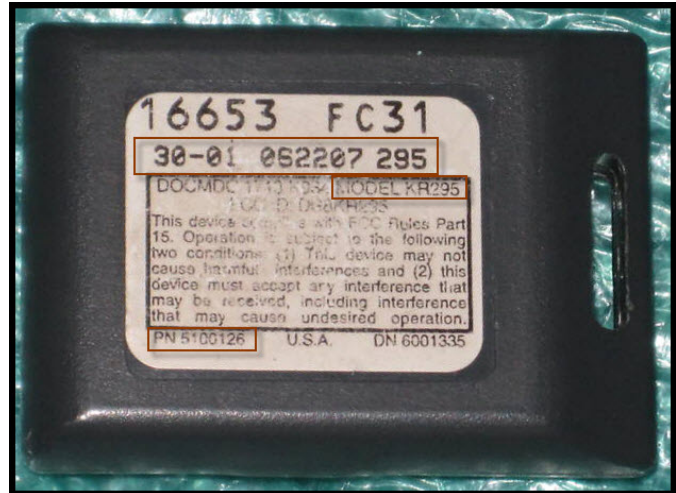
Figure 1. Sentex Transmitter (back view) with model number KR295, where “295” denotes the operational frequency.

2. If the transmitting frequency is found to be 295Mhz, the garage door opener control module needs to be replaced. Follow the steps below.

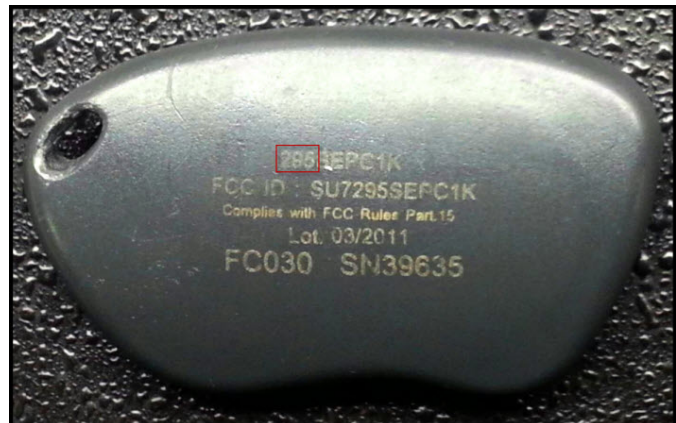
Figure 2. Stingray Transmitter (back view) with model number 295SEPC1K, where “295” denotes the operational frequency.

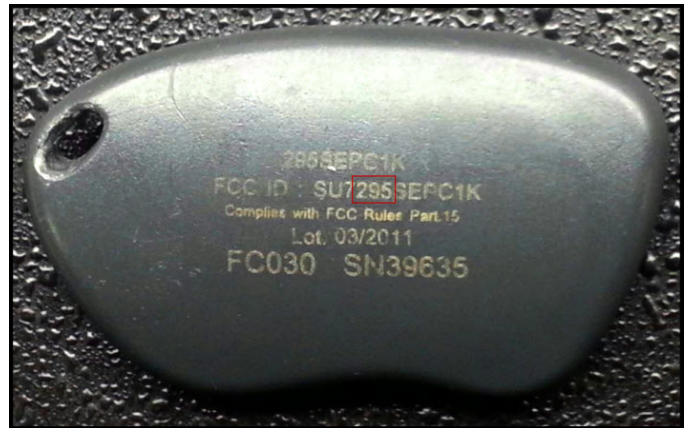
Figure 3. FCC ID is listed as “SU7295SEPC1K”, where “295” indicates the transmitting frequency.

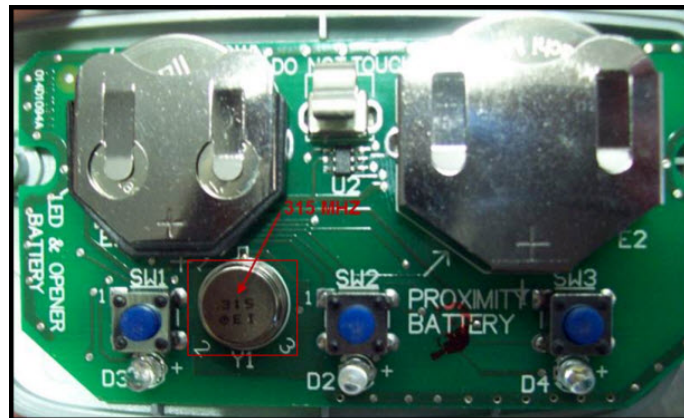
Figure 4. Circuit board component with stamped frequency of “315”, indicating the transmitting frequency. This unit is not affected by this condition because it operates at 315Mhz.

If the transmitting frequency is not found to be 295Mhz, this TSB does not apply. Continue analysis on the issue.

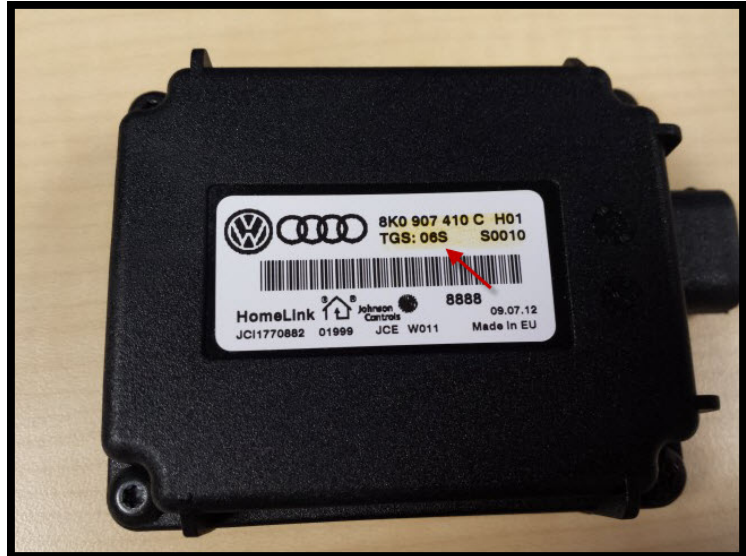
1. Check the TGS level of the currently installed part (Figure 5):
 - For part number **8K0907410C**: if the TGS level is **06S** or higher, *do not* replace the part. This TSB does not apply.
 - For part number **4G0907410A**: if the TGS level is **03S** or higher, *do not* replace the part. This TSB does not apply.
 - If the TGS level is lower than the values stated above, proceed to step 2, below.

Figure 5. Locating the TGS level on the part label. This example shows part number 8K0907410C, with TGS level 06S.

4. Replace the garage door opener control module, J530, using the instructions in ElsaWeb: *Repair Manual*>>*Electrical System*>>*Electrical Equipment*>>*96 Interior Lights, Switches*>>*Removal and Installation*>>*Roof Trim Lamps and Switches*>>*Garage Door Opener Control Module –J530-*.
