94 Headlight cracked / water ingress into headlight lens

94 13 25 2034735/1 July 24, 2013.

Model(s)	Year	VIN Range	Vehicle-Specific Equipment	
A6	2012-2013	All	Xenon or LED Headlights	
A6	2014	000001-026800	Xenon or LED Headlights

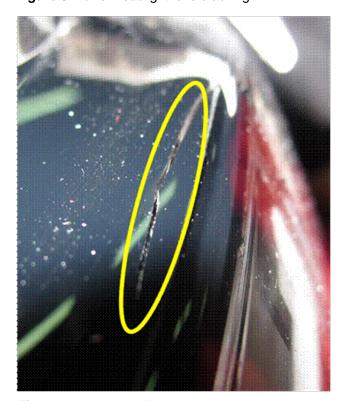
• Upper headlight housing cracking (at transition from lens to black surround) (Figure 4 and Figure 5).

Figure 4. Upper headlight housing cracking.

The production process causes stress on the headlights from the bumper, as well as torsion force from installation.

Replace the affected headlight with the new part number:
