Technical Service Bulletin

94 Daytime Running Light (DRL) inoperative

94 13 21 2032184/2 July 9, 2013. Supersedes Technical Service Bulletin Group 94 number 13-05 dated February 8, 2013 for reasons listed below.

Model(s)	Year	VIN Range	Vehicle-Specific Equipment
Q5	2013 - 2014	All	Audi Xenon Plus with LED Daytime Running Lights

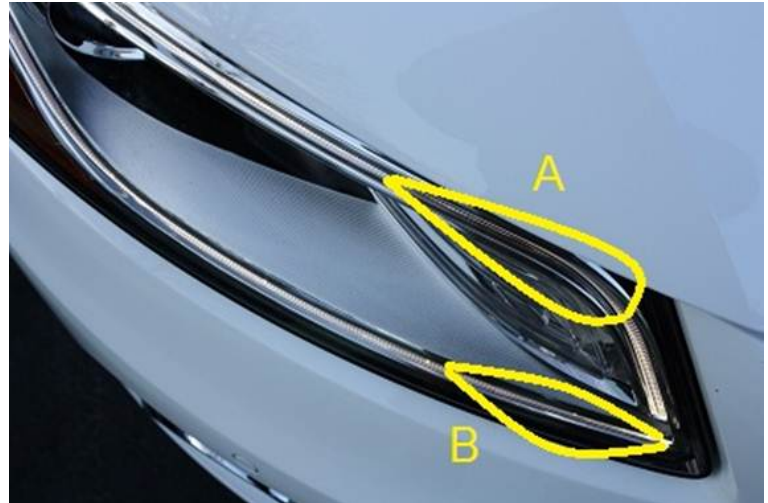
- A defect may be perceived for top-down viewing angle (Figure 3).

Figure 3. Upper light pipe perceived defect (A). Lower light pipe perceived defect (B).

Explain to the customer that the LED illumination appears differently to someone standing in front of the vehicle than it appears to oncoming traffic. The viewing angle of someone standing in front of the vehicle will give a visual effect of an LED DRL inoperative or partially-inoperative condition.

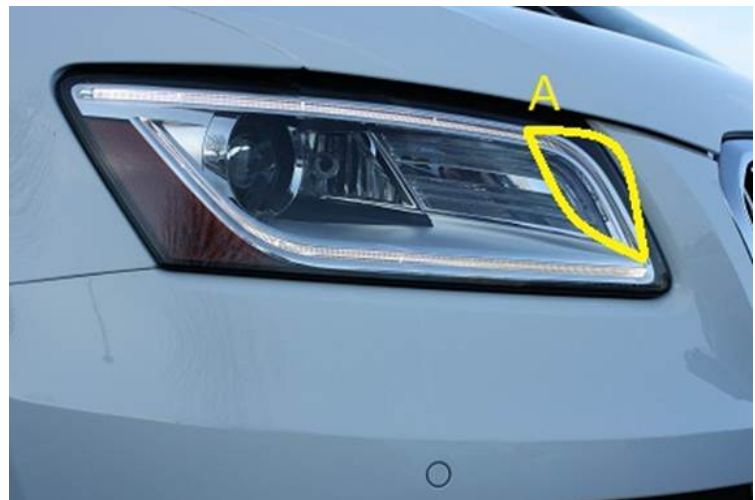
- A defect may be perceived for corner viewing angle (Figure 4).

Figure 4. Upper light pipe perceived defect (A).

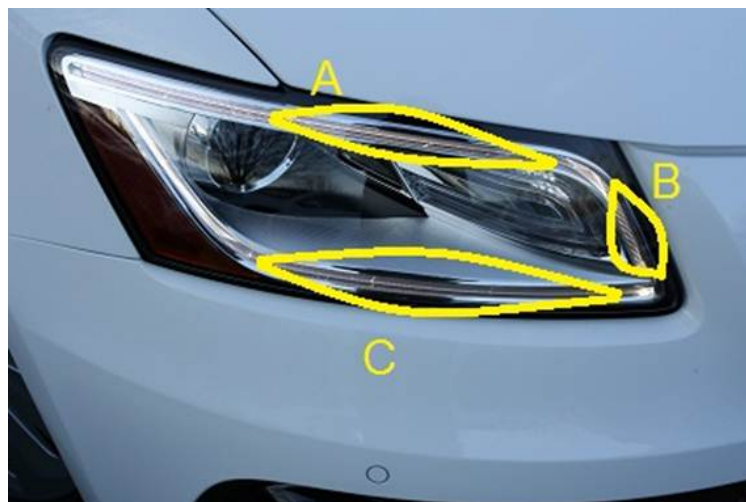
- A defect may be perceived for acute corner viewing angle (Figure 5).

Figure 5. Upper light pipe perceived defect (A, B). Lower light pipe perceived defect (C).
