Technical Service Bulletin

91 Bluetooth call quality poor / VR commands not recognized

91 13 94 2034842/1 July 24, 2013.

Model(s)	Year	VIN Range	Vehicle-Specific Equipment
A7	2012-2013	All	All
A7	2014	000001-020793	All

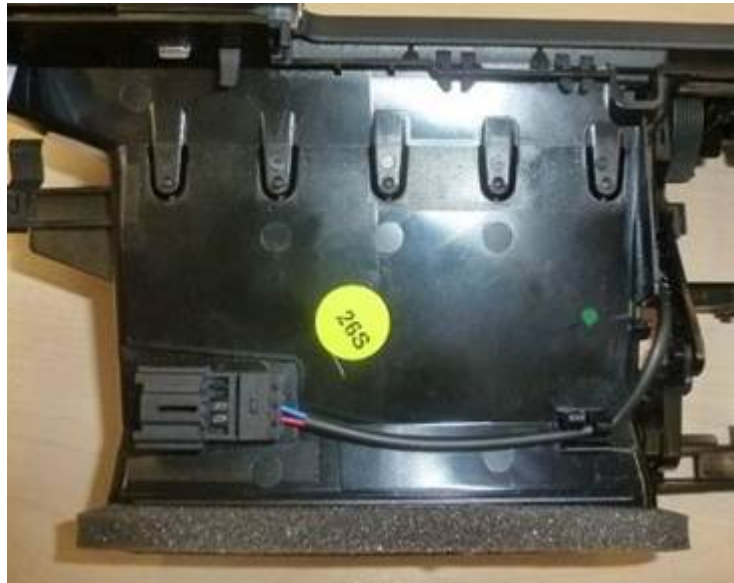
The location of the microphones within the roof module make them susceptible to interference by the vehicle air vents and climate control settings. When the center air vents are pointed upward, they can cause a "swirling" effect that affects the audio quality of Bluetooth® and voice recognition. This is particularly evident on hot days when the A/C system is set to "auto".

Figure 1. Part version sticker on top of center air vent.

2. Remove the center air vents and inspect for a sticker on top of the vents (Figure 1).
 - If the sticker is not present, or if the sticker is below version **26S**, replace the vents.
 - If the part is already at version **26S**, do not replace the vents.
