# Technical Service Bulletin

## 24Z6 UPDATE – Manifold Actuator (NVLW)

August 26, 2013

| Model(s) | Year | VIN Range | Vehicle-Specific Equipment |
|---|---|---|---|
| A6, A7, A8, Q7, A5 Cab, A4, Q5, A5 | 2013-2014 | See Campaign/Action screen in ElsaWeb | None |

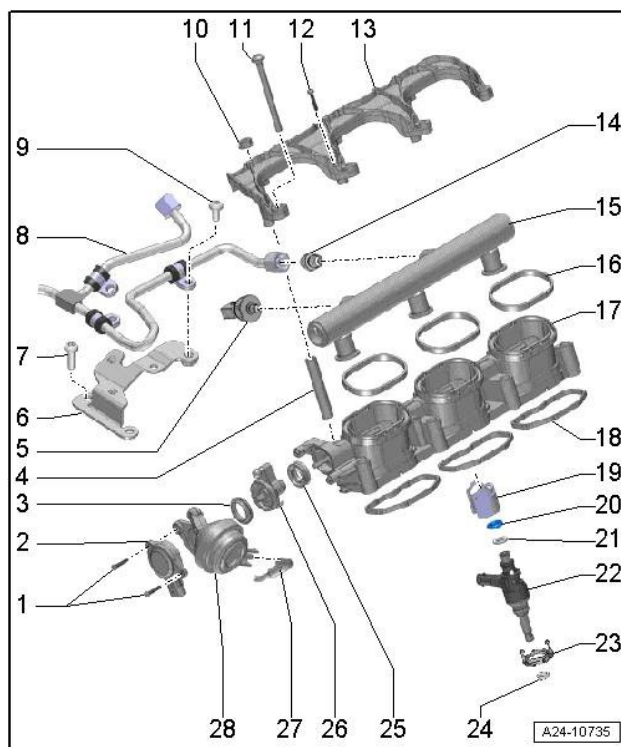
28 – Vacuum actuator

On Audi vehicles with a 3.0L TFSI engine produced during a certain period, it is possible that the membrane on the vacuum actuator for the intake manifold flaps may tear. As a result, the intake manifold flaps do not function and the engine indicator light turns on.
