Technical Service Bulletin

96 Alarm horn does not work or turns on without cause

96 13 73 2034322/2 August 28, 2013. Supersedes Technical Service Bulletin Group 97 number 13-36 dated July 10, 2013 for reasons listed below.

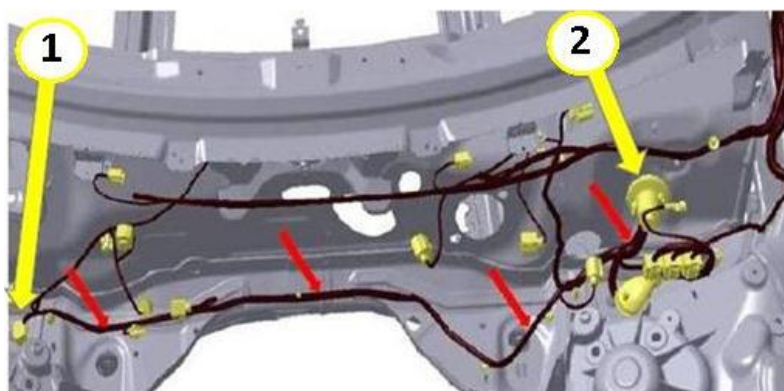
The horn, cables, and grommet are located in the plenum chamber. The grommet is located on the bulkhead in the plenum chamber (Figures 1 and 2).

Figure 1. A6 (C7) and A7 horn plug (1), grommet on bulkhead/plenum chamber (2), and cable routing (red arrows).

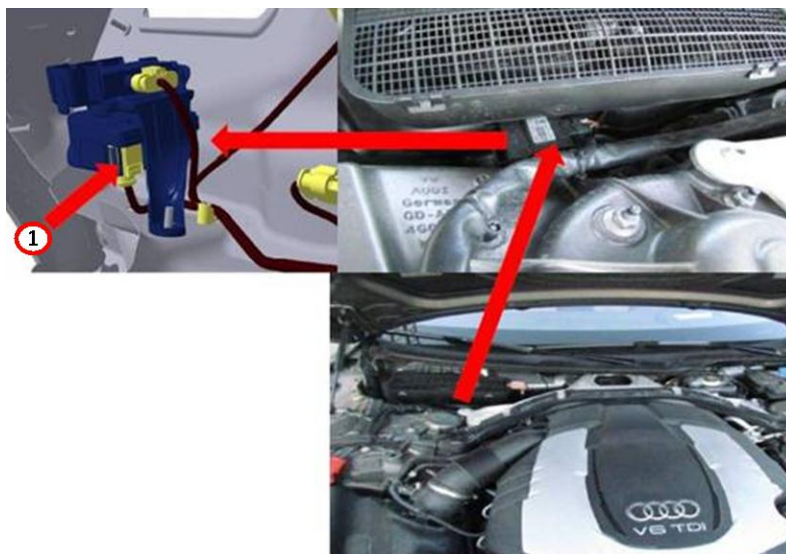
Figure 2. A6 (C7) and A7 horn position (1).

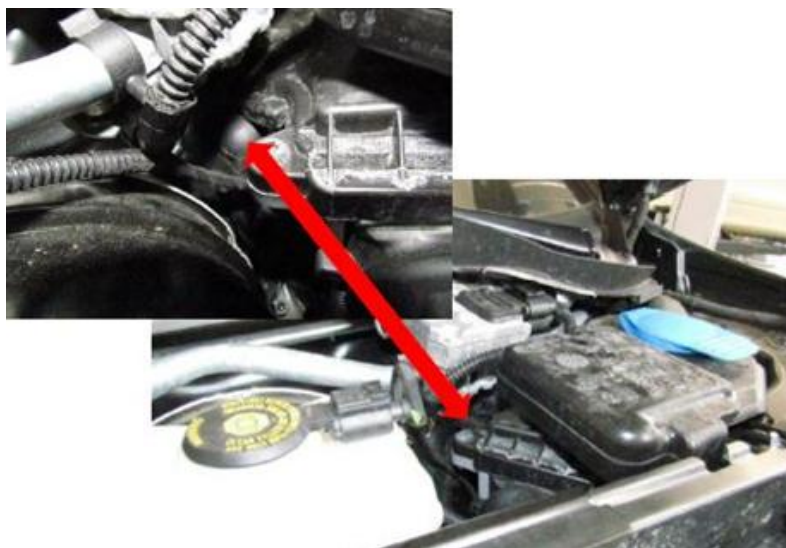
The horn, cables, and grommet are located in the plenum chamber. The cable routing is similar to that on the A6 (C7) and A7, but the grommet is located on the E-box and not on the bulkhead (Figures 3 and 4).

Figure 3. A4 grommet location.

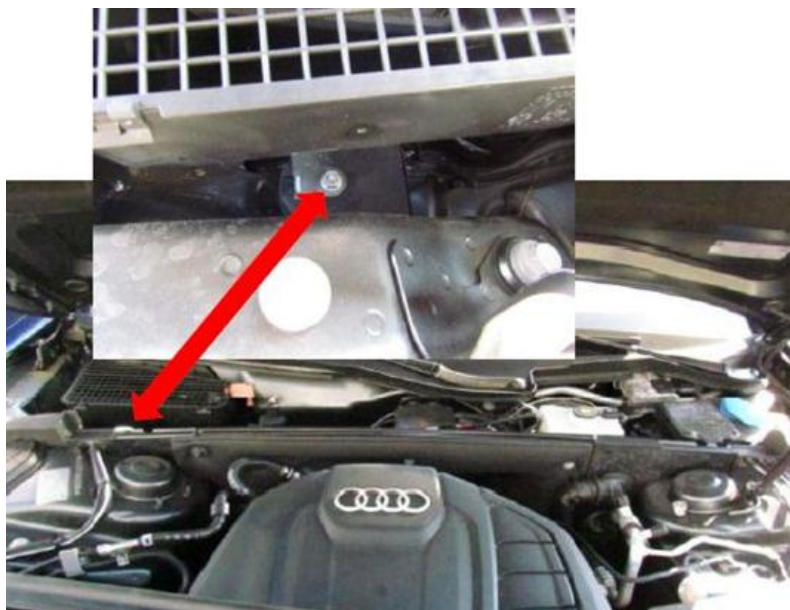
Figure 4. A4 horn position.

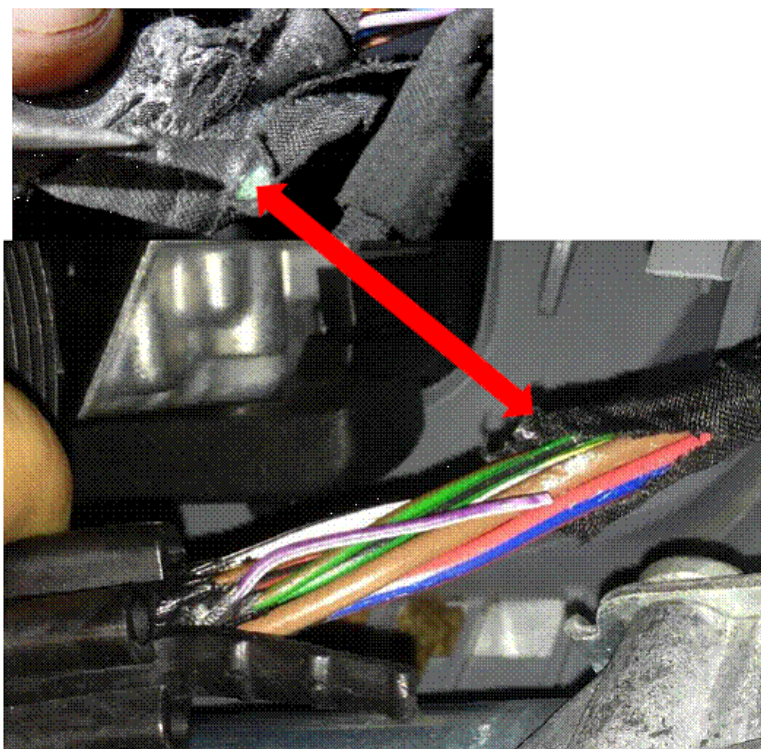
The wiring harness insulation for the alarm horn can be damaged during the vehicle production assembly. Because the cable is routed through the plenum chamber, water can enter into the cable via the damaged insulation. The water causes the alarm to activate for no reason or it causes the alarm horn to not work.

4. Examine the inside of the webbing for a white/green or red/green imprint. This imprint is a result of the production assembly damage to the wire insulation and of the corrosion caused by water ingress (Figure 5).

Figure 5. Color imprint on inside of webbing indicates point of damage.

5. Using the wiring repair kit **VAS 1978 B**, repair the damaged section as needed.
