Technical Service Bulletin

96 Lane Change Assistant "Sensors Blocked" warning in DIS (DTC C1114F3 and C1115F5)

96 13 72 2035047/1 August 26, 2013.

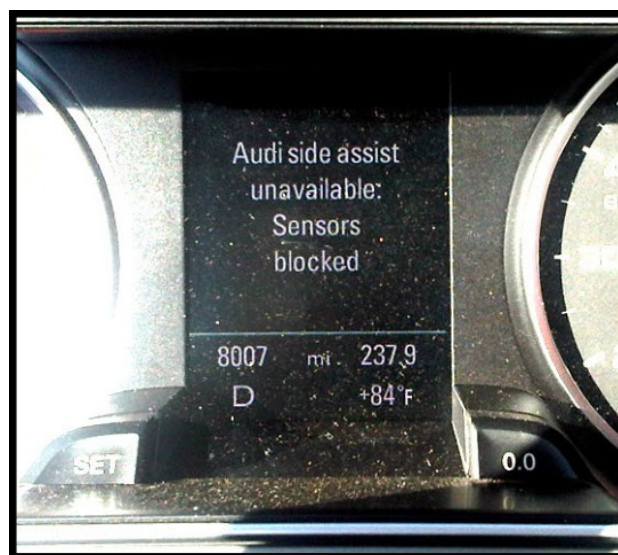
- Audi Lane Change Assistant deactivates or is sporadically inoperative when the vehicle is driven in slow-moving stop-and-go traffic, especially on roads with multiple lanes.
- The message "Audi side assist unavailable: Sensors blocked" appears in the driver information system (Figure 1).

Figure 1. Audi Side Assist warning in DIS

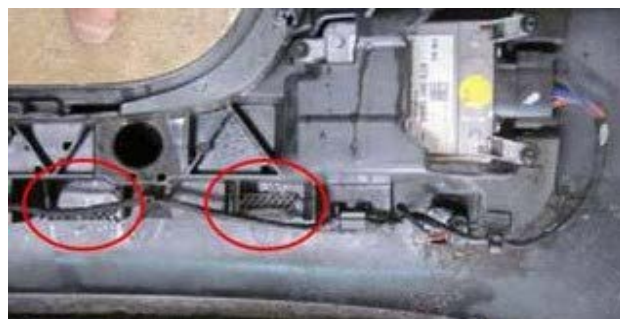
Figure 2. Mounting bracket for one of the ECUs.

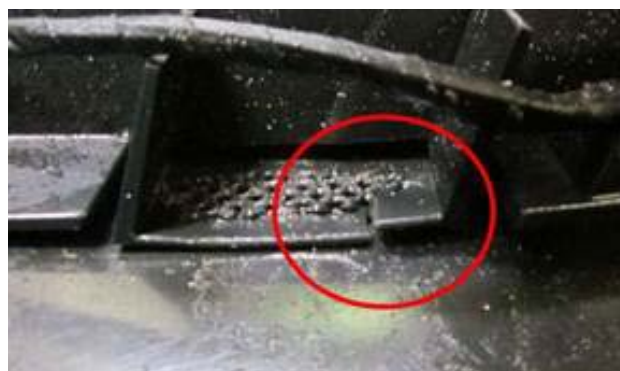
Figure 3. Broken mounting bracket

Tip: If a loose bracket is found, repair as necessary using the Elsa Repair Manual. Submit a separate warranty claim, as this TSB does not cover this repair.

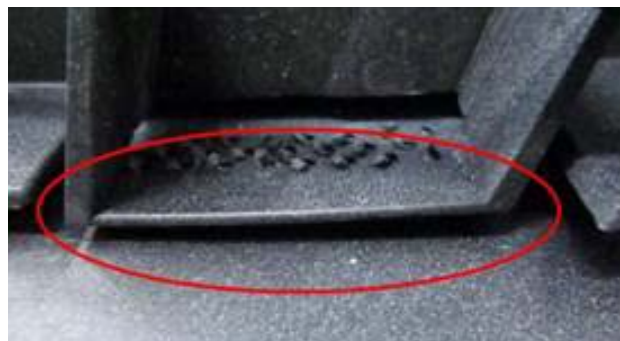
Figure 4. Loose mounting bracket.
