Technical Service Bulletin

94 Rear lighting does not switch from bumper to lid (DTC 03073)

94 13 27 2033675/5 August 13, 2013. Supersedes Technical Service Bulletin Group 55 number 13-31 dated July 18, 2013 for reasons listed below.

Model(s)	Year	VIN Range	Vehicle-Specific Equipment
Q7	2007-2014	All	Not Applicable

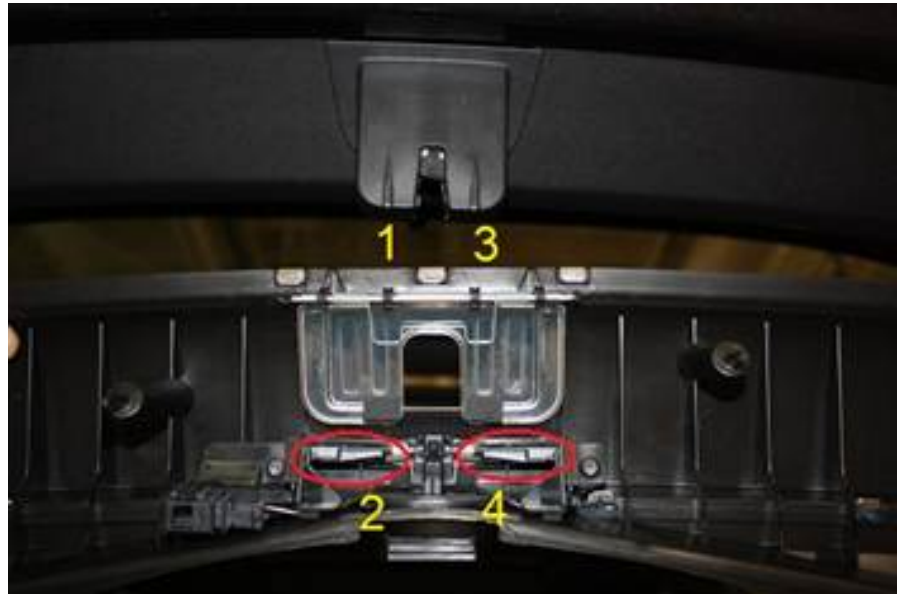
In order for the taillight lighting to switch between the rear lid and the bumper when the lid is operated, the paddle switches on the rear sill trim must contact the opposing lid latch points uniformly.

- Paddle switch G526 (Figure 1, 2) must contact lid latch point 1 (Figure 1, 1), as shown in the image at right.
- Paddle switch G525 (Figure 1, 4) must contact lid latch point 3 (Figure 1, 3), as shown in the image at right.

Figure 1. Inside vehicle view of rear lid latch showing location of G526 (2) and G525 (4) on rear sill trim, and contact points (1 and 3).

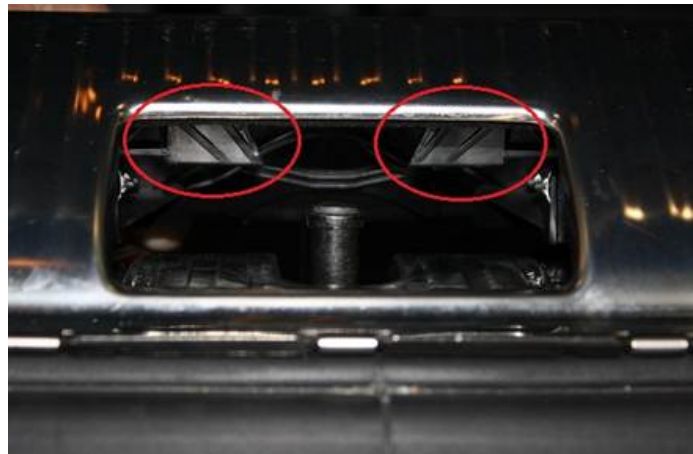
Figure 6. Overhead view of paddles contacted by rear lid latch.

Tip: Moving the striker plate latch towards the front of the vehicle will bring the lid latch closer to actuating the paddle switches (Figure 6). Do not move the latch forward too far to ensure that the lid is not pulled in with greater force than necessary.
