Technical Service Bulletin

94 Dimmer cap missing from headlight switch

94 13 26 2031378/2 August 1, 2013. Supersedes Technical Service Bulletin Group 94 number 12-93 dated October 25, 2012 for reasons listed below.

Model(s)	Year	VIN Range	Vehicle-Specific Equipment
A6 (C7)	2011 - 2013	All	Not Applicable

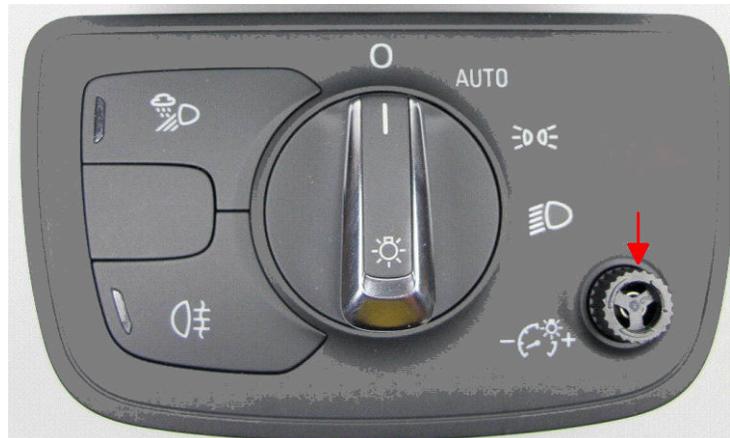
Cap on dimmer knob (light switch) has fallen off and cannot be found (Figure 1).

Figure 1. Dimmer knob on main light switch

Replace missing cap. Do *not* replace the main light switch. Switches replaced for this condition will be charged back.
