# Technical Service Bulletin

## 91 MMI 3G Sound system "popping" and various other technical issues (K0133 Update)

91 13 99 2034923/1 August 5, 2013.

Model(s)	Year	VIN Range	Vehicle-Specific Equipment
A4	2011-2012	All	MMI 3G
A5/A5 Cab	2011-2012		
A6	2011		
Q5	2011-2012		
Q7	2011

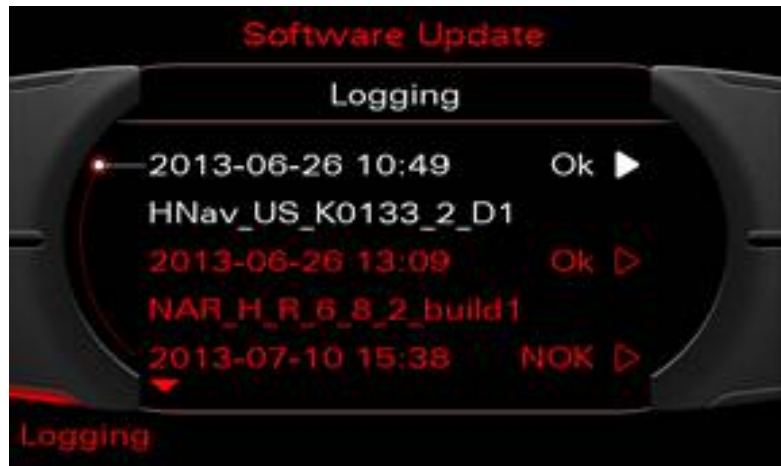
After a successful update, the screen will show the date on which the update was performed and the software that was installed (HNav\_US\_K0133\_X\_XX — The X characters will be one of several different numbers or letters). 'Ok' will be listed on the right. If K0133 does not have any rows with 'Ok', the update must be retried until it is successful.

**Figure 1.** Software update log showing a successful software installation.

2. Verify that the software update has been completed successfully by accessing the logging page (Figure 1). To access this screen, proceed to step 8 in TSB 2028141 and press the lower left softkey.

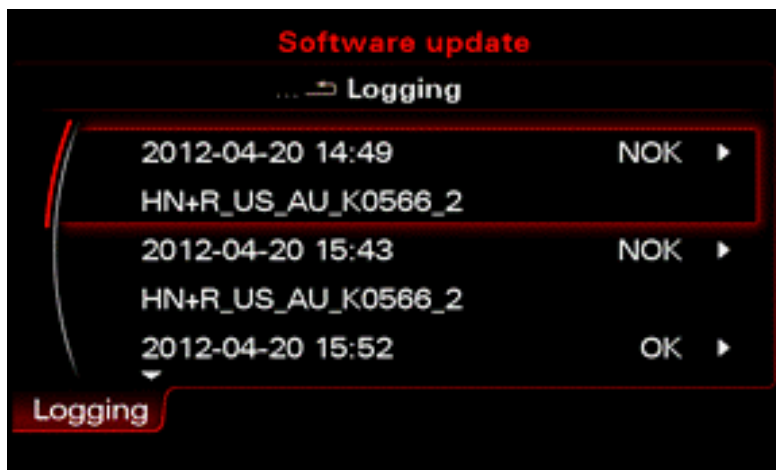
**Figure 2.** Software update log showing 2 failed attempts before a successful installation (MMI 3G+ screenshot used as reference).

**Tip:** If the update must be performed two or more times because the modules are not updating correctly, a screenshot of the software update log is required (Figure 2). This should be kept on-hand for warranty auditing purposes. To take a screenshot, insert an SD Card into slot 1 and press and hold the left and right arrow keys at the same time. All 4 softkeys will flash when the screenshot is taken. A screenshot should be taken of each page in the logging display.
