# Technical Service Bulletin

## 91 MMI 3G+ Sound system "popping" and various other technical Issues (K0715 Update)

91 13 98 2030465/5 August 5, 2013. Supersedes Technical Service Bulletin Group 91 number 12-65 dated October 25, 2012 for reasons listed below.

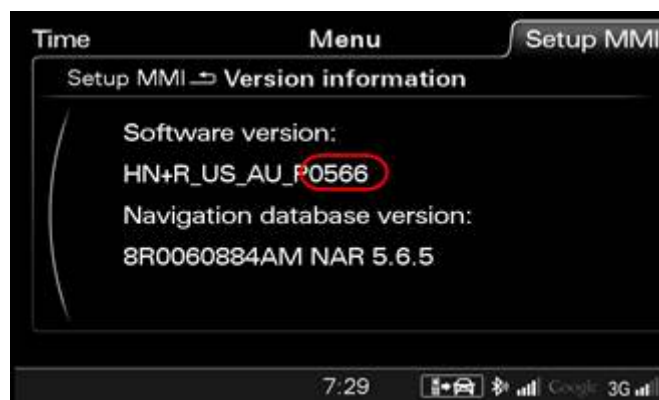
**Tip:** The MMI software version can be found under *Menu >> Setup MMI >> Version Information* (Figure 1).

Figure 1. MMI software version (566).

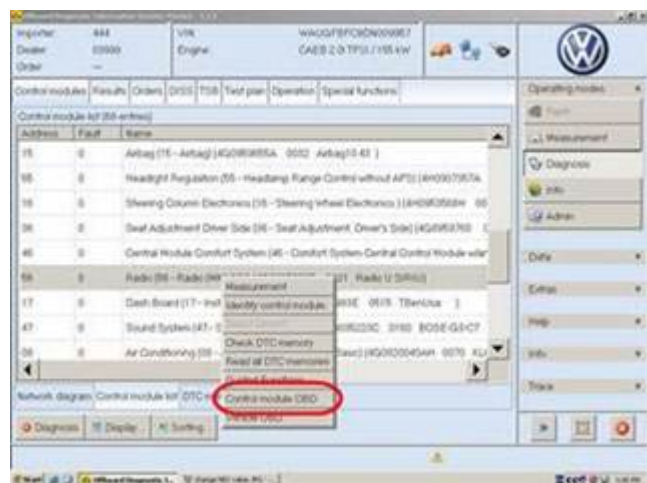
Figure 2. Radio self-diagnosis.

1. Verify the HD radio is enabled in the MMI by navigating to *Radio >> Settings*.
  - If the HD radio options are present in the MMI menu, proceed directly to Step 6.
  - If the HD radio options are not present in the MMI menu, continue with Step 2.
2. Using ODIS in the Control module list, right-click on 56 – *Radio*, and select *Control Module OBD* (Figure 2).

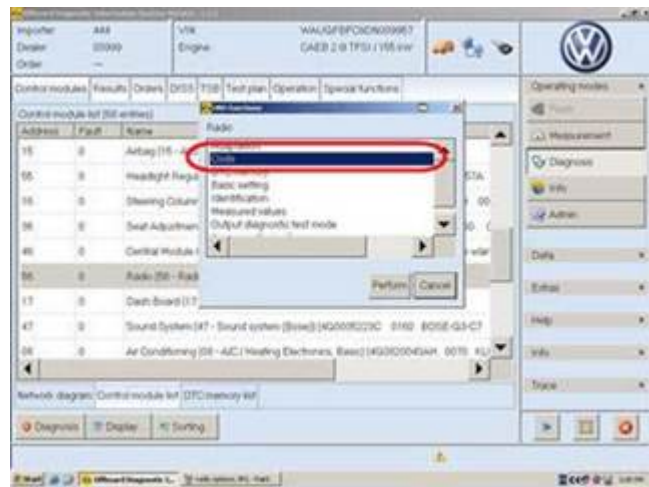
Figure 3. Code radio option.

3. Select *Code* (Figure 3).

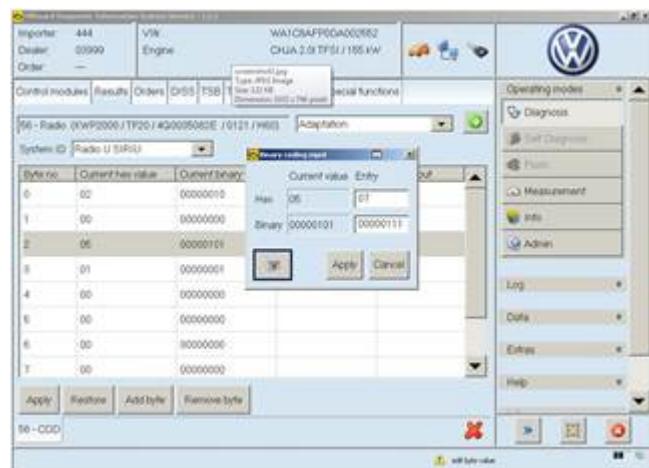
Figure 4. Changed radio coding.

4. Verify the coding in byte 2 is HEX 07.

- If it is not HEX 07, change the coding to HEX 07. Apply changes (Figure 4).

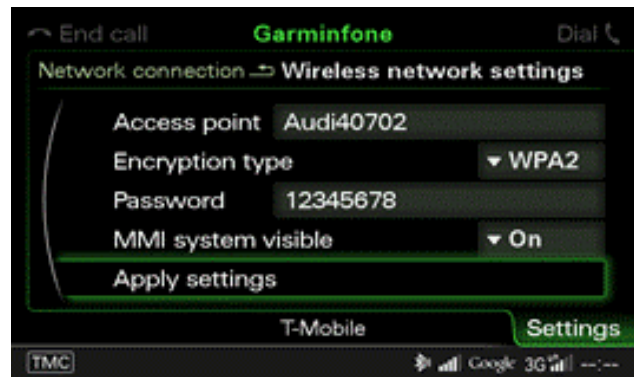
**Figure 5.** Wireless network settings.

6. As part of the update, wireless settings and paired devices will be deleted. All devices will need to be re-paired after the update, and all wireless settings restored to the customer's settings. To access the Wireless network settings on the MMI (Figure 5), press *TEL >> Settings >> Wireless network connection >> Wireless network settings*. Record all settings so they can be re-entered at the end of the update.

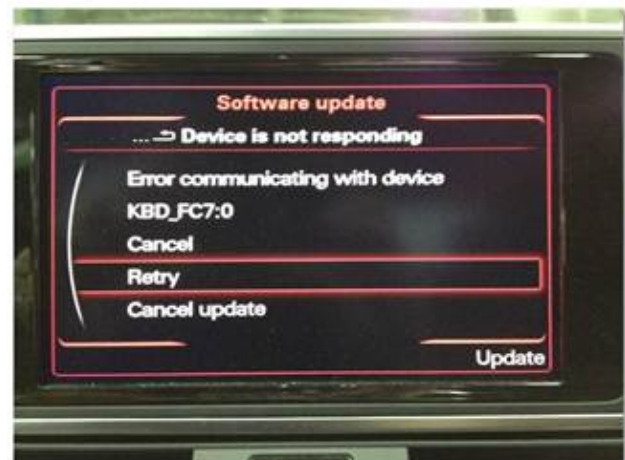
**Figure 6.** A device requiring a 'Cancel' selection.

Some earlier model year 2012 vehicles, or vehicles equipped with Bose® sound systems may experience certain modules that will not update properly during Step 16 of TSB 2028141. If this should occur, either choose 'Cancel' (Figure 6), or 'Skip device' (Figure 7), depending on the type of error. Do *not* choose 'Cancel update', as this may cause the software update to fail entirely. After the update is finished and the summary page is shown, select 'Retry' at the bottom of the list if it is available to attempt to update the modules again. If 'Retry' is greyed out, then the software update was successful. Select 'Continue' to proceed. In some cases 'Retry' may have to be repeated two or three times to get all modules to update successfully.

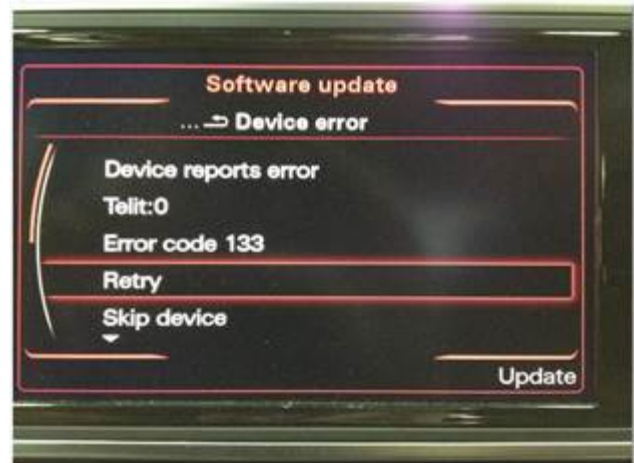
Figure 7. A device requiring a 'Skip device' selection.

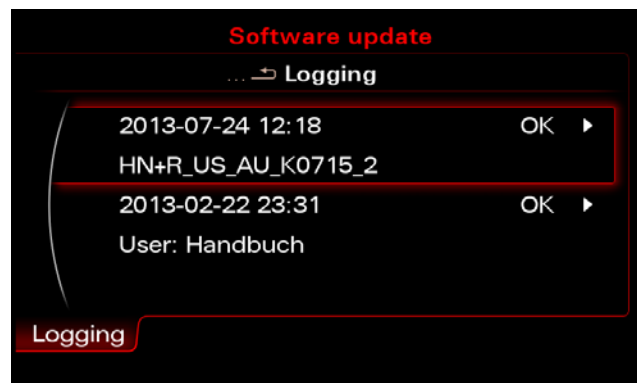
Figure 8. Software update log showing a successful software installation.

- Verify that the software update has been completed successfully by accessing the logging page (Figure 8). To access this screen, proceed to step 8 in TSB 2028141 and press the lower left softkey. A successful update will show the date the update was performed and the software that was installed (HN+R\_US\_AU\_K0715\_X), with 'OK' listed on the right. The 'X' may be one of several different numbers. If K0715\_X does not have any rows with 'OK', the update must be retried until it is successful.

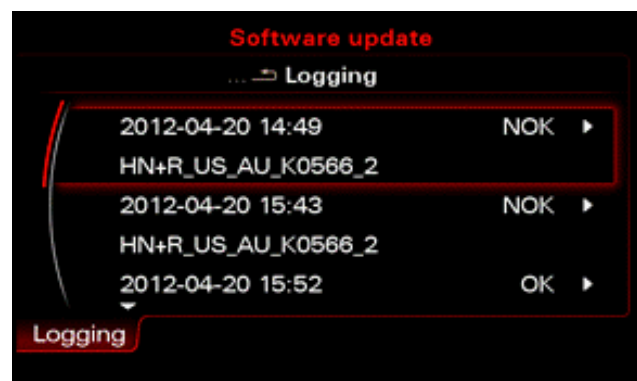
Figure 9. Software update log showing 2 failed attempts before a successful installation.

**Tip:** If the update must be performed two or more times due to modules not updating correctly, a screenshot of the software update log is required (Figure 9). This should be kept on-hand for warranty auditing purposes. To take a screenshot, insert an SD Card into slot 1. For A6/A7/A8/Q7, press and hold the left and right arrow keys at the same time. For A4/A5/Q5, press and hold the bottom two softkeys at the same time. All 4 softkeys will flash when the screenshot is taken. A screenshot should be taken of each page in the logging display.
