Technical Service Bulletin

91 MMI 3G various technical issues (K0133 update)

91 13 97 2034926/1 August 5, 2013.

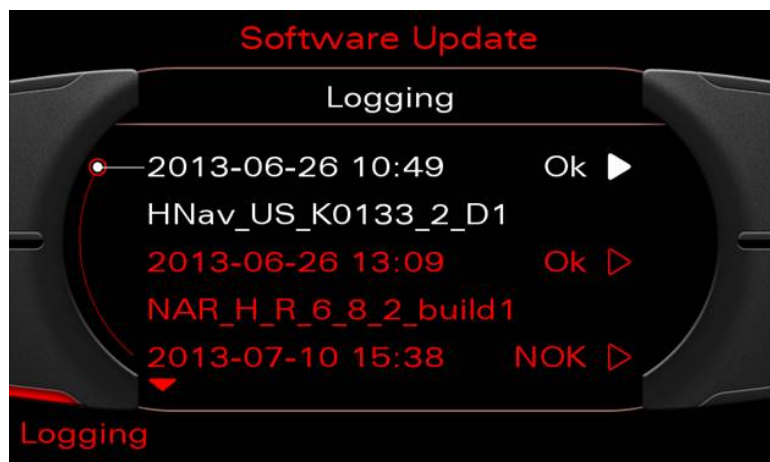
After a successful update, the screen will show the date on which the update was performed and the software that was installed (HN+R_US_AU_K0133_X_XX — The X characters will be one of several different numbers or letters). 'Ok' will be listed on the right. If K0133 does not have any rows with 'Ok', the update must be retried until it is successful.

Figure 1. Software update log showing a successful software installation.

2. Verify that the software update has been completed successfully by accessing the logging page (Figure 1). To access this screen, proceed to step 8 in TSB 2028141 and press the lower left softkey.

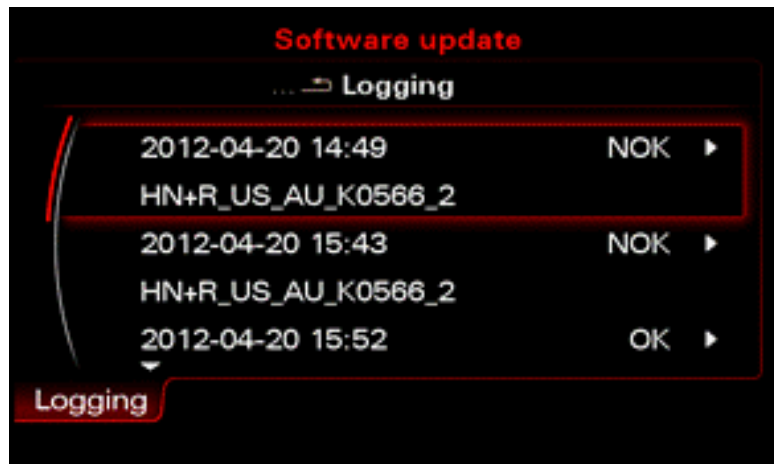
Figure 2. Software update log showing 2 failed attempts before a successful installation (MMI 3G+ screen shown for reference).

Tip: If the update must be performed two or more times because the modules are not updating correctly, a screenshot of the software update log is required (Figure 2). This should be kept on-hand for warranty auditing purposes. To take a screenshot, insert an SD Card into slot 1 and press and hold the left and right arrow keys at the same time. All 4 softkeys will flash when the screenshot is taken. A screenshot should be taken of each page in the logging display.
