Technical Service Bulletin

91 MMI Screen Carrier Shudders/Noisy

91 13 01 2028446/4 August 15, 2013. Supersedes Technical Service Bulletin Group 91 number 12-51 dated August 2, 2012 for reasons listed below.

Model(s)	Year	VIN Range	Vehicle-Specific Equipment
A6, A7	2012	All	Not Applicable

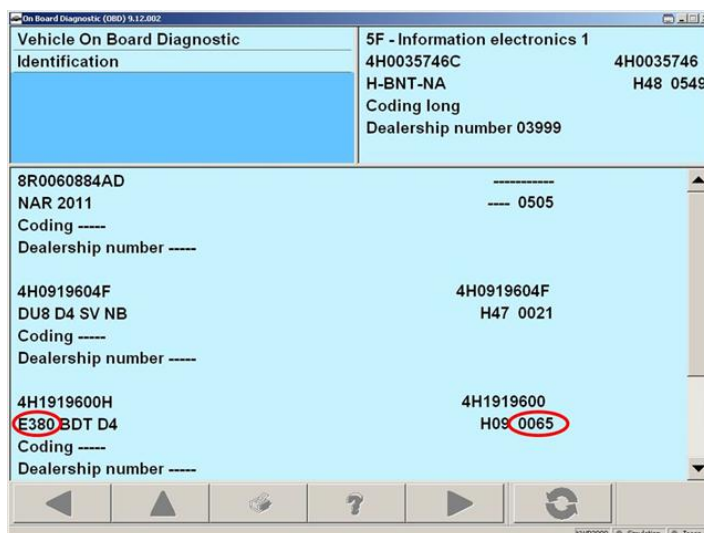
Figure 1. Location of E380 software version.

2. Using GFF, determine the software level of the E380 controller. This can be accessed through *Vehicle Self-Diagnosis >> On Board Diagnostic (OBD) >> 5F- Information Electronics 1* (Figure 1). It will be the third item on the list.

- If the software is *below* 0204; please continue with this bulletin.
- If the software is 0204 or above, no update is required and the rest of this bulletin does not apply.

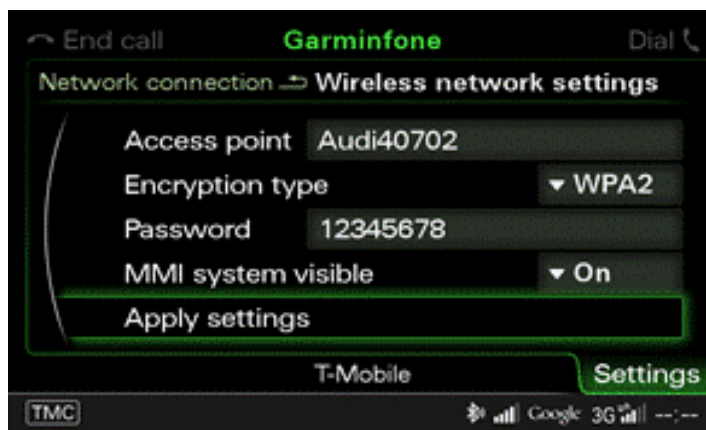
Figure 2. Wireless network settings.

3. As part of the update, wireless settings and paired devices will be deleted. All devices will need to be re-paired after the update, and all wireless settings restored to the customer's settings. To access the Wireless Network Settings on the MMI (Figure 2), press *TEL >> Settings >> Wireless network connection >> Wireless network settings*. Record all settings so they can be re-entered at the end of the procedure.

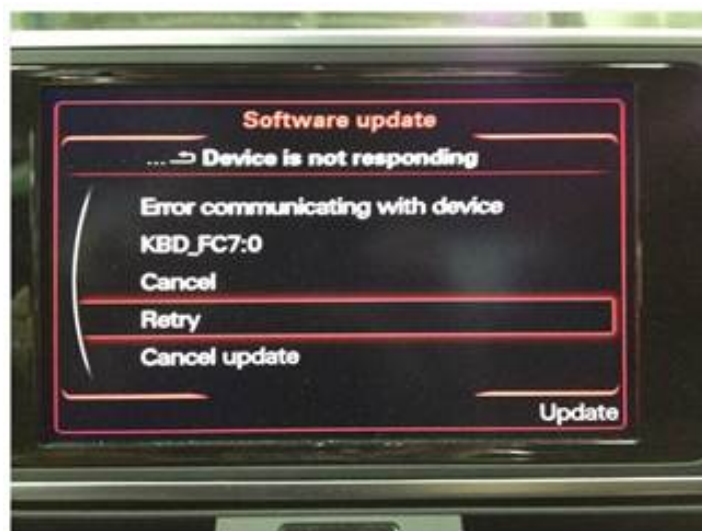
Figure 3. A device requiring a 'Cancel' selection.

Some earlier model year 2012 vehicles or vehicles equipped with Bose sound systems may experience certain modules that will not update properly during Step 16 of TSB 2028141. If this should occur, either choose 'Cancel' (Figure 3), or 'Skip device' (Figure 4), depending on the type of error. Do *not* choose 'Cancel update', as this may cause the software update to fail entirely. After the update is finished and the summary page is shown, select 'Retry' at the bottom of the list if it is available to attempt to update the modules again. If 'Retry' is greyed out, then the software update was successful, so select 'Continue' to proceed. In some cases 'Retry' may have to be repeated two or three times to get all modules to update successfully.

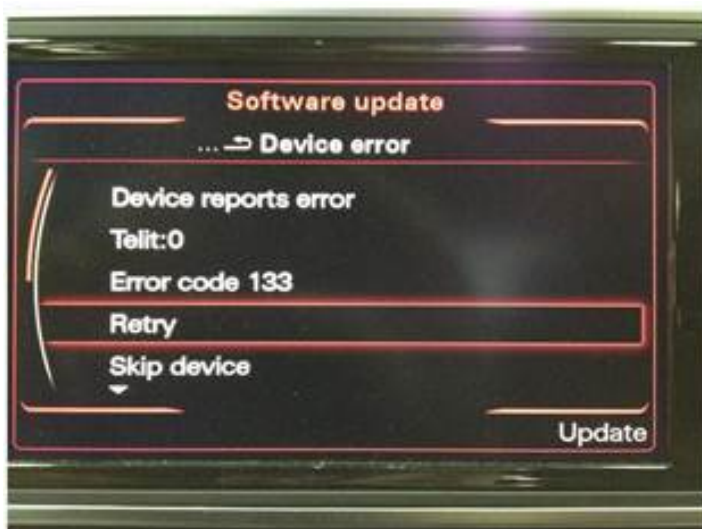
Figure 4. A device requiring a 'Skip device' selection.

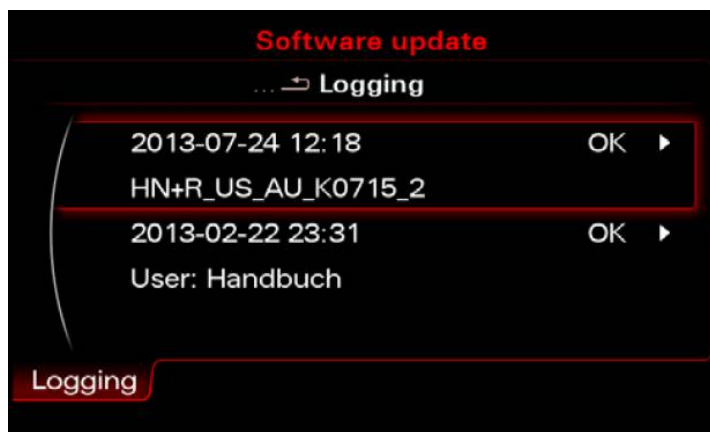
Figure 5. Software update log showing a successful software installation.

5. Verify that the software update has been completed successfully by accessing the logging page (Figure 5). To access this screen, proceed to step 8 in TSB 2028141 and press the lower left softkey. A successful update will show the date the update was performed, the software that was installed (HN+R_US_AU_K0715_X), with 'OK' listed on the right. The 'X' may be one of several different numbers. If K0715_X does not have any rows with 'OK', the update must be retried until it is successful.

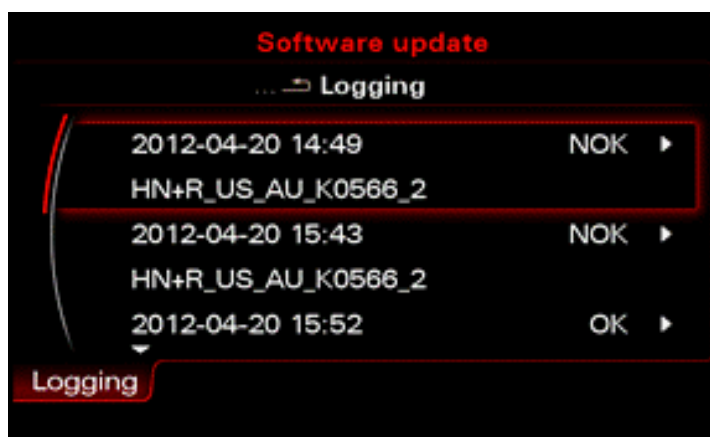
Figure 6. Software update log showing 2 failed attempts before a successful installation.

Tip: If the update must be performed two or more times due to modules not updating correctly, a screenshot of the software update log is required (Figure 6). This should be kept on-hand for warranty auditing purposes. To take a screenshot, insert an SD Card into slot 1 and press and hold the left and right arrow keys at the same time. All 4 softkeys will flash when the screenshot is taken. A screenshot should be taken of each page in the logging display.
