Technical Service Bulletin

87 Air conditioning inoperative

87 13 44 2020124/11 August 26, 2013. Supersedes Technical Service Bulletin Group 87 number 13-43 dated July 12, 2013 for reasons listed below.

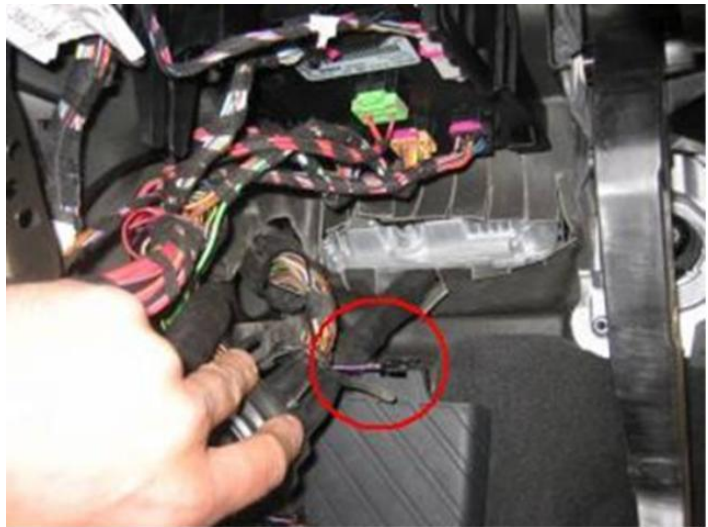
There are two known sections in the wiring harness that can be affected, but the potentially affected areas are not limited to these two known sections. One of the known sections is in the driver's footwell area where the wire harness enters the interior of the car from the engine bay (Figure 1).

Figure 1. Wire harness in driver footwell area.

6. If a cut wire is found, install an overlay wire for the LIN bus signal. Do *not* attempt to repair the existing wire harness.

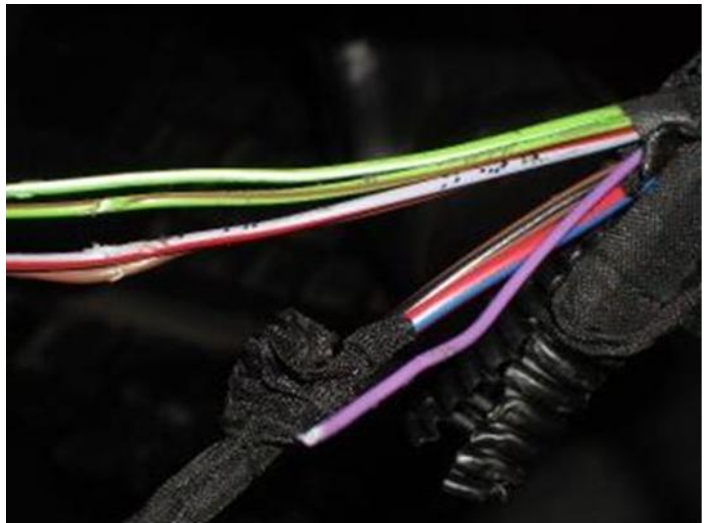
The second known section is in the wire harness located under the driver's side headlight (Figure 2).

Figure 2. Wire harness under driver's side headlight.

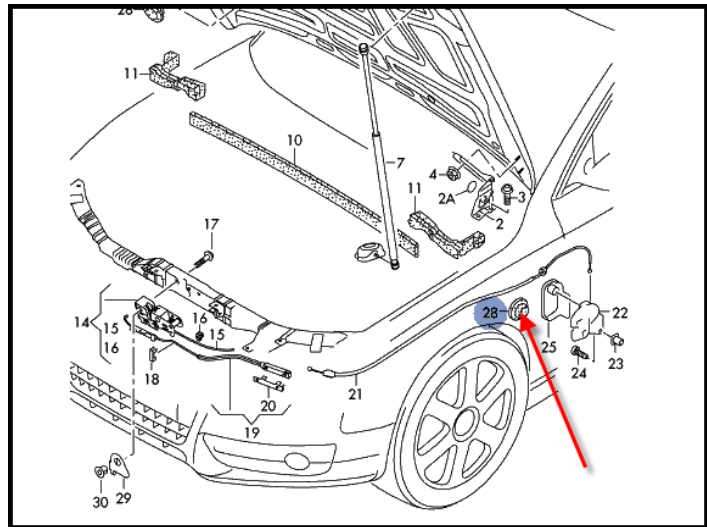
Figure 3. Grommet in driver's side fender/lower A-pillar area used for pass-through for new overlay wire.

- a. Route the new LIN bus wire from the vehicle electrical system control module, J519, to the sender for sensor G395 so that it enters the interior of the vehicle through the driver's side fender/lower A-pillar area through the grommet indicated in the images at right (Figures 3 and 4).

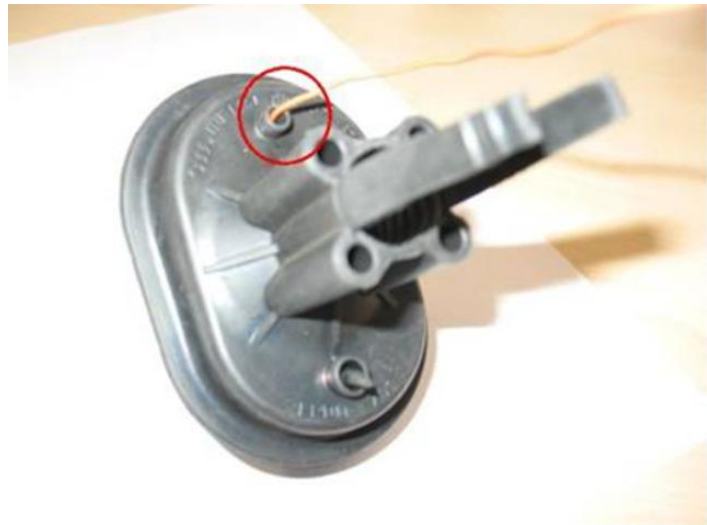
Figure 4. Access hole in grommet.

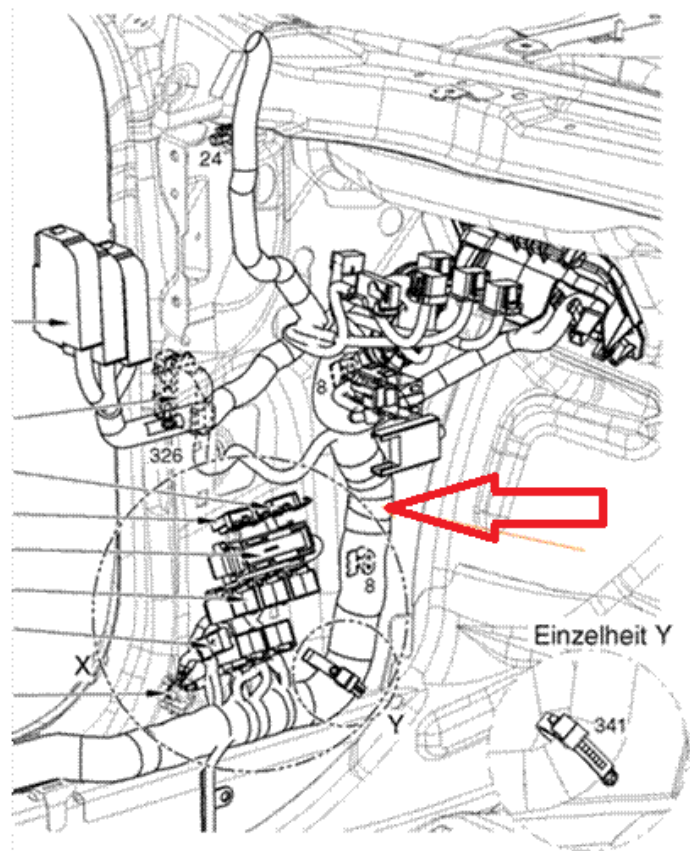
Figure 5. Cable routing with charisma switch option.

On vehicles with a charisma switch (ride selection switch located on the instrument panel) route the new cable of the sender for sensor G395 to junction B549 (Figure 5, red arrow).

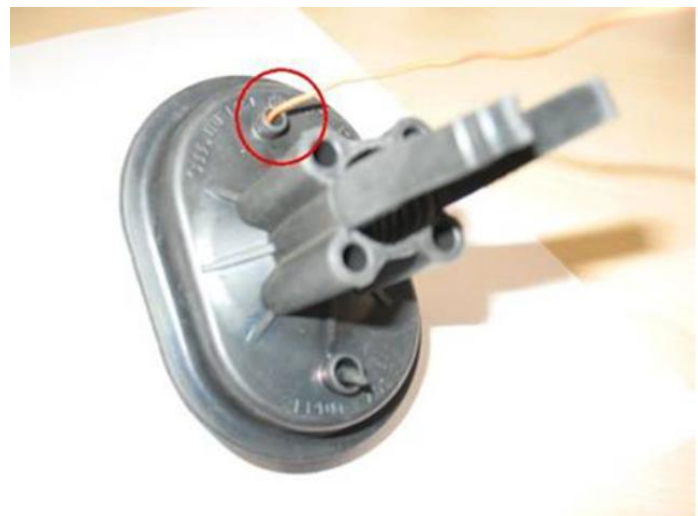
Figure 6. Access hole in grommet to be sealed with Butyl sealant.

- b. Seal off the opening around the wire with Butyl sealant to prevent water intrusion (Figure 6).
