Technical Service Bulletin

64 Squeaking noises during window operation

64 13 30 2034955/2 August 23, 2013. Supersedes Technical Service Bulletin Group 64 number 13-28 dated August 12, 2013 for reasons listed below.

Model(s)	Year	VIN Range	Vehicle-Specific Equipment
A8	2012	All	Not Applicable
A8	2013	000001 - 030112	Not Applicable

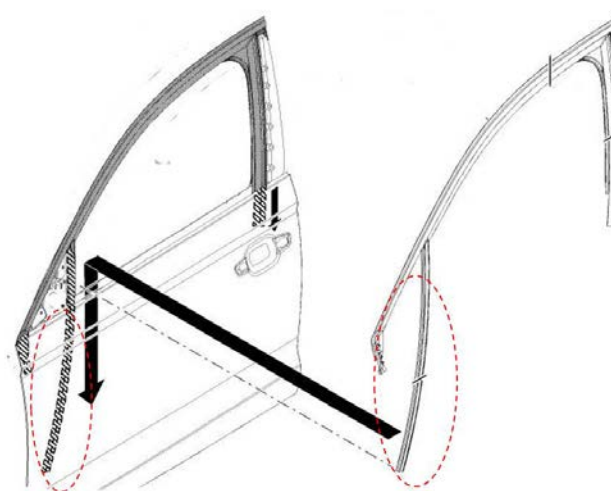
When the window guide seal (Figure 1) is not correctly fitted in the rail of the front door, it can lead to increased friction. This increased resistance causes the squeaking noises.

Figure 1. Front door window guide seal.

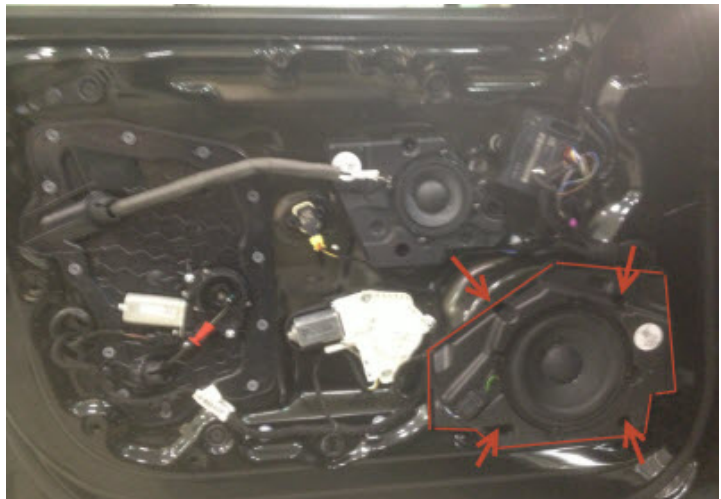
Figure 2. Front inner door panel removed, with bass speaker outlined in red.

1. Confirm that the squeaking noises are coming from the window guide, then check the installation of the window guide seal by following the steps below.
2. Remove the inner door panel on the affected side, then remove the bass speaker. See the Elsa Repair Manual for instructions.

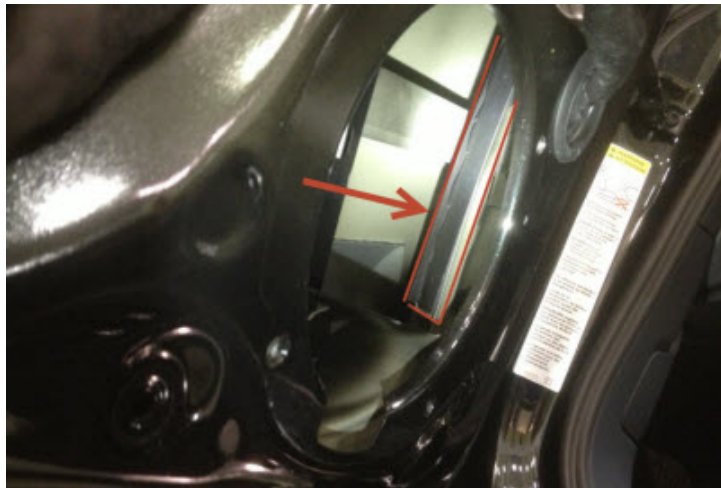
Figure 3. Access to window guide with door speaker removed.

3. With the bass speaker removed, the window guide is accessible (Figure 3). Examine the installation of the window guide seal:

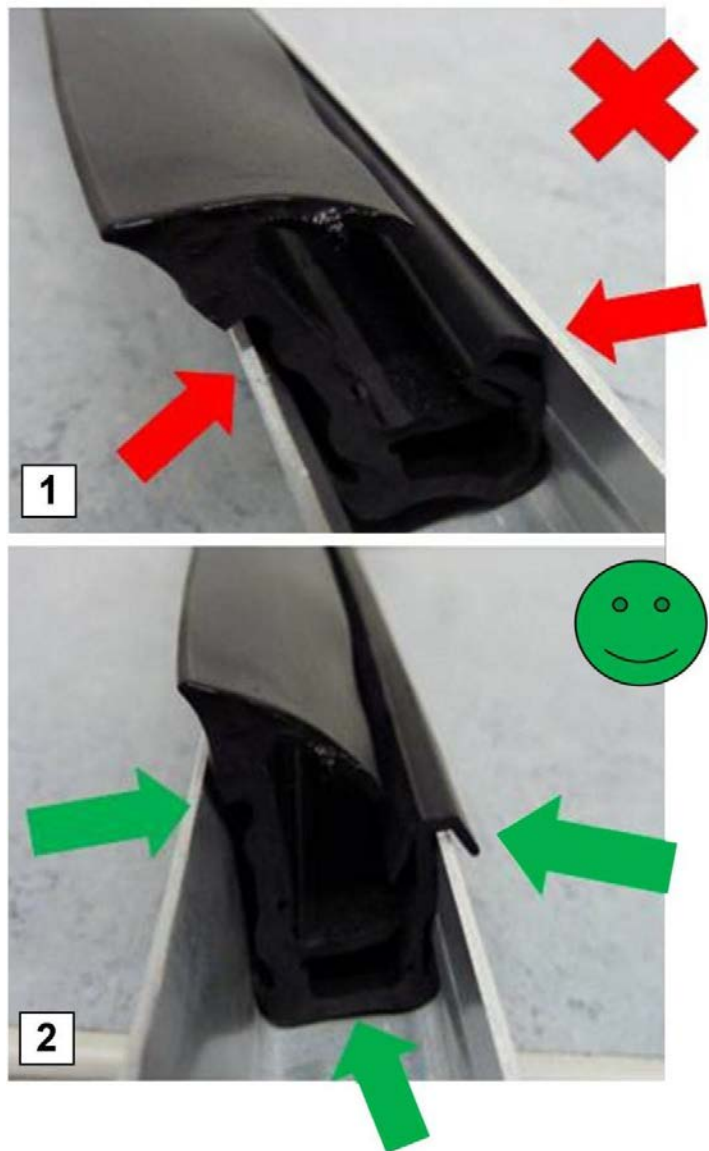
Figure 4. An incorrectly-fitted guide seal (1) and a correctly-fitted guide seal (2).

- If the window guide seal is not correctly positioned and the support lips are pushed into the guide (Figure 4, 1), adjust the seal so that it is correctly positioned in the guide (Figure 4, 2).

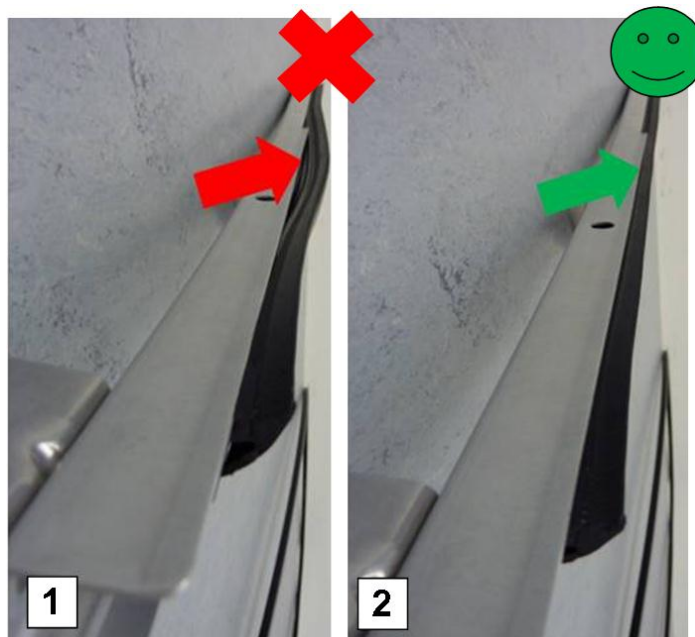
Figure 5. An incorrectly-installed guide seal (1) and a correctly-installed guide seal (2).

- If the window guide seal is not installed across the complete length of the guide (Figure 5, 1), adjust the seal so that it is installed across the complete length of the guide (Figure 5, 2).
