# Technical Service Bulletin

## 64 Squeaking noises during window operation

64 13 28 2034955/1 August 12, 2013.

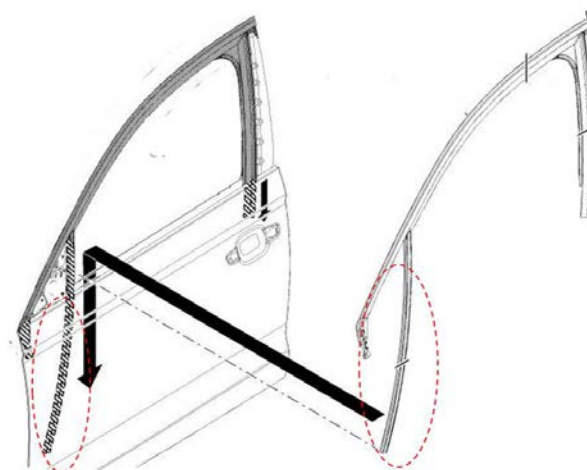
If the squeaking noises are coming from the window guide, check the installation of the window guide seal (Figure 1).

Figure 1. Front door window guide seal.

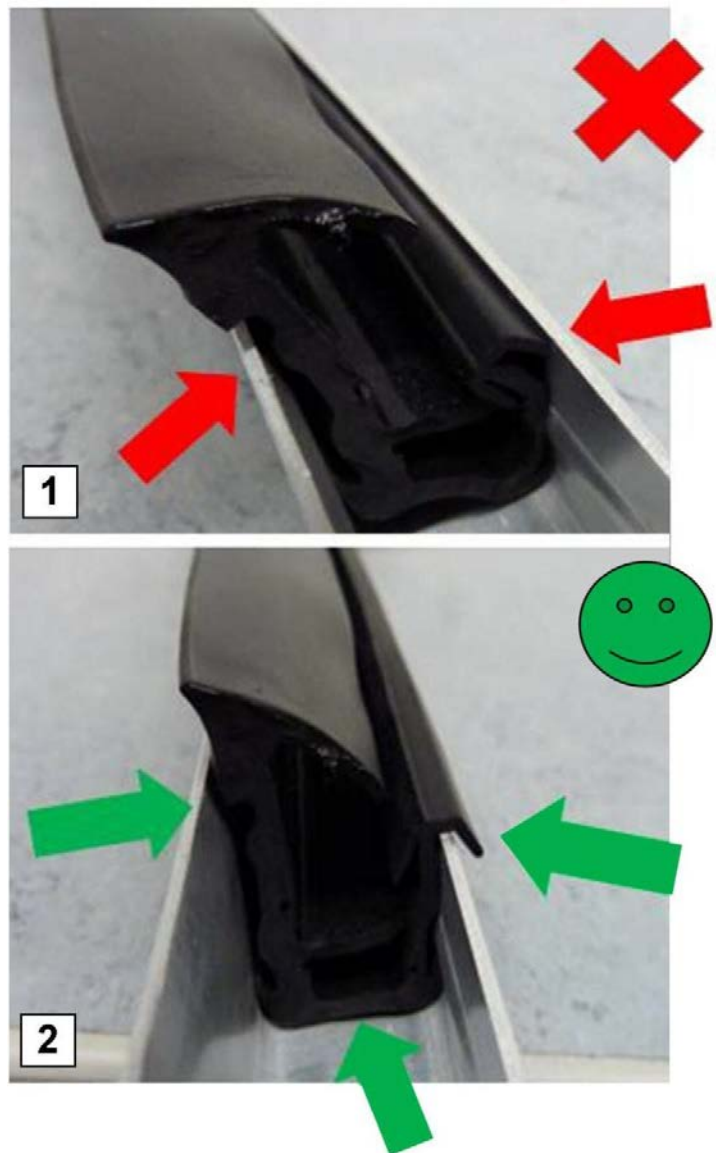
When the window guide seal is not correctly fitted in the rail of the front door, it can lead to increased friction. This increased resistance causes the squeaking noises.

- The window guide seal might not be correctly positioned in the guide, so the support lips are pushed into the guide (Figure 2, 1). As a result, the pressure of the guide seal on the window is increased.

**Figure 2.** An incorrectly-fitted guide seal (1) and a correctly-fitted guide seal (2).

Ensure that the window guide seal is correctly positioned in the guide (Figure 2, 2).

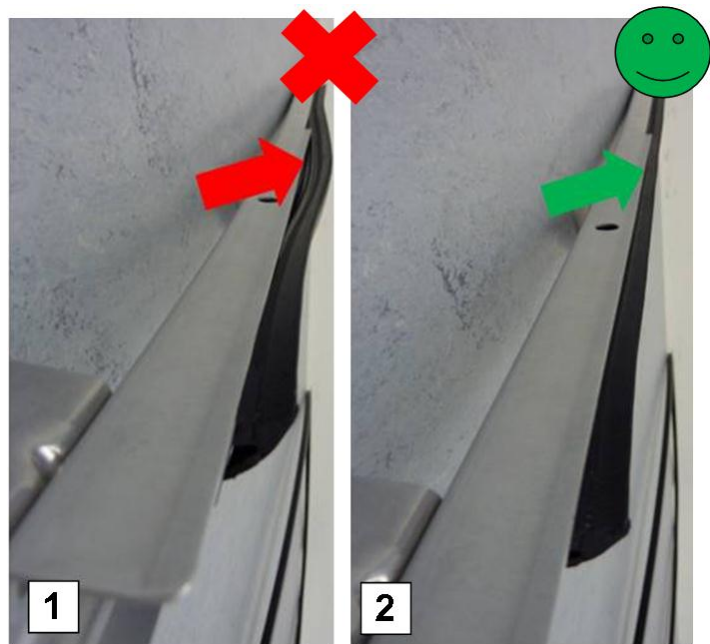
- The window guide seal might not be installed across the complete length of the guide (Figure 3, 1).

**Figure 3.** An incorrectly-installed guide seal (1) and a correctly-installed guide seal (2).

Ensure that the window guide seal is installed across the complete length of the guide (Figure 3, 2).
