Technical Service Bulletin

PSS 64 Noise in rear door windows during operation

64 13 27 2034959/1 August 9, 2013.

Model(s)	Year	VIN Range	Vehicle-Specific Equipment
A7	2012 - 2014	All	Not Applicable

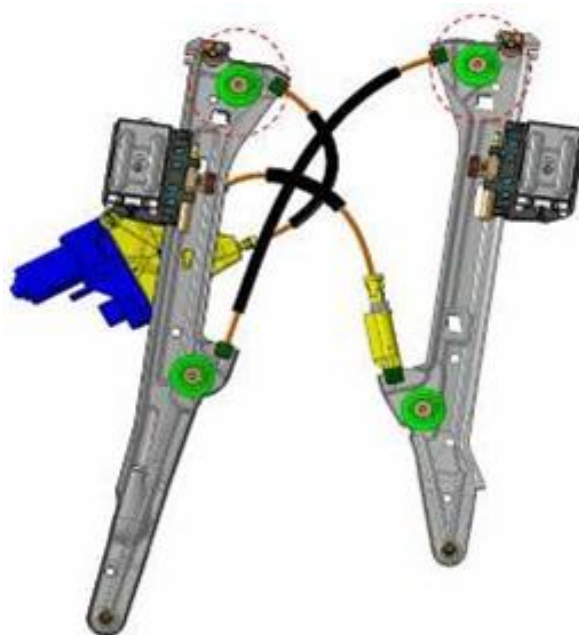
There are noises coming from the rear window during operation. The noises are often characterized as a “grinding” sound.

The noises arise from the mating surface between the drive cable and the upper pulleys (Figure 1). The noises may be more common in higher temperatures.

Figure 1. Upper pulleys of the rear window regulator where the noise is generated.

1. Explain to the customer that a solution is forthcoming and that no repairs are necessary at this point. Do not replace the rear window regulator for this condition since this will not resolve the customer's concern. There is no functional limitation in the window operation.
2. Create a PSS record in the PSS application via the hyperlink in Accessaudi.com (Figure 2) or Technical Assistance page in Elsa (Figure 3).
