# Technical Service Bulletin

## 48 Electric steering column adjustment is inoperative

48 13 51 2017266/6 August 30, 2013. Supersedes Technical Service Bulletin Group 48 number 10-09 dated August 13, 2010 for reasons listed below.

Model(s)	Year	VIN Range	Vehicle-Specific Equipment
A8	2003 - 2010	All	Not Applicable
A6	2005 - 2012		
Q7	2007 - 2015

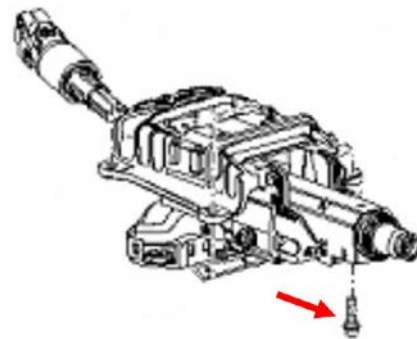
**Figure 1.** The right upper bolt .

1. Remove the steering wheel column trim and detach the right upper bolt (Figure 1).

2. Use a feeler gauge to measure the gap between the steering column and cross carrier:
  - If the gap is *less than* 0.3 mm wide:
    - a. Retighten the upper bolt.

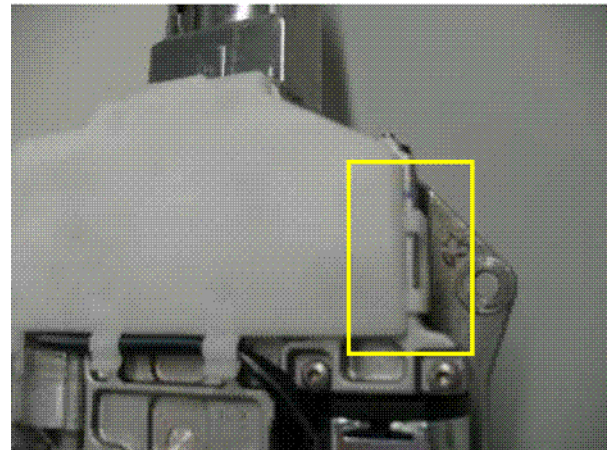
Figure 2. Side clips.

1. Loosen the belt cover of the steering column:
  1. If necessary, remove the footwell and steering column cover.
  2. Move the height adjustment of the steering column to a central position.
  3. Carefully loosen the side clips without damaging the clasps (Figure 2).

Do not disconnect the wiring harness at the side on the cover attachment.

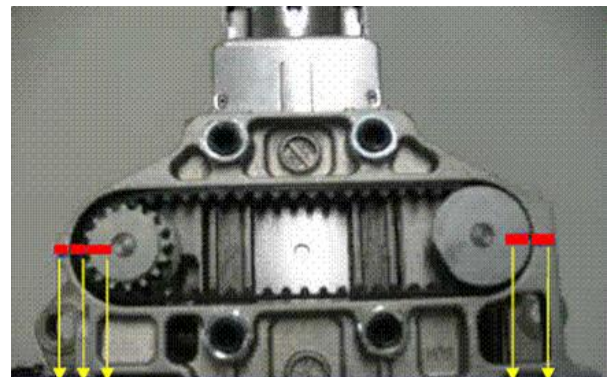
Figure 3. Positions of the gear wheels and gear belt to be marked.

2. Mark the position of the gear wheels and the gear belt on the housing (Figure 3). Use a touch-up pencil so that it is easily noticeable.

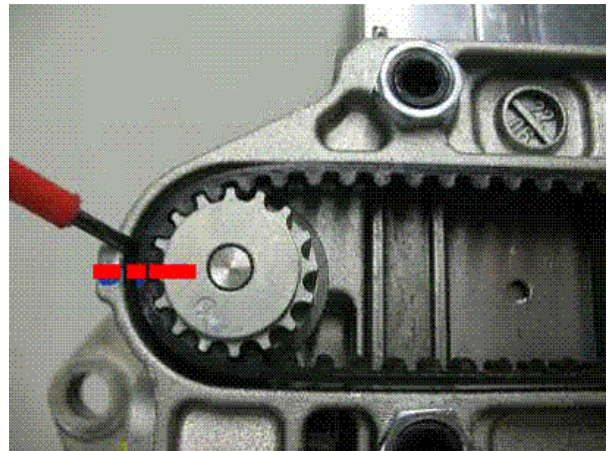
**Figure 4.** Loosening the gear belt with a fine screwdriver.

- Carefully loosen the gear belt from one gear wheel, using a fine screwdriver.

Make sure that the belt does not come off the opposite gear wheel.

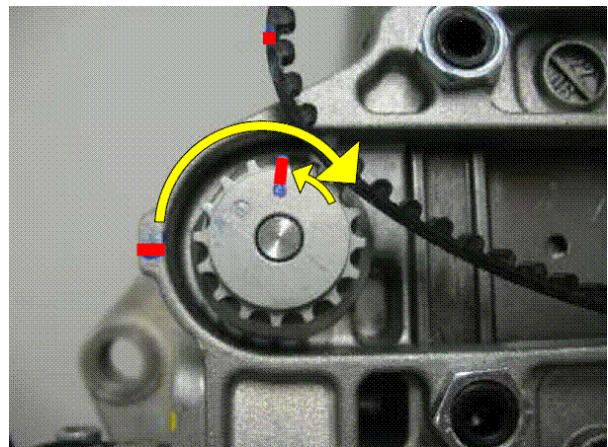
**Figure 5.** Turning the gear wheel to reduce tension.

- Reduce the tension (Figure 5):
  - Turn the gear wheel clockwise by hand until there is no resistance. The gear wheel should now move very lightly.
  - Turn the gear wheel counter-clockwise until a light resistance (hand-tight) is felt.
  - Depending on the measured gap, use the following gear offset:
    - Gap <1mm: 1-2 teeth
    - Gap <1.7mm: 3-5 teeth

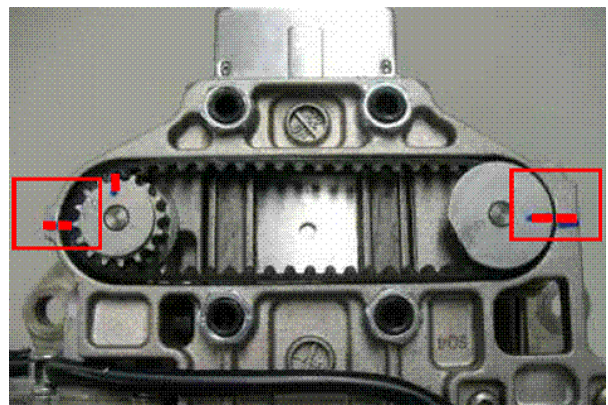
**Figure 6.** The location on which to place the gear belt, with gear offset.

- Place the gear belt by hand on the gear wheel (Figure 6).

The identification on the belt must match the identification on the housing.

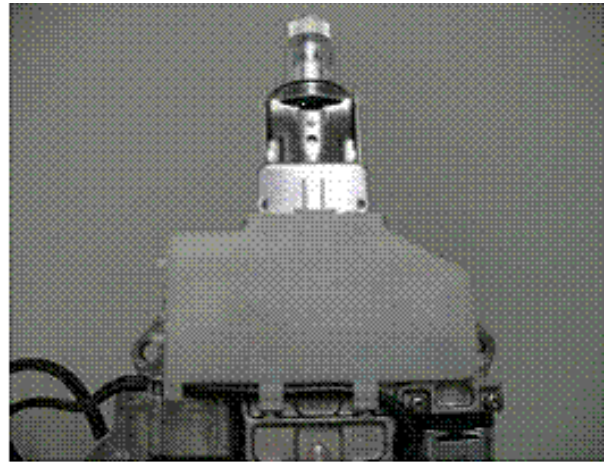
*Figure 7. The cover, installed on the housing.*

6. Carefully reinstall the cover on the housing (Figure 7).
