Technical Service Bulletin

46 Brake noise analysis and handling

46 13 56 2034181/2 August 16, 2013. Supersedes Technical Service Bulletin Group 46 number 13-53 dated August 7, 2013 for reasons listed below.

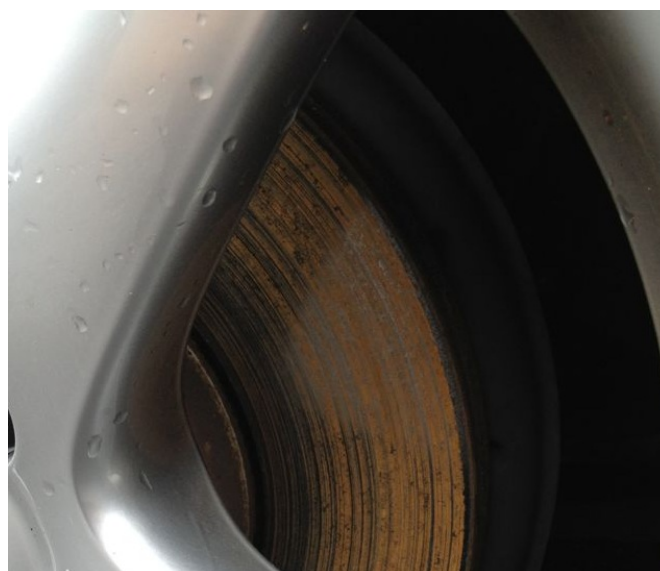
1. Brake discs or brake pads are close to or below their wear limit.
2. Aftermarket pads or discs have been installed.
3. Debris (such as small stones, grit, road salt, or sand) between brake disc and brake pad.
4. Discs are covered with rust. Rust can form when the vehicle has not been driven for a long period of time (Figure 1).

Figure 1. Disc covered with rust.

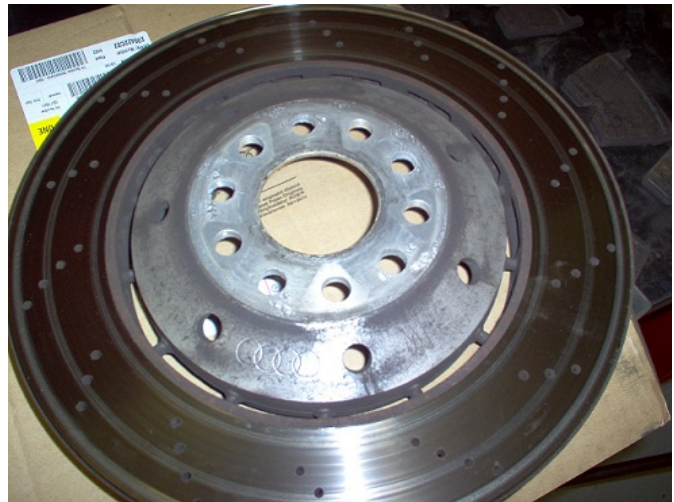
5. Discs are grooved (Figure 2).

Figure 2. Grooved disc.

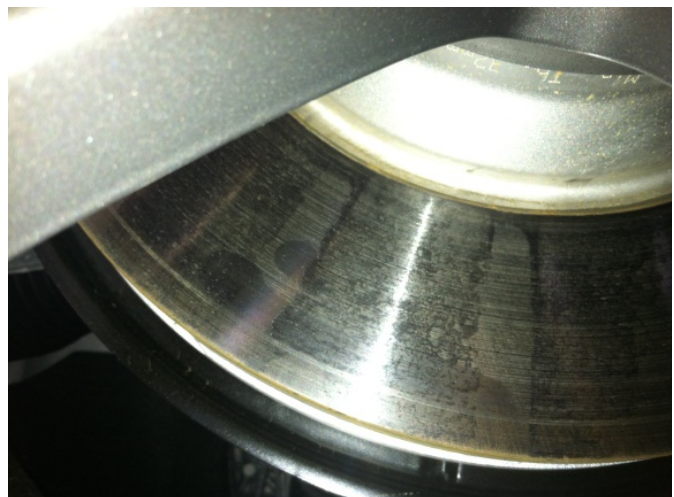
6. There is chemical contamination on the braking surface of the brake disc due to wheel or tire cleaner being sprayed directly onto the brake disc (Figure 3 and Figure 4).

Figure 3. Discoloration on the brake disc due to chemical contamination from cleaner that was sprayed directly onto the disc.

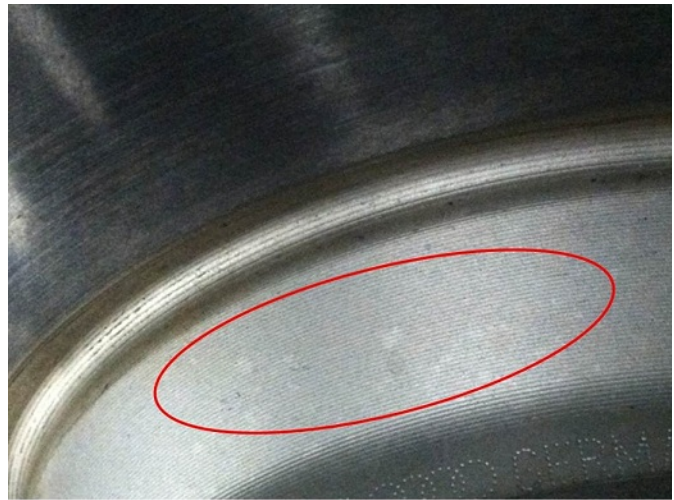
Figure 4. Small spots and discoloration due to chemical contamination from cleaner that was sprayed directly onto the disc.

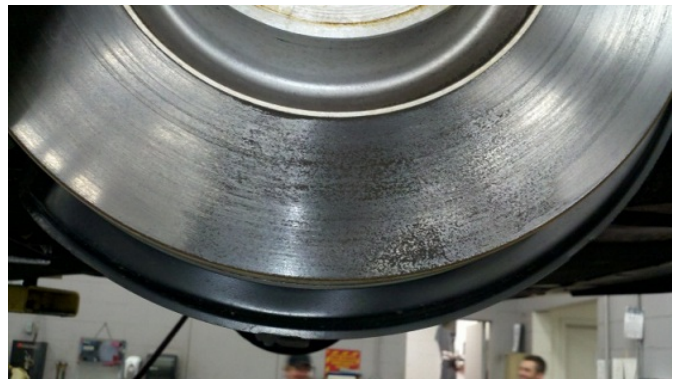
7. There are “pad marks” on the brake disc as a result of brake pad material transferring to the discs (Figure 5). Pad marks can occur when a vehicle has been parked for long periods of time in a wet or snowy environment.

Figure 5. Brake pad material has transferred to the discs.
