Technical Service Bulletin

40 Technical changes on front and rear axle

40 13 33 2026402/2 August 16, 2013. Supersedes Technical Service Bulletin Group 40 number 11-18 dated July 14, 2011 for reasons listed below.

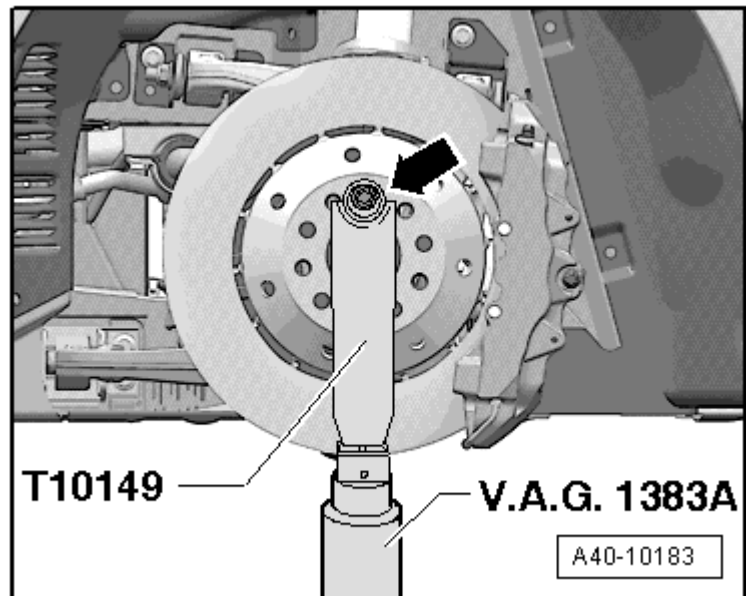
As explained in Elsa, it is essential to simulate the curb height when reassembling the suspension links with bonded rubber bushings (Figure 1).

Figure 1. Tools used when installing links with bonded rubber bushings
