Technical Service Bulletin

40 Front stabilizer bar is noisy

40 13 32 2010330/5 August 16, 2013. Supersedes Technical Service Bulletin Group 40 number 13-31 dated July 19, 2013 for reasons listed below.

Model(s)	Year	VIN Range	Vehicle-Specific Equipment
TT	2004	000001 - 025177	Not Applicable

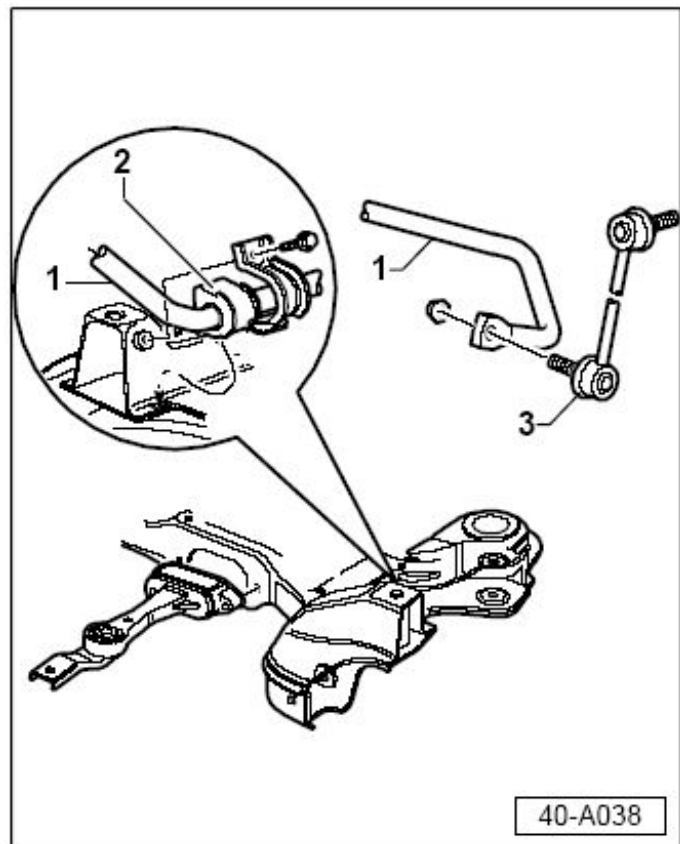
The noise may be caused by the bushing sleeve separating from the stabilizer bar. The noise is generated when the bar moves up and down.

1. Test drive the vehicle to verify customer concern. The noise may only be present when vehicle is either warm or cold.
2. Visually inspect underbody for damage.
3. Inspect the front stabilizer bar (Figure 1, 1) at rubber mount (Figure 1, 2) for any signs of damage, such as the bushing sleeve separated from stabilizer bar.

Figure 1. Front stabilizer bar (1), rubber mount (2) and coupling links (3).

1. Disconnect left and right side coupling links (Figure 1, 3) from front stabilizer bar and move stabilizer bar (Figure 1, 1) up and down several times. Observe rubber mount (Figure 1, 2) for any signs of damage, such as the bushing separated from stabilizer bar.
2. If bushing has separated from stabilizer bar, replace stabilizer bar. (Only new version parts are available as replacement parts).
