# Technical Service Bulletin

## 32 Transmission leaking

32 13 04 August 12, 2013. Supersedes Technical Service Bulletin Group 32 number 08-01 dated December 20, 2007 for reasons listed below.

Model(s)	Year	VIN Range	Vehicle-Specific Equipment
Q7	2007	000000 - 079498	4.2 L

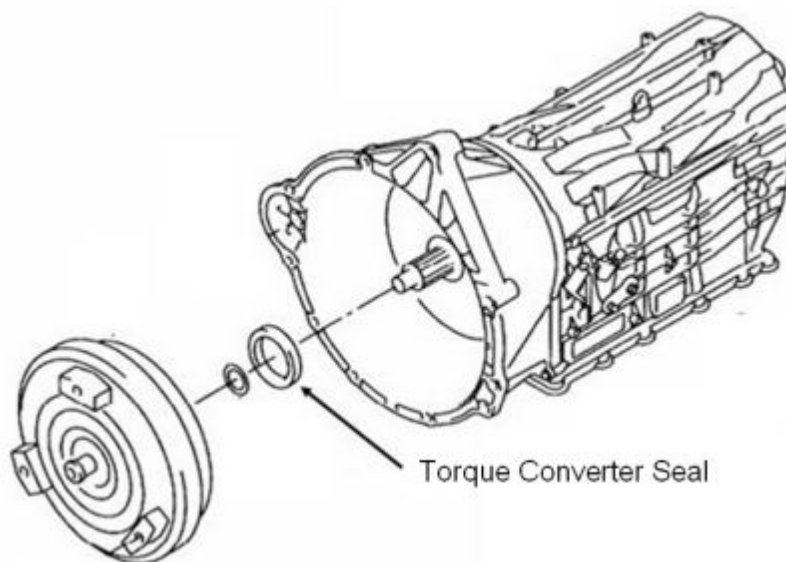
Figure 1. Torque converter seal

ATF is leaking from torque converter oil seal (Figure 1).

Dust/dirt intrusion into the bell housing may damage the seal.

1. Replace the torque converter seal (refer to *Repair Manual Gr.32*).
2. Snap close-out caps into openings at both sides of transmission bell housing.
3. Install starter motor cover during installation of the transmission.
