Technical Service Bulletin

21 Miscolored pipe on turbocharger

21 13 17 2034999/1 August 16, 2013.

Model(s)	Year	VIN Range	Vehicle-Specific Equipment
S6	2013-2015	All	4.0T FSI
S7	2013-2015		
A8	2013-2015		
S8	2013-2015		
RS7	2014-2019

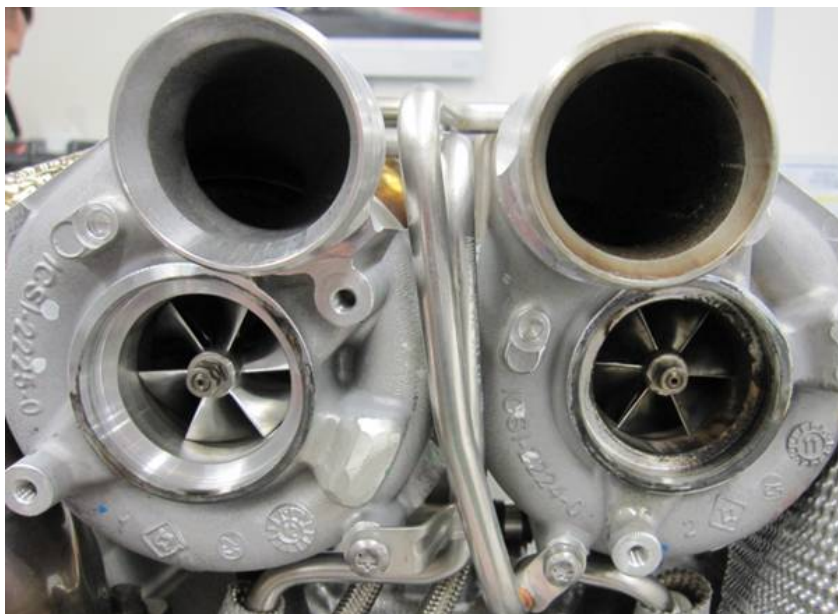
On 4.0l bi-turbo FSI engines, the pipe on the impeller side of the bank 2 turbocharger looks discolored when compared to the pipe on the bank 1 turbocharger.

The crankcase breather is only connected to the bank 2 turbocharger inlet. Blow-by gases from the crankcase breather discolor the pipe (Figure 1). This is a normal condition.

Figure 1. The pipe on the impeller side of the bank 2 turbocharger is discolored due to blow-by gases from the crankcase breather.

1. If necessary, explain to the customer that this is a normal condition.
2. Do not replace any parts due to this condition.
