01 MIL on (DTC P2006(00) or P2007(00))

01 13 26 2033919/10 August 29, 2013. Supersedes Technical Service Bulletin Group 01 number 13-20 dated August 2, 2013 for reasons listed below.

Model(s)	Year	VIN Range	Vehicle-Specific Equipment
A6, A7, S4, S5, S5 Cab, Q7, Q5	2013	All	3.0 FSI Engine

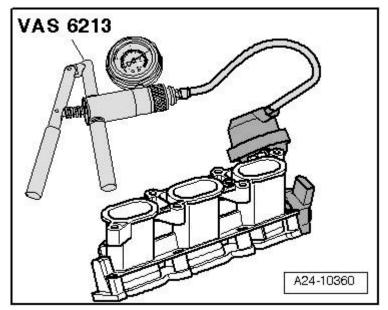
Figure 1. Vacuum pump VAS 6213

Ensure that the fault is not caused by a defective vacuum line by using the vacuum pump (Figure 1) to confirm there is no leak in the vacuum supply to the actuators.

The vacuum lines are working correctly if they are able to maintain vacuum while the actuators are disconnected and the lines are plugged up.

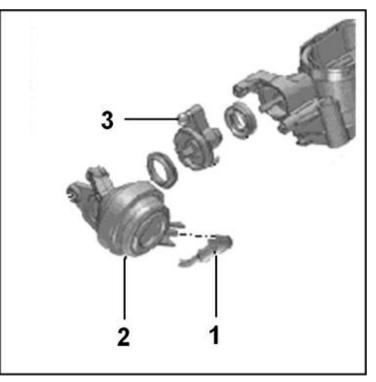
Figure 14. Vacuum hose (1), vacuum actuator (2), and ball head (3)

One of the vacuum actuators on intake runner bank 1 or bank 2 is defective. It is possible that the membrane on the vacuum actuator may tear. As a result, the intake manifold flaps do not function.

11. Pry the vacuum actuator (Figure 14, 2) off of the ball head (Figure 14, 3), then disconnect the vacuum hose (Figure 14, 1).

- 12. Reinstall the new actuator by following the above steps in reverse order.
- 13. Top off coolant, if necessary.
