Technical Service Bulletin

01 Mil on (DTC P0491/P0492 secondary air system bank 1/2 through-flow too low/malfunction)

01 13 25 2035002/1 August 23, 2013.

Model(s)	Year	VIN Range	Vehicle-Specific Equipment
A8	2011-2012	000001 - 999999	4.2 FSI

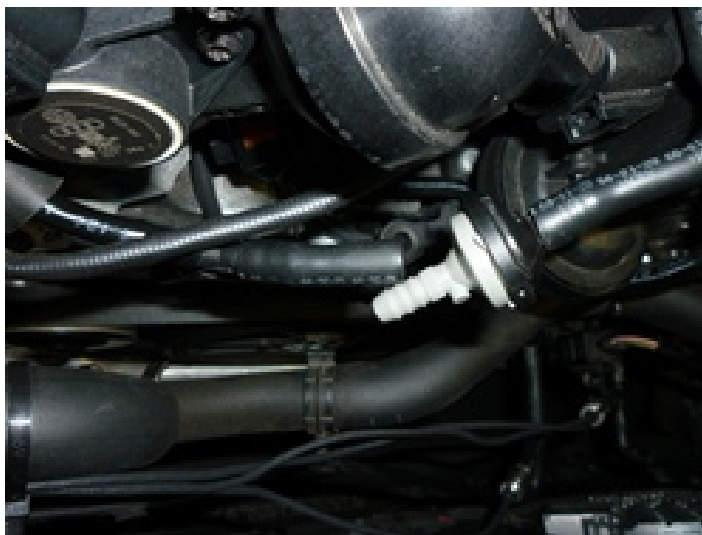
Figure 1. Vacuum check valve.

During the catalyst heating phase, the secondary air valves could close too early if vacuum supply is low. Low vacuum supply can be a result of a leak in the vacuum system, so it is necessary to check the entire system for leaks.

1. Check the vacuum check valve for leaks (Figure 1). The direction of flow should only be towards the intake manifold.

If a leak is found at the check valve, replace the valve and recheck.
