# Analyzing squeaking windows on frameless doors (A5/A7) Sample video

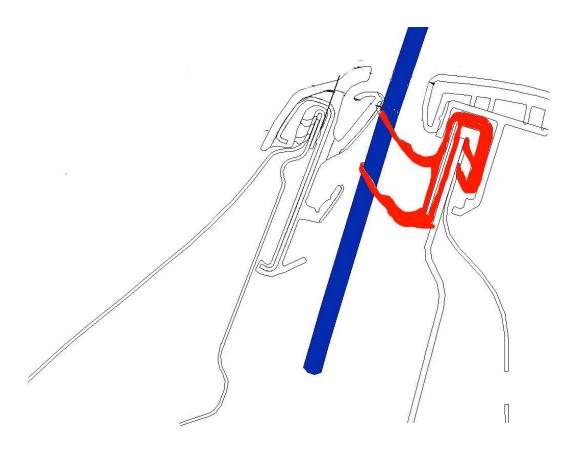
Frequently, excessive contact pressure between the door window pane and the inner window slot trim strip is the cause of squeaking door windows.

Blue: door window

Red: inner window slot trim strip

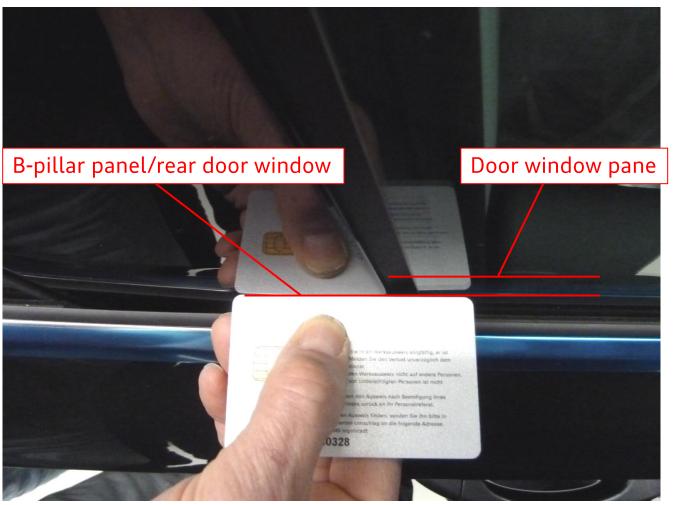
The first step is to check the installation position of the door window in the vehicle.

If the window pane is too far in the center in relation to the vehicle, this is the first sign that a window may be squeaking.

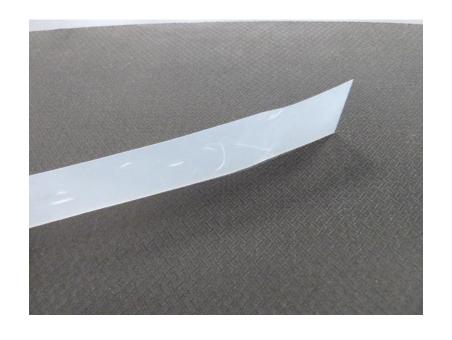
It is very easy to analyze whether the contact pressure between the inner window slot trim strip and the door window pane is too great.

To do this, a film strip of around 20 x 4.5 cm in size is required. It is important to ensure that this film is approx. 0.3 mm thick.

Film strips can be made from folder film/label tabs, such as Avery no. 05113081.

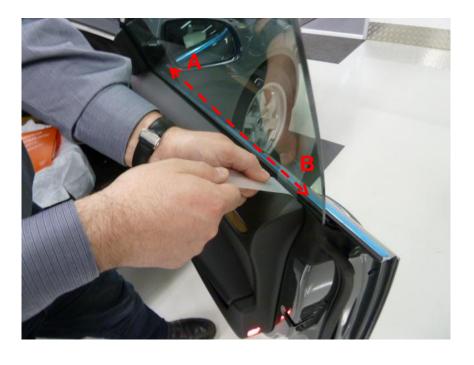
Using this film, you can now analyze whether the pressure between the window trim slot strip and the door window panes is too great.

In order to insert the film between the inner window slot trim strip and the door window pane, the door window must be gently pushed outwards.

Now slide the inserted film from A to B; this will determine whether there is a specific area in which it is considerably harder to slide/pull the film.

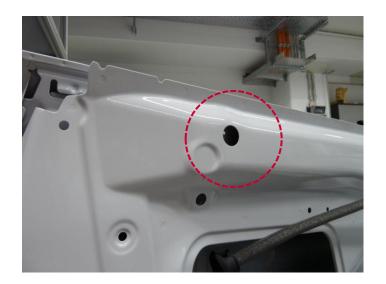
If the door window is now too low in the area around

the vehicle's B-pillar or the pressure between the

using the top contact point on the B-pillar. To change the position, loosen the nut and rotate the inner torx to position the door window pane in relation to the B-pillar.

1 revolution = 1.25 mm

The door window must not protrude into the B-pillar panel/rear door window! The vehicle must continue to be wind and watertight.
