Technical Service Bulletin

01 MIL on (DTC P2006(00) or P2007(00) stored in ECM)

01 13 03 2033919/3 May 29, 2013. Supersedes Technical Service Bulletin Group 01 number 13-02 dated May 29, 2013 for reasons listed below.

Model(s)	Year	VIN Range	Vehicle-Specific Equipment
A6/A7, S4, S5, S5 Cab, Audi Q7, Audi Q5	2013	All	3.0 FSI Engine

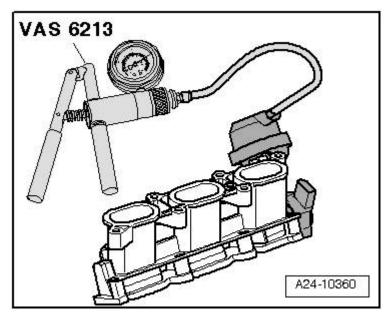
Figure 1. Vacuum pump VAS 6213

Identify the defective vacuum actuator. Use Guided Fault Finding (GFF), or use the vacuum pump (Figure 1) to determine which actuator is defective.
