Technical Service Bulletin

01 MIL on, no start or rough running (DTC P0087 - Rail fuel pressure too low or DTC P0088 - Rail fuel pressure too high)

01 13 96 2023360/4 May 13, 2013. Supersedes Technical Service Bulletin Group 01 number 13-79 dated March 20, 2013 for reasons listed below.

Model(s)	Year	VIN Range	Vehicle-Specific Equipment
Audi A3	2010 - 2013	All	2.0 TDI clean diesel Engine
Audi Q7	2009 – 2013	All	3.0 TDI clean diesel Engine
Audi A8	2014	All	3.0 TDI clean diesel Engine

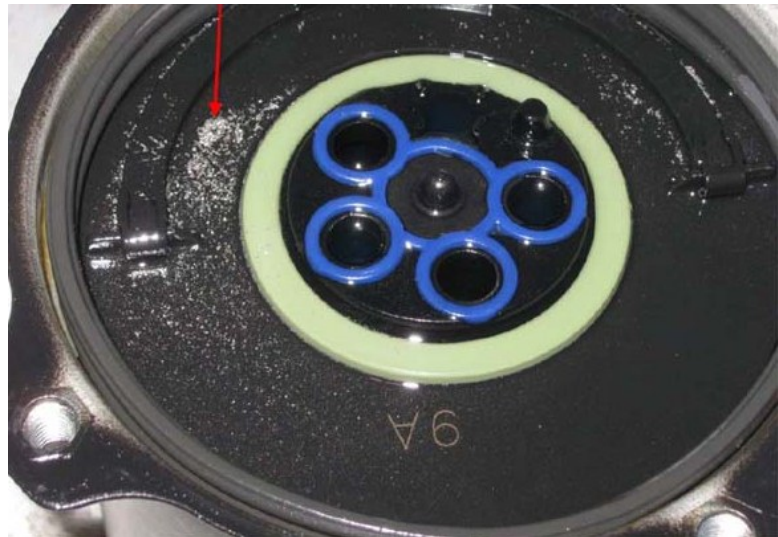
Figure 1. Example of metal shavings and debris on top of fuel filter. Some shavings can be picked up with a magnet.

If there is any indication of fuel contamination, metal shavings/debris, or rust inside the fuel filter housing (Figures 1 and 2), open a ticket with the Technical Assistance Center (TAC) **before** attempting any repair.

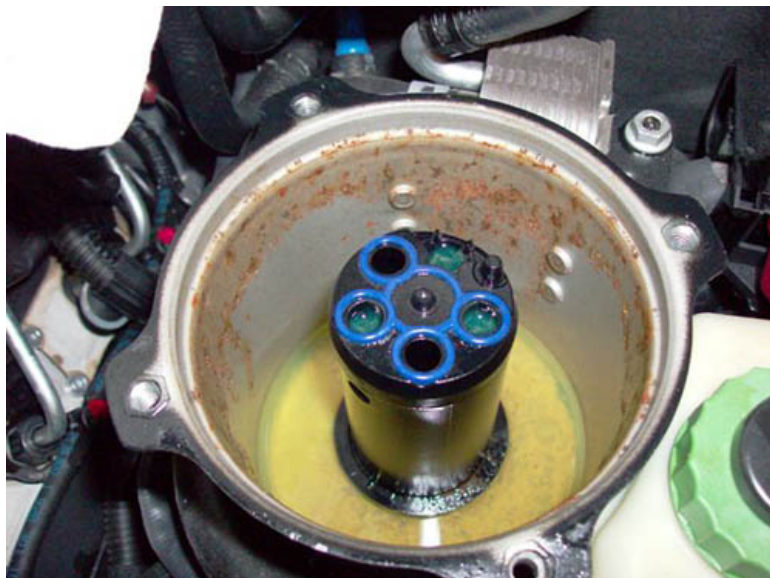
Reasons for fuel contamination can include: water ingress in the fuel station's holding tanks, errors made in fuel transport, or incorrect fuel has been dispensed into the vehicle.

Figure 2. Example of rust in fuel system caused by water contamination.

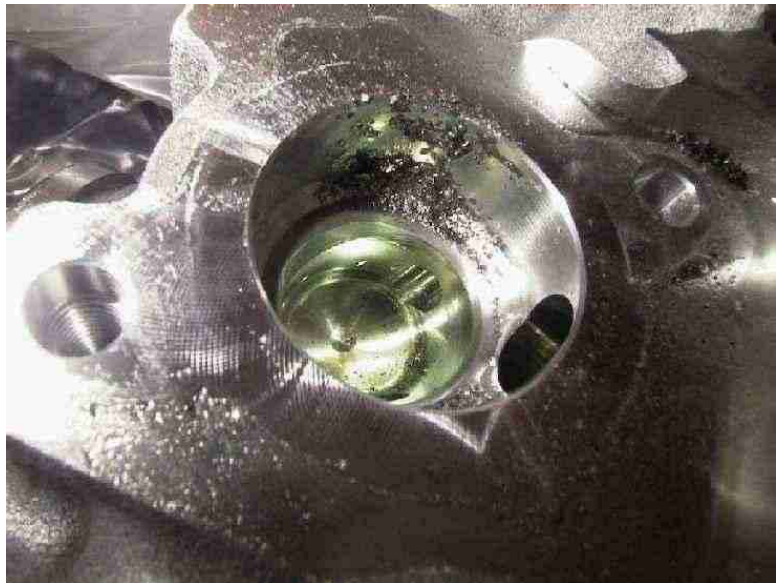
Figure 3. Metallic debris in N290 housing.

If there is any indication of fuel contamination, metal shavings/debris, or rust inside the N290 valve (Figures 3 and 4), open a ticket with the Technical Assistance Center (TAC) **before** attempting any repair.
