Technical Bulletin

91 13 05 February 8, 2013 2031136 Supersedes T. B. V911304 dated January 22, 2013 to include a special claiming note above the warranty table.

Update Programming RCD-510 Radio (Premium 8)

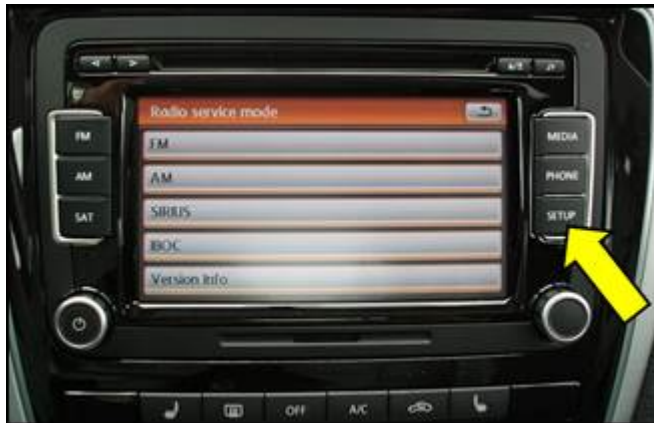
- Switch ignition ON.
- On the radio, hold “setup” button <arrow> for 3 to 5 seconds.
- “Radio service mode” will display <as shown>.

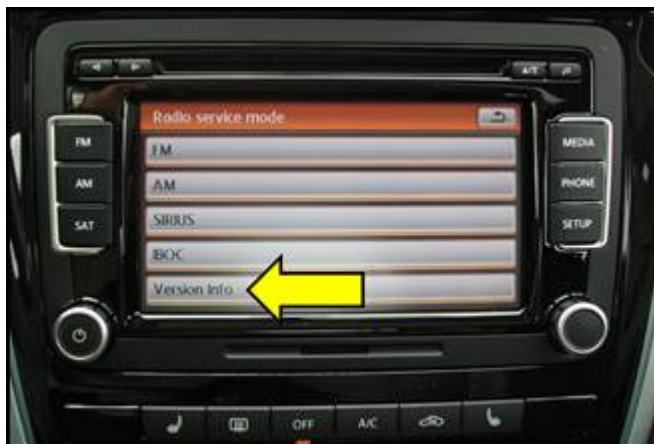
- On screen, press “Version Info” <arrow>.

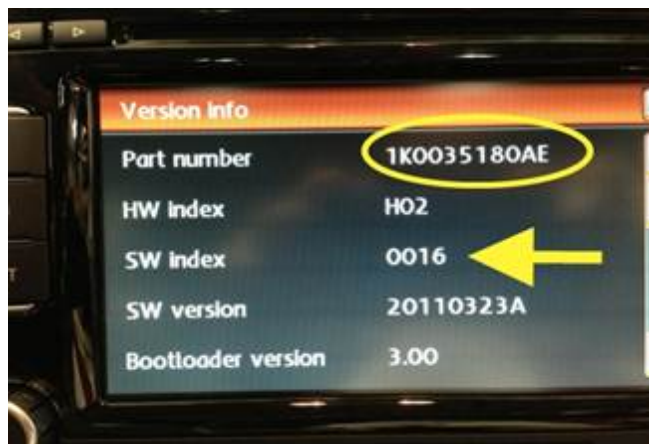
2012 vehicles, software 383F

- Verify current part number is **1K0.035.180.AE, 1K0.035.180.T, 1K0.035.188.D, 1K0.035.188.E** <circle>.
- Verify current SW index is one of the following software levels: 0007, 0008, 0009, 0010, 0011, 0012, 0013, 0014, 0015, 0016 <arrow>.

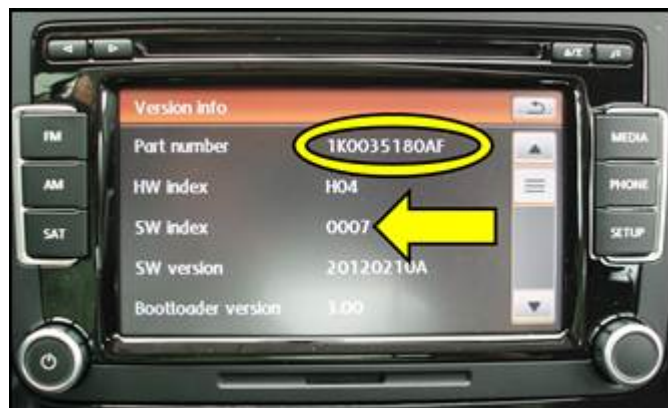
2013 vehicles, software 37DC

- Verify current part number is **1K0.035.180.AF, 1K0.035.180.AG, 1K0.035.188.F, 1K0.035.188.G, 5C6.035.180, 5C6.035.180.A** <circle>.
- Verify current SW index is "0006, 0007, 0008" <arrow>.

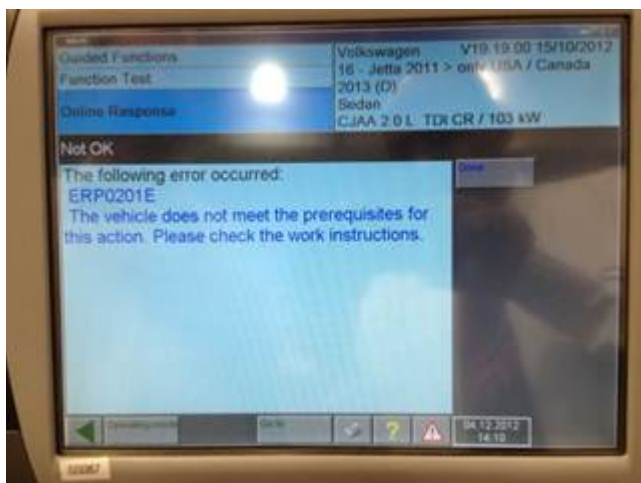
- Wrong radio used will display the following error code.

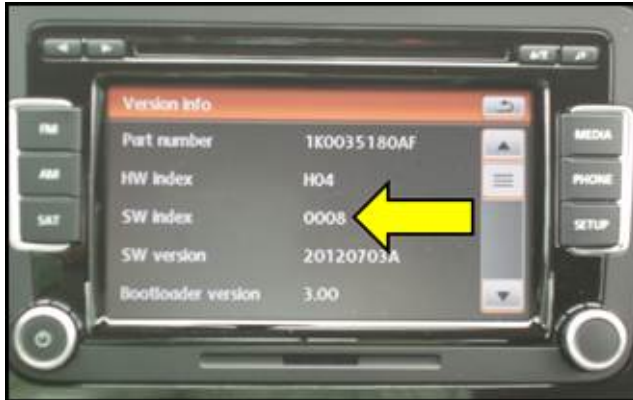
- Press and Hold the “Setup” button for 3 to 5 seconds.
- Verify new “SW index” is “0008, 0009” as shown <arrow>.
