Technical Bulletin

Model(s)	Year	Eng. Code	Trans. Code	VIN Range From	VIN Range To
Golf,GTI, Jetta SportWagen	2010 - 2013	All	All	All	All
Jetta Sedan	2011 - 2013	All	All	All	All
Passat	2012 – 2013	All	All	All	All

69 13 01 February 11, 2013 **2029767** Supersedes T.B. V691202 dated October 2, 2012 to include additional model.

Airbag Warning Lamp Illuminated in Instrument Cluster, DTC B101614 Stored in Airbag Control Module

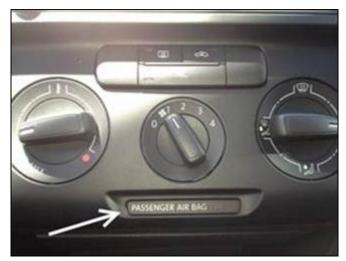
Figure 3 Figure 4

- If DTC is present, clear fault memory and recheck for code.
- If fault clears, and the airbag indicator in the instrument cluster does not illuminate, no repairs necessary.
- If DTC reoccurs, remove center console cover using wedge tool 3409, inspect wiring connections to "PASSENGER AIR BAG WARNING LAMP" (see figures 3 and 4), for loose connection.
- Secure wiring connections as necessary.
- If connection is secure, further diagnosis is needed. This technical bulletin does not apply.
- Clear DTCs again and retest operation to verify airbag lamp is OFF in instrument cluster.
