Technical Bulletin

01 13 05 February 21, 2013 2031341 Supersedes T.B. V011233 dated December 4, 2012 to correct labor operation in warranty table.

DTC P0441 Stored in the Engine Control Module

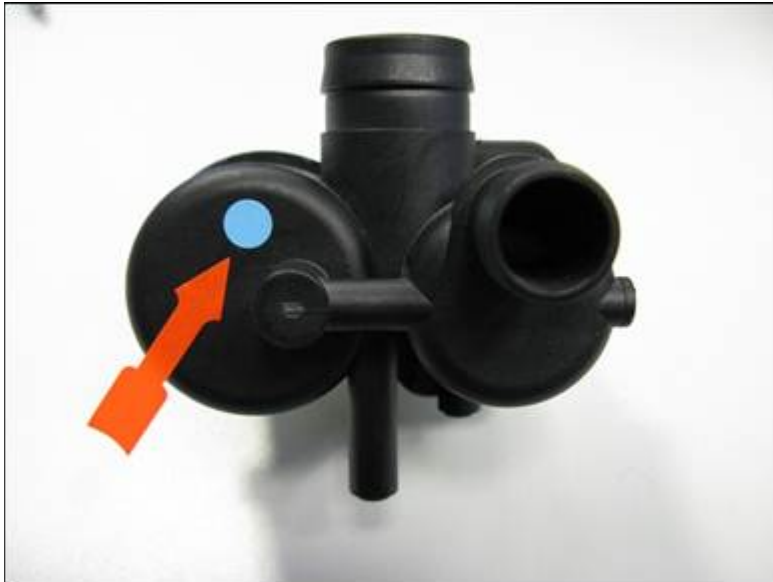
Updated DMTL pumps as of pumps' production date September 2012. (Pumps marked with a dot (color may vary blue, green, white and yellow), implementation dates from plants unavailable at this time).

Dot color may vary blue, green, white and yellow.

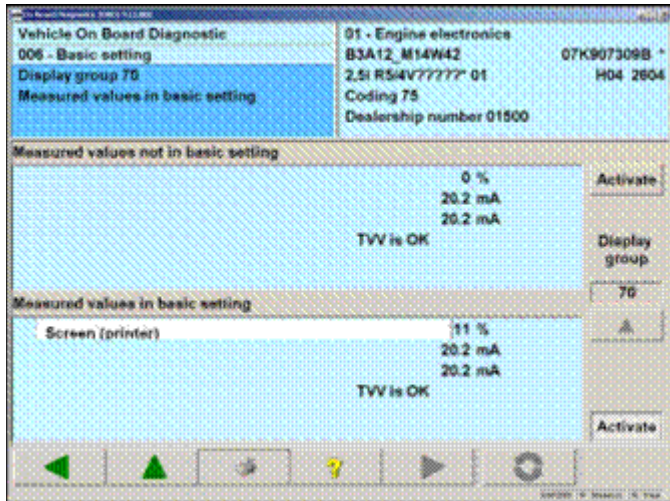
- Check maximum value in row one (lower window).

If maximum value is less than 70%, DMTL is OK, replace the Purge Valve.

If maximum value is greater than 70%, DMTL is not OK and needs to be replaced.

If maximum value is close to 70%, rerun the test 2 more times to get a more accurate reading.
